Project Description – 143 S. High Street

Rob and Noriko Stevens
143 S. High Street
Dublin, Ohio 43017

Description of Conformance – 143 S. High Street

Reference: 143 S. High St.

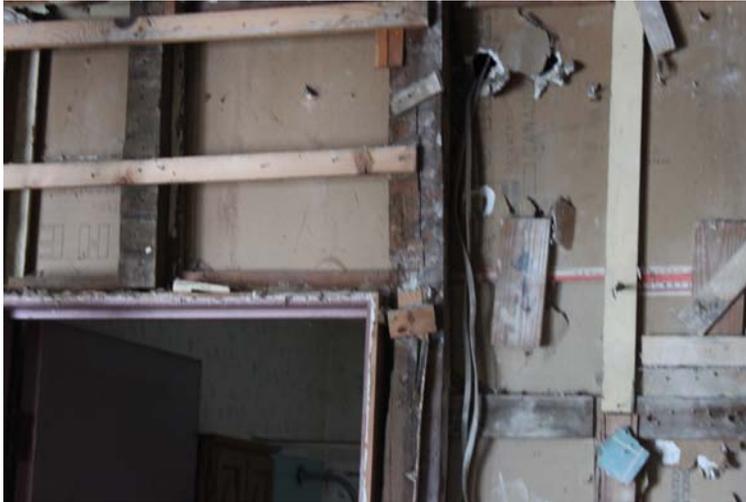
Cracked support post

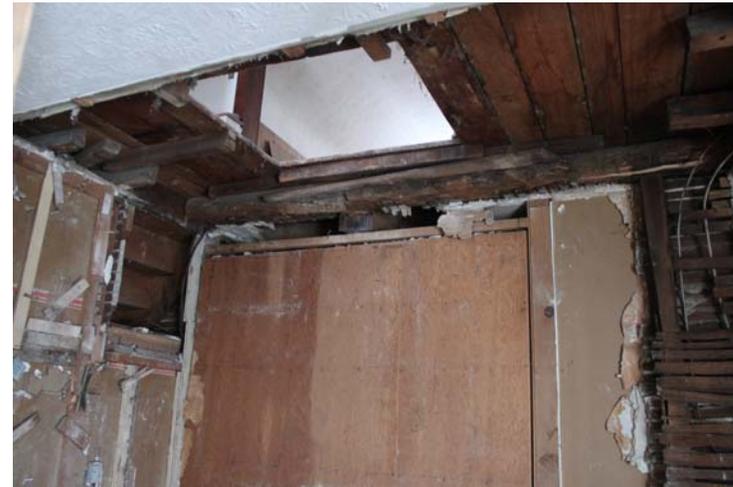
Structurally unsound existing structure

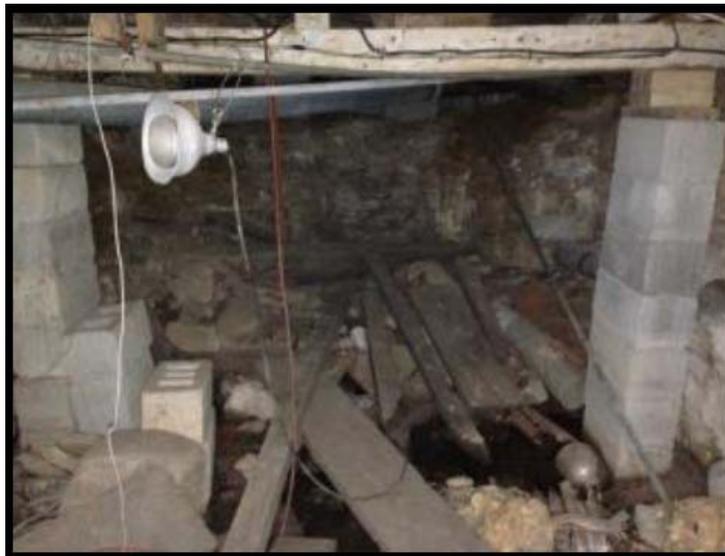
Structurally unsound piers in crawl space

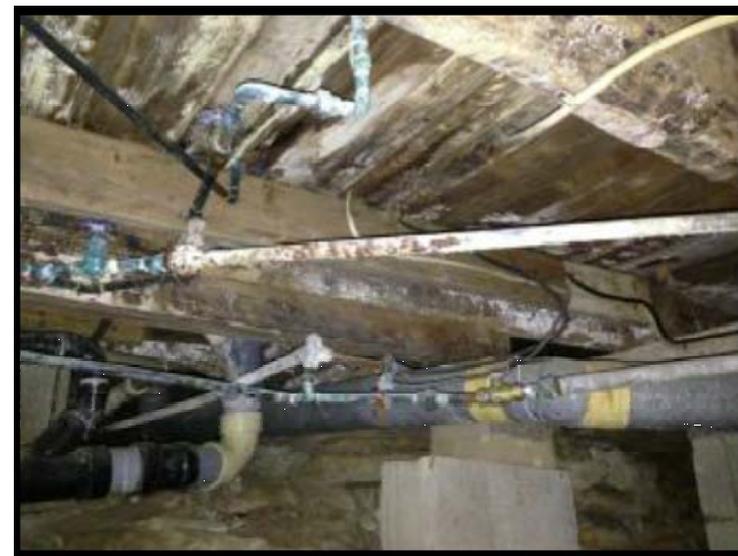
Mold and rot on framing and floor in the crawl space

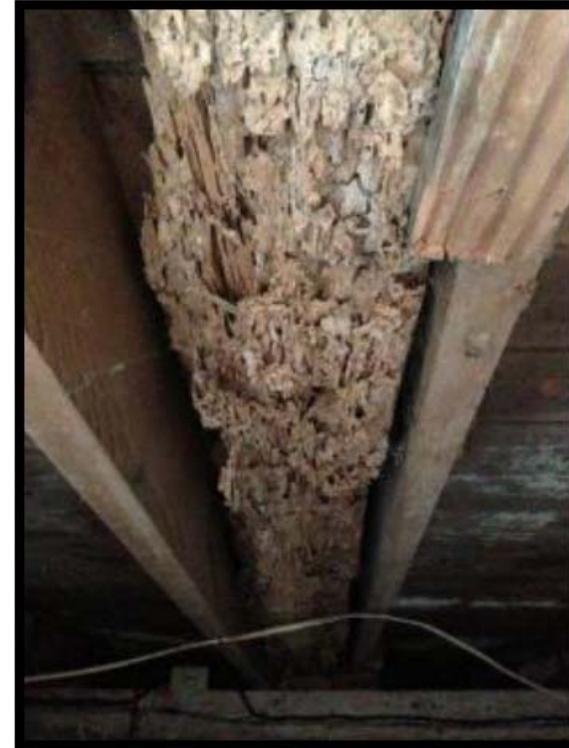
There is also significant mold in the attic to both the rafters and roof sheathing.

Mold on sheathing and framing in the attic

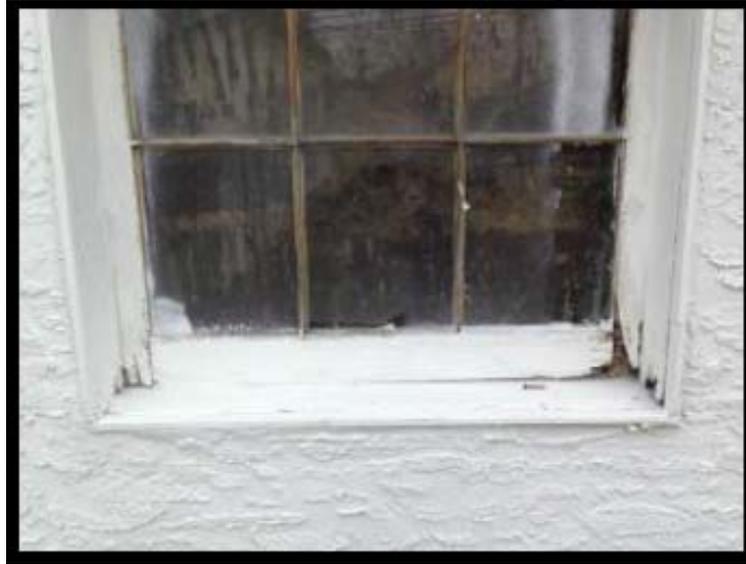
Rotting window sills

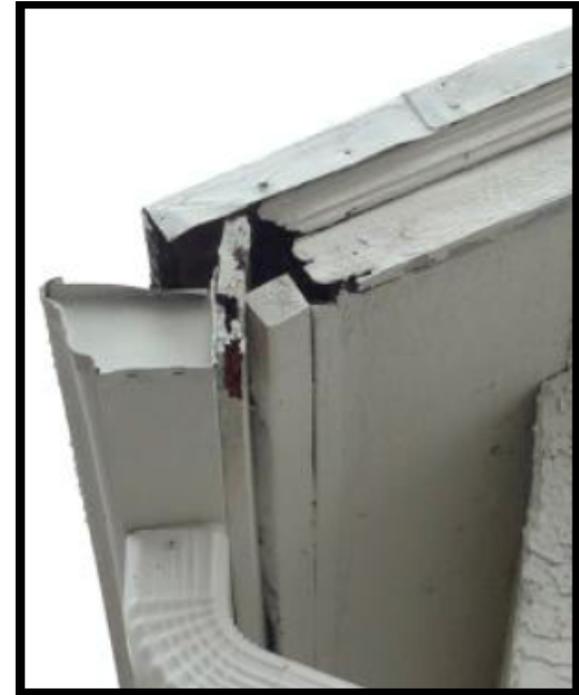
Exterior deterioration

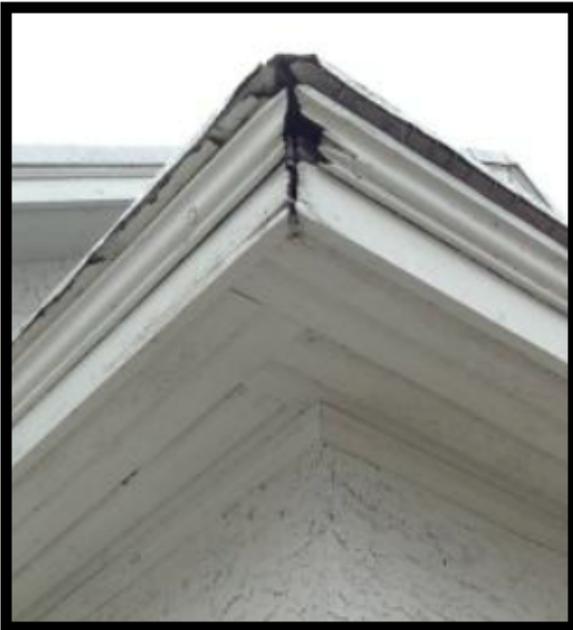
Exterior deterioration
