15-055ARB
Demolition
5051 Brand Road

5051 BRAND RD.

Upon arriving at the subject property on Wednesday, May 20, 2015 we observed the home to be a two story style, wood frame constructed dwelling that according to the County Auditor's website was constructed in the 1800's and contains approximately 2,695 square feet of living space. We understand that the home has been vacant for some time and currently is in an estate and/or trust. During our

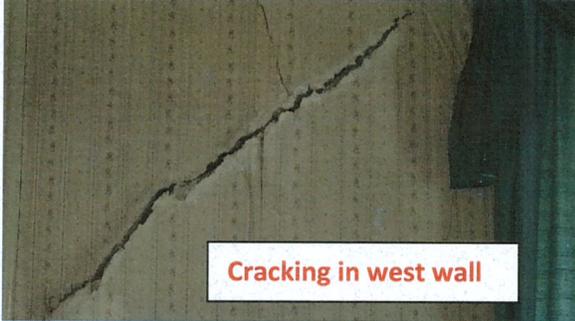
Cracking in west wall

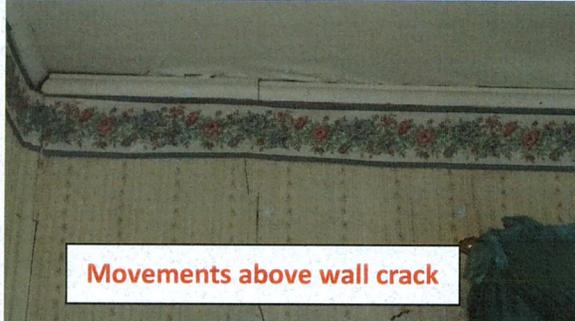
Movements above wall crack

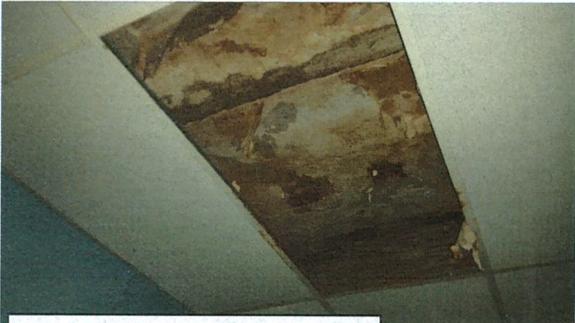
- There is evidence of moisture damage along the ceilings visible in the open stairwell of the house leading to the second floor. It appears that there are dark areas along the lathe and plaster which indicates there is mold like substances in the ceilings from moisture penetration.

View of 2nd floor ceiling,
damage from moisture.

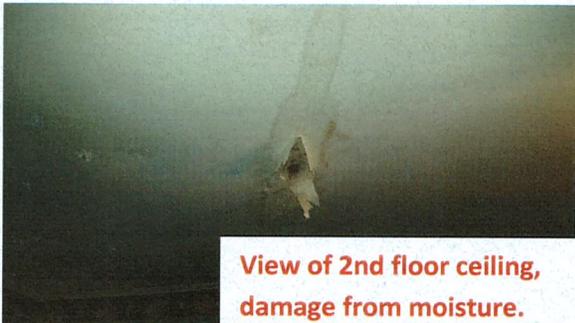
View of 2nd floor ceiling,
damage from moisture.

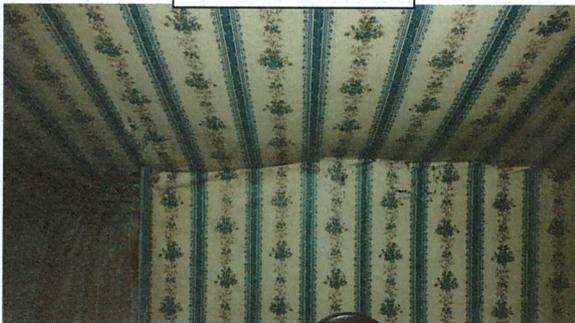
Wall movement

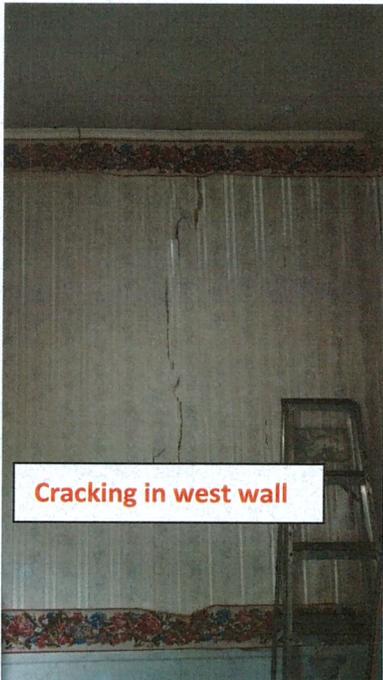
- The interior walls on both floors are covered with wall paper, but there are large cracks along the north walls of the house. Without performing any invasive and/or destructive testing the cracks within the walls are consistent with movements observed from the exterior. The same can be said for the floor conditions, especially along the west interior and portions of the north interior where the floor has dropped as much as three plus inches. Now it must be noted that we understand that this is an old home and that we commonly find sloping floor conditions and some plaster cracks; however, the movements and cracks observed are excessive even for this age of home.

Cracking in west wall

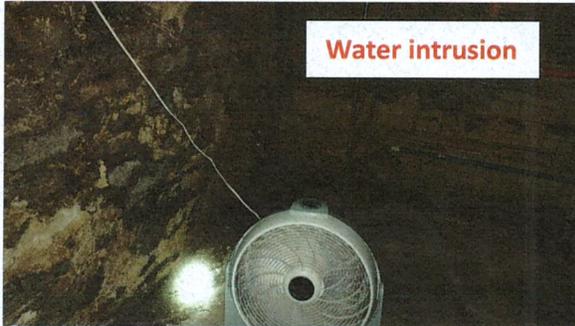
- In the basement there is evidence of moisture coming in from the walls above the basement walls.
- It appears that the water has been entering the basement for years. There is no waterproofing system currently in place and we typically don't find them in this age and style of home. The moisture appears to be a result of exterior conditions such as negative grades, water going over top of the gutter system and downspouts that are not carrying the rain water far enough from the foundation. In areas of the most significant damage to the foundation, the downspouts discharge directly on the ground and appear to be undermining the foundation.

Water intrusion

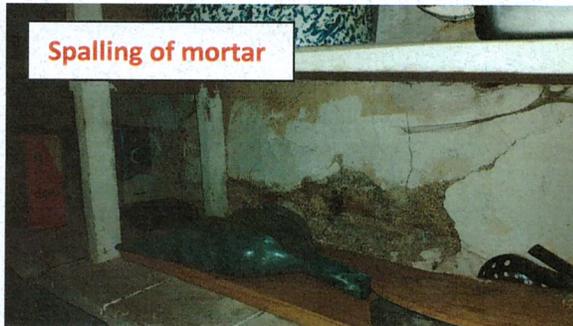
- The constant water intrusion within the basement from these exterior problems previously listed has caused damage and/or deterioration to the stone and mortar foundation over the years. In some sections of the basement the walls will require significant repairs and/or upgrades to insure the long term stability of these foundation walls.

Spalling of mortar

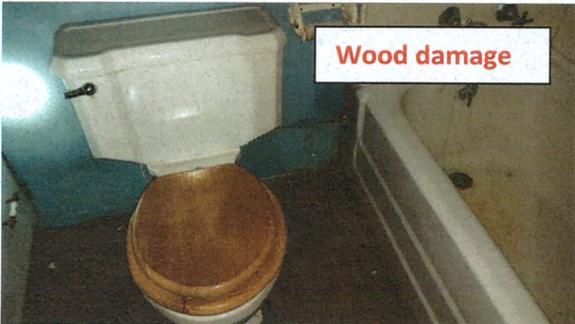
Wood damage

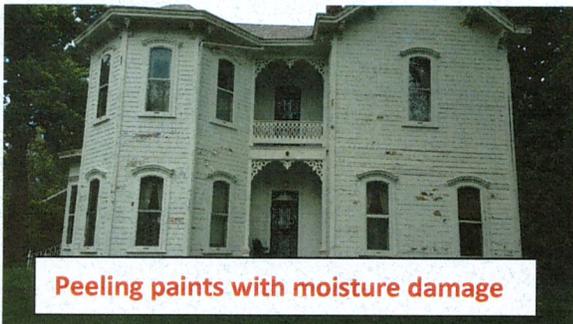
Peeling paints with moisture damage

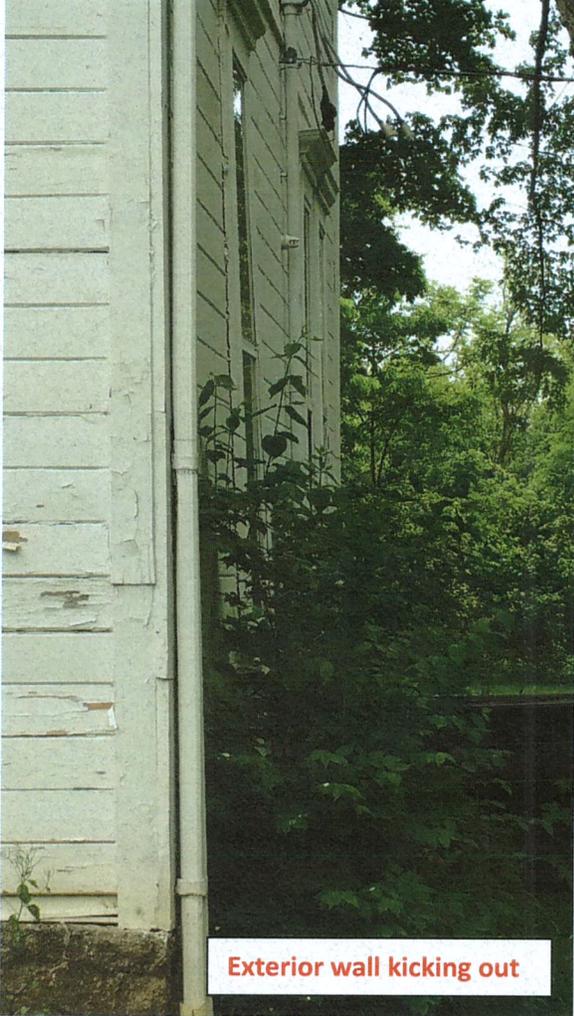
Exterior wall kicking out

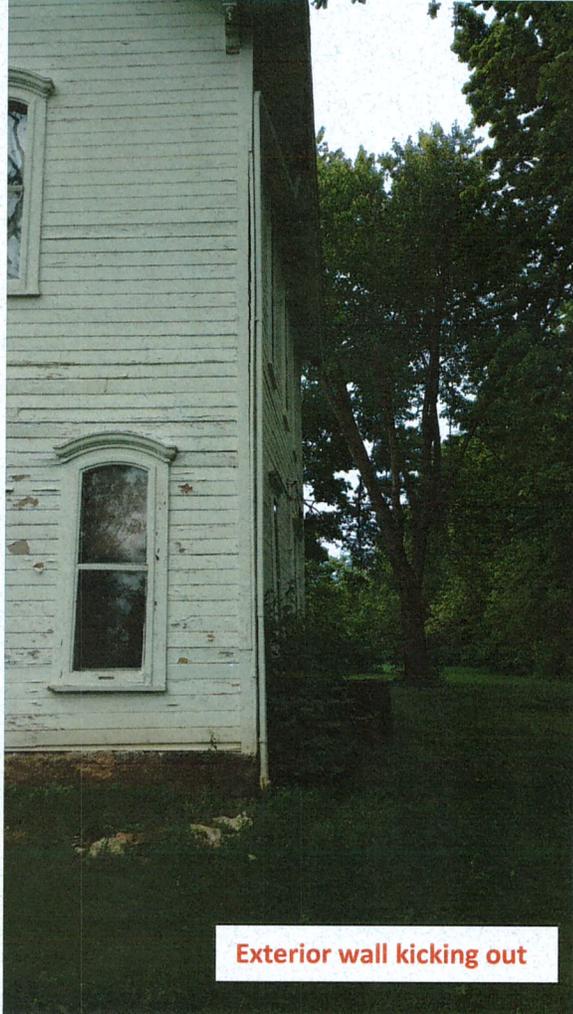
Exterior wall kicking out

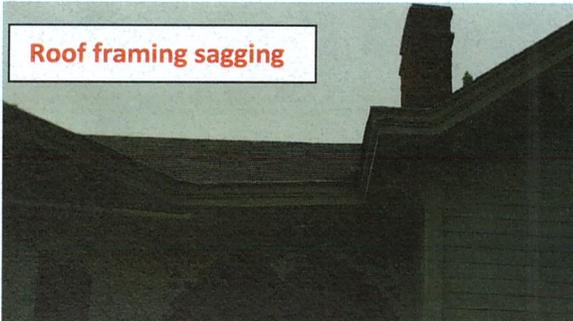
Roof framing sagging

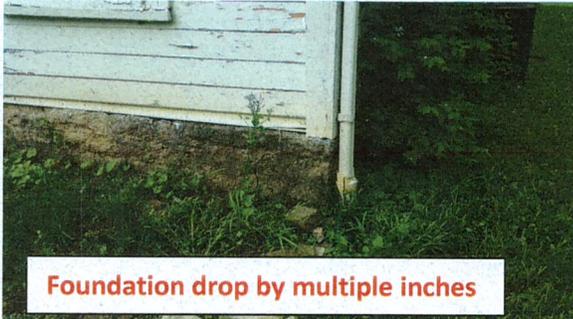
Foundation drop by multiple inches

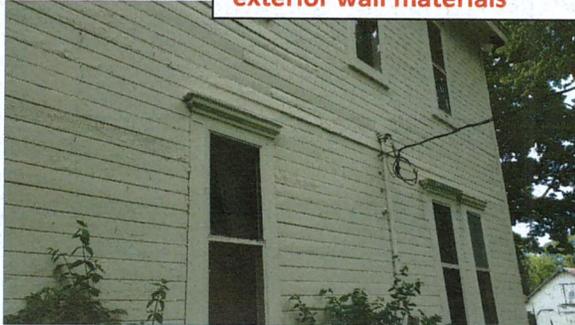
Moisture damage behind exterior wall materials

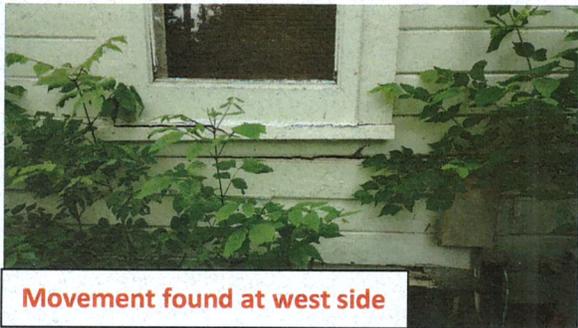
Movement found at west side

- The west foundation wall of the home has been compromised over the years which in turn have caused partial failures of walls that the foundation has been supporting.

- It will be necessary to replace the foundation wall from the northwest corner of the home to the southwest corner. We also believe that once the excavation starts, a portion of the north wall may need to be replaced based on our visual observation.
