27 May 2015

Re: Structural Inspection  
5051 Brand Road  
Dublin, Ohio 43017

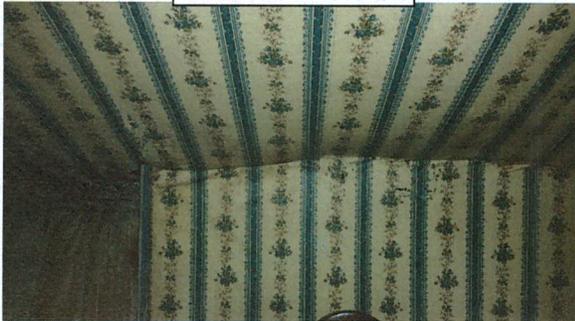
Wall movement

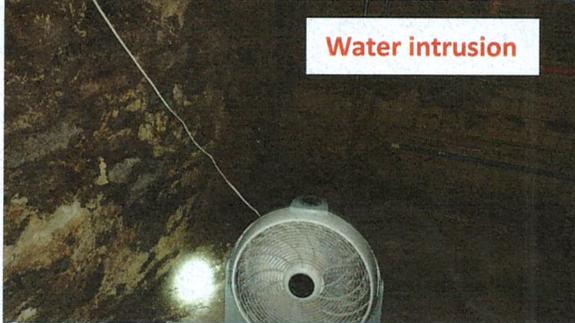
**Water intrusion**

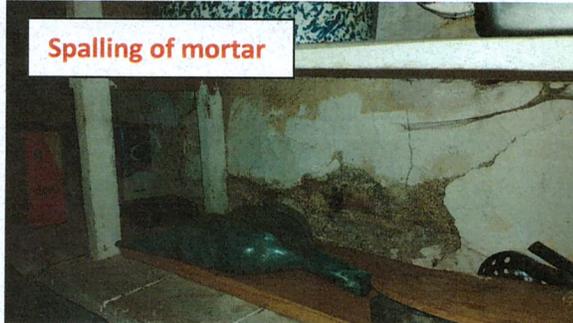
**Spalling of mortar**

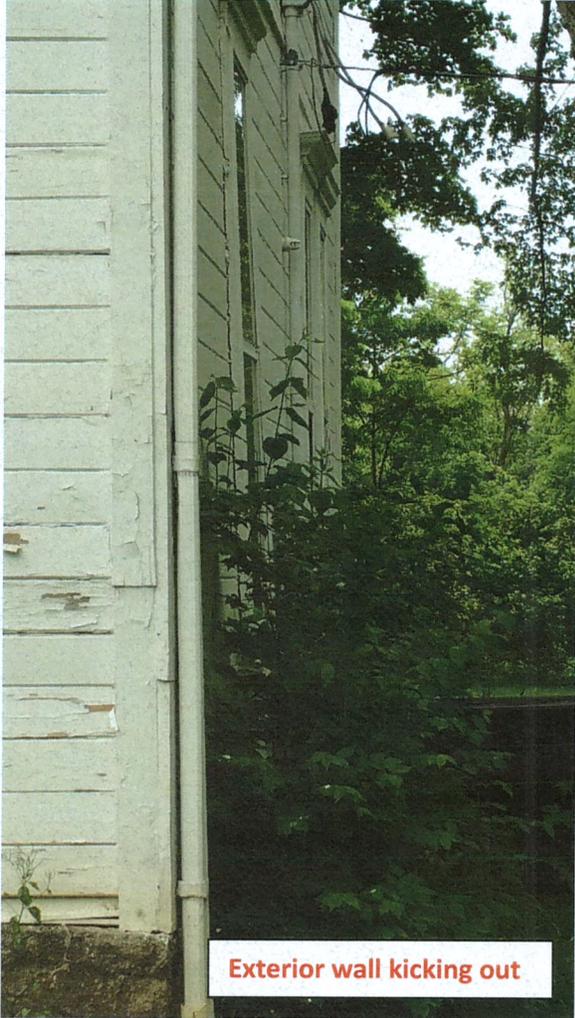
Exterior wall kicking out

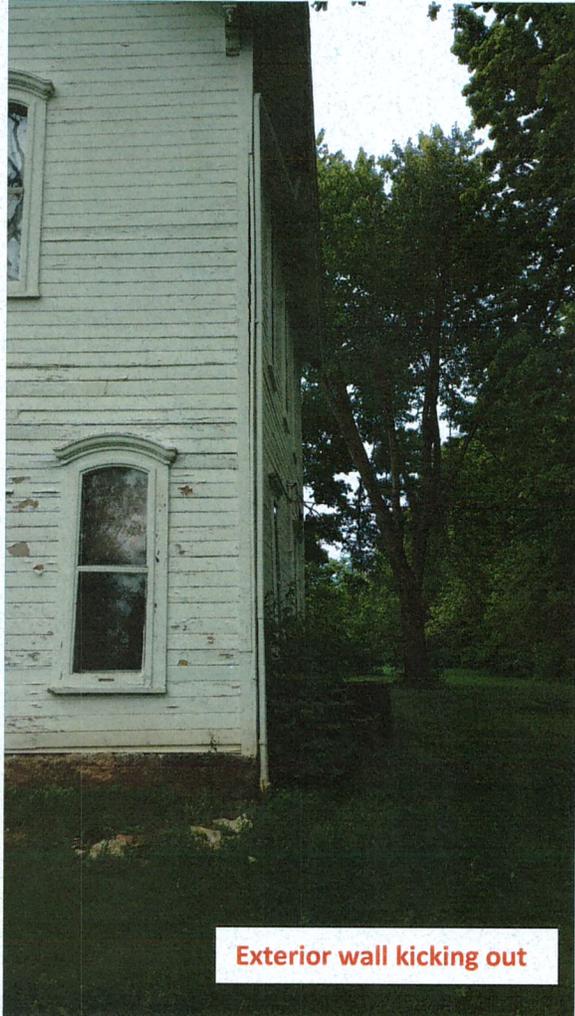
Exterior wall kicking out

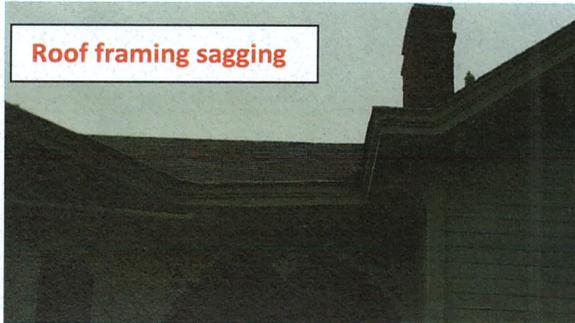
Roof framing sagging

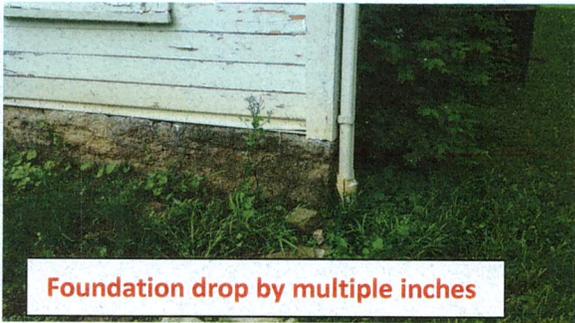
Foundation drop by multiple inches

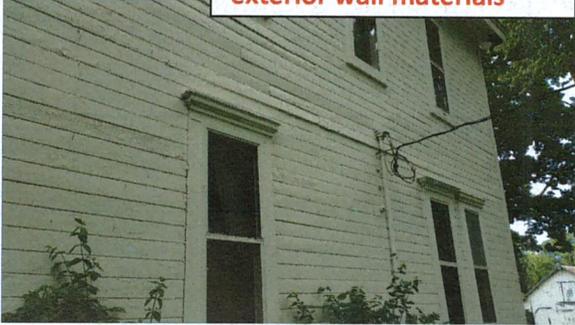
Moisture damage behind exterior wall materials
