Dublin Police Department Accident Reconstruction Report

Det. Erik Gilleland#161, Traffic Crash Reconstructionist, A.C.T.A.R.#1336

Incident# 17-172

Crash Date: 01/23/2017

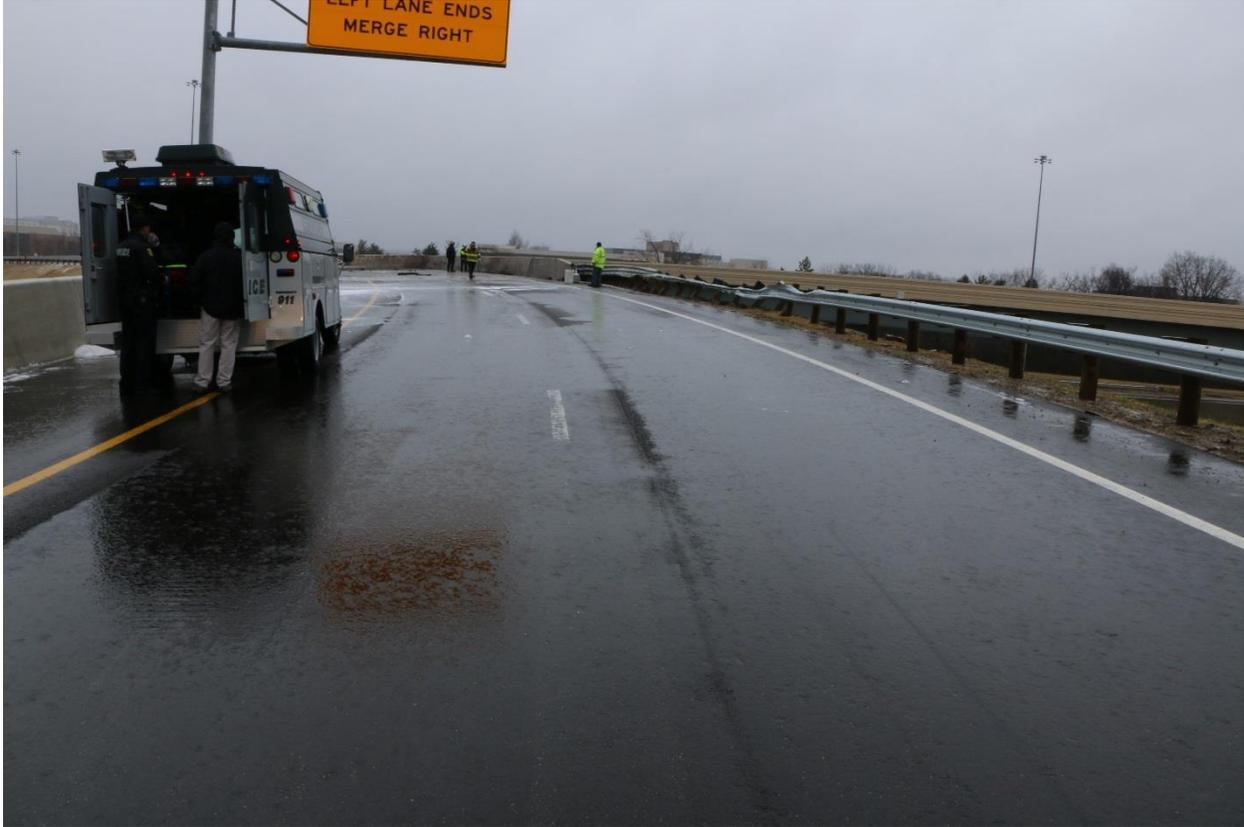
The right guardrail is damaged for approximately 50 feet before the connection point to the concrete parapet on the right side. The damage appears to be from the top down with folding and paint rubs. The supporting posts have been forced to the outside of the roadway in their respective holes. There is a concrete curb approximately 20 feet west of the parapet which appears to be pushed from inside to the outside of the roadway and is cracked in several places.

At the end, the guardrail is noticeably charred and at the connection point to the parapet has contact damage.

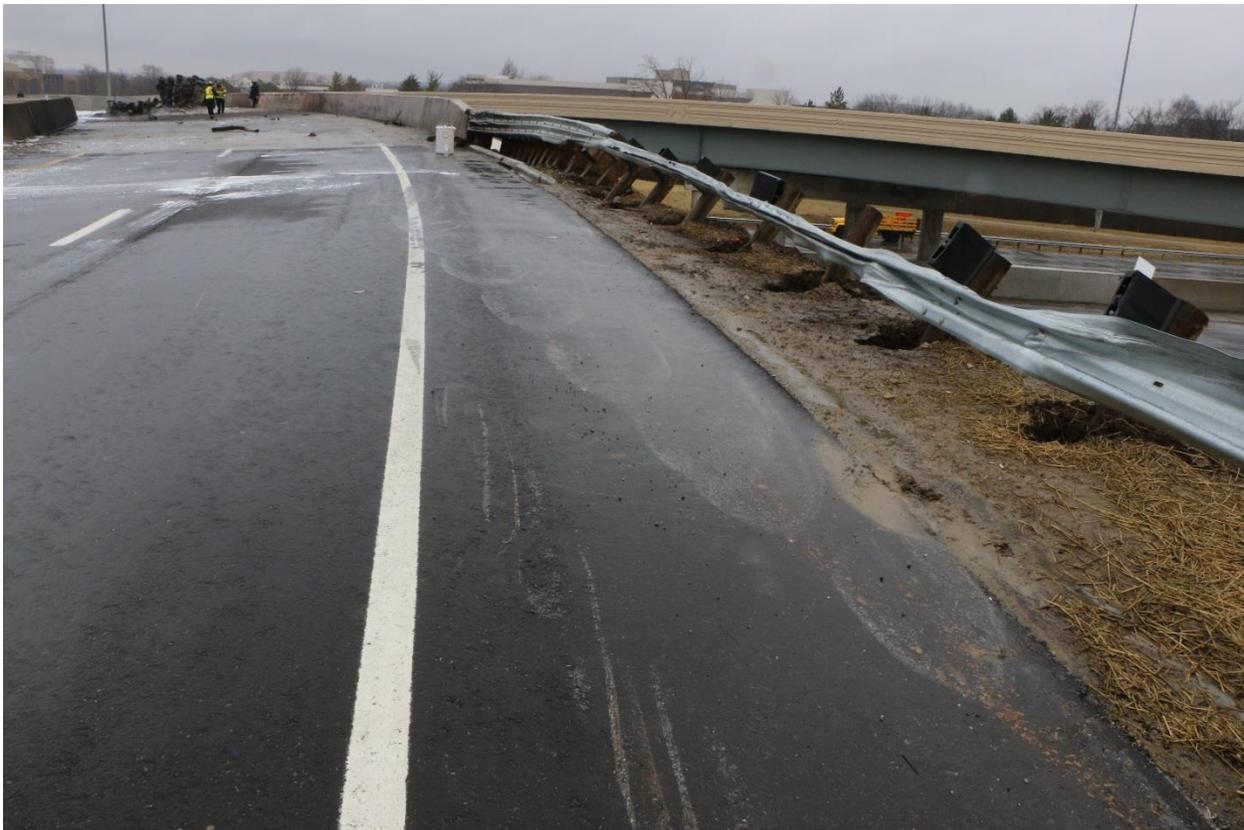
At approximately the first point of damage to the guardrail, there are roadway markings that are rotational and are consistent with the diameter of a commercial wheel and tire. At the same point, there are straight line gouges that are inline but inside of the rotational marks. These rotational markings start from the edge of the roadway and get consistently bigger as they travel through the right fog line. They are at their largest point approximately the size of a commercial vehicle truck tire. The gouges start from approximately half way through the apron and travel to the fog line. Where the rotational markings end, a set of wide scrapes begin traveling in the right lane of travel.

The damage from the guardrail is consistent with the circular roadway markings showing rotation. I believe that these markings are consistent with the rear tandem tires' sidewalls contacting the pavement as the trailer overturned marking the roadway. There are observable linear scrapes and gouges in the roadway that are consistent with other non-rotating parts of the trailer scraping the roadway in line with the travel of the roadway as it began to slide on its side. Approximately 40 feet before the parapet start, the rotating markings diminish and the scrapes become much wider. At this point, I believe that the trailer is on its side. Since the tolerance between the king pin and 5th wheel assembly is small, the trailer rolling would pull the tractor over as well. This is also consistent with the orientation of the trailer and remains of the tanker at final rest.

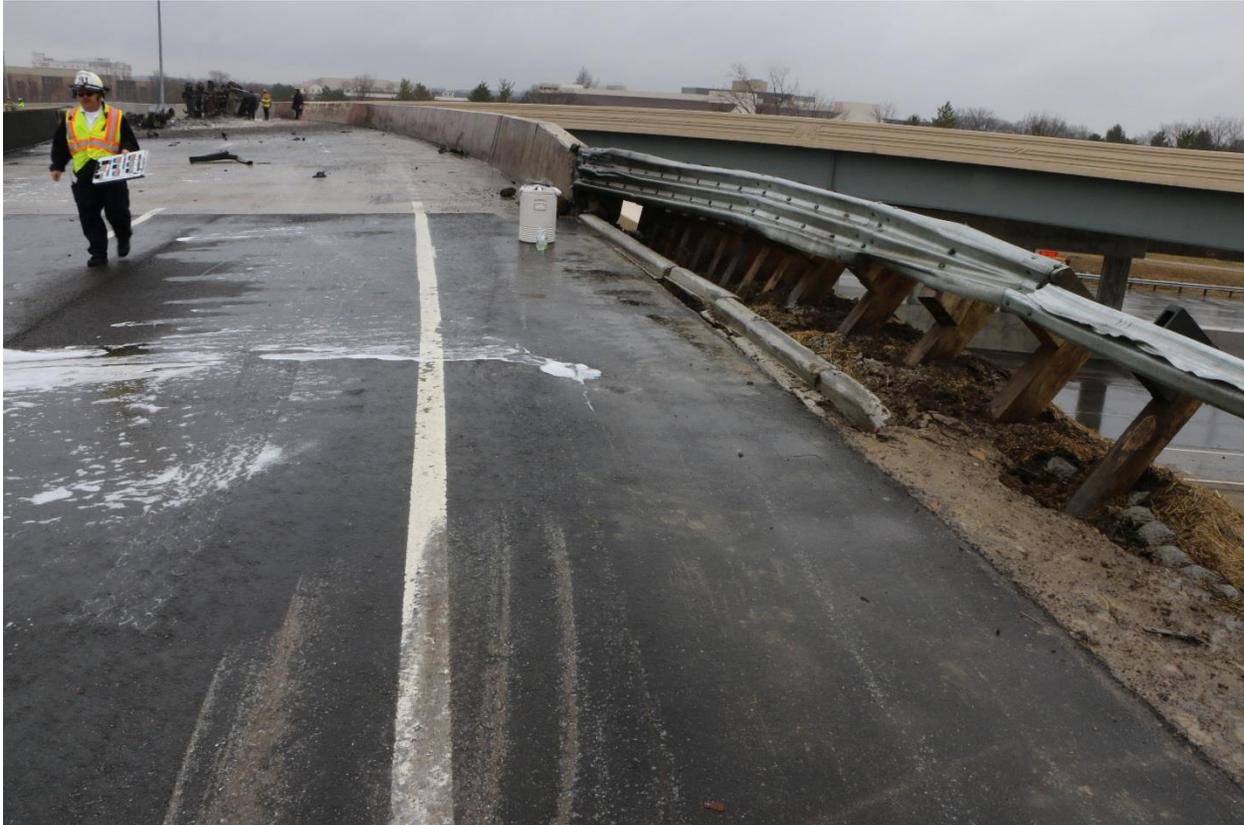
The bridge is a concrete structure with grooves along the longitudinal axis of the roadway. Approximately halfway through the bridge, the deck concrete begins to spall and at places has rubble approximately 2 inches deep. This spalling continues the length of the concrete, goes from side to side, and is evident on both sides on the parapets. There is black charring on the left (inside) wall along the spalling. The inside wall has significantly more damage than the outside wall.

Starting prior to the parapet, large scrapes are seen from the right edge of the roadway and beginning near the bridge start to slide from right to left. Discolorations consistent with erasure

marks are seen from right to left into the rubble pile. These are consistent with the tractor's final rest point.

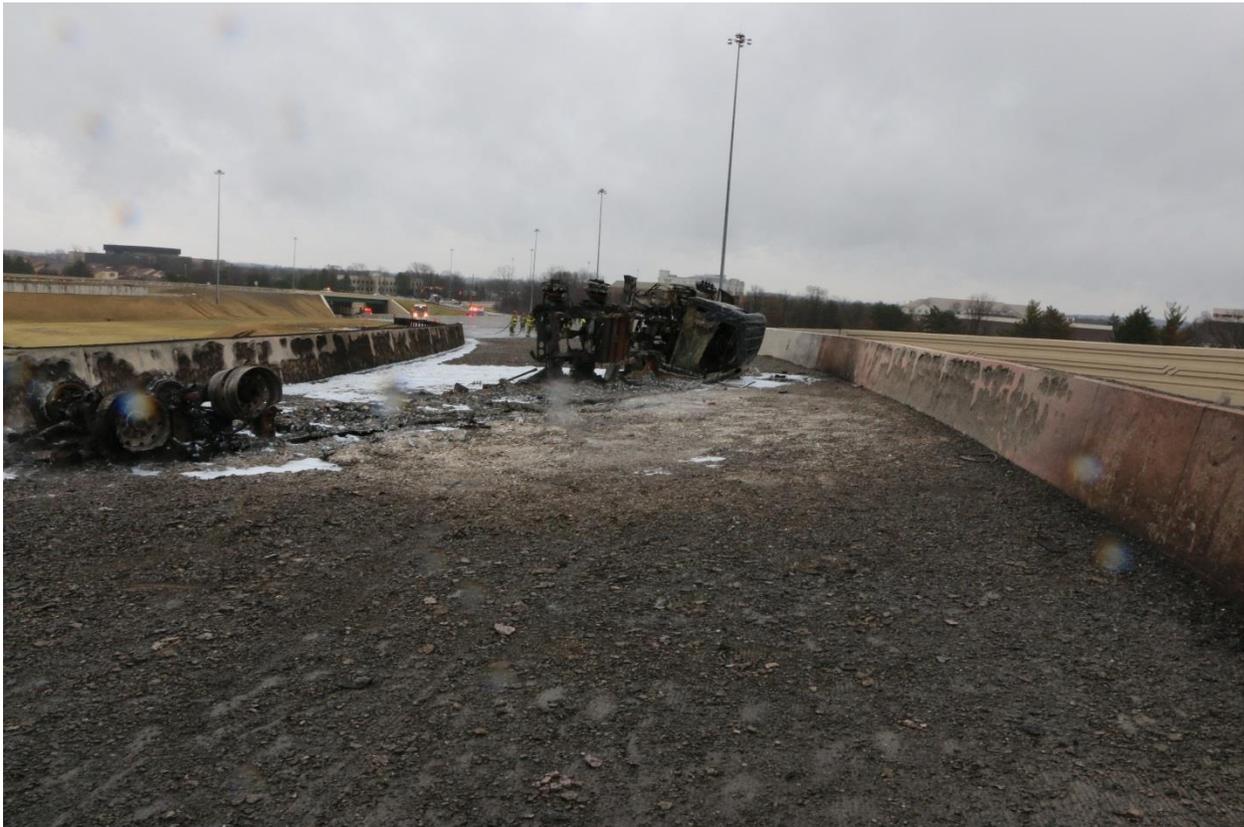
The tanker has melted and is all but destroyed except for the side on the roadway. The rear tandems appear to have fallen from their initial sideways orientation to being upside down which is consistent with the support of the tanker itself no longer being there due to the melting of the aluminum. The tires have been burnt down to the cords and the rims and wheels have been damaged by the heat of the fire. Several of the brake chambers have failed due to the fire and the springs are distributed throughout the scene.

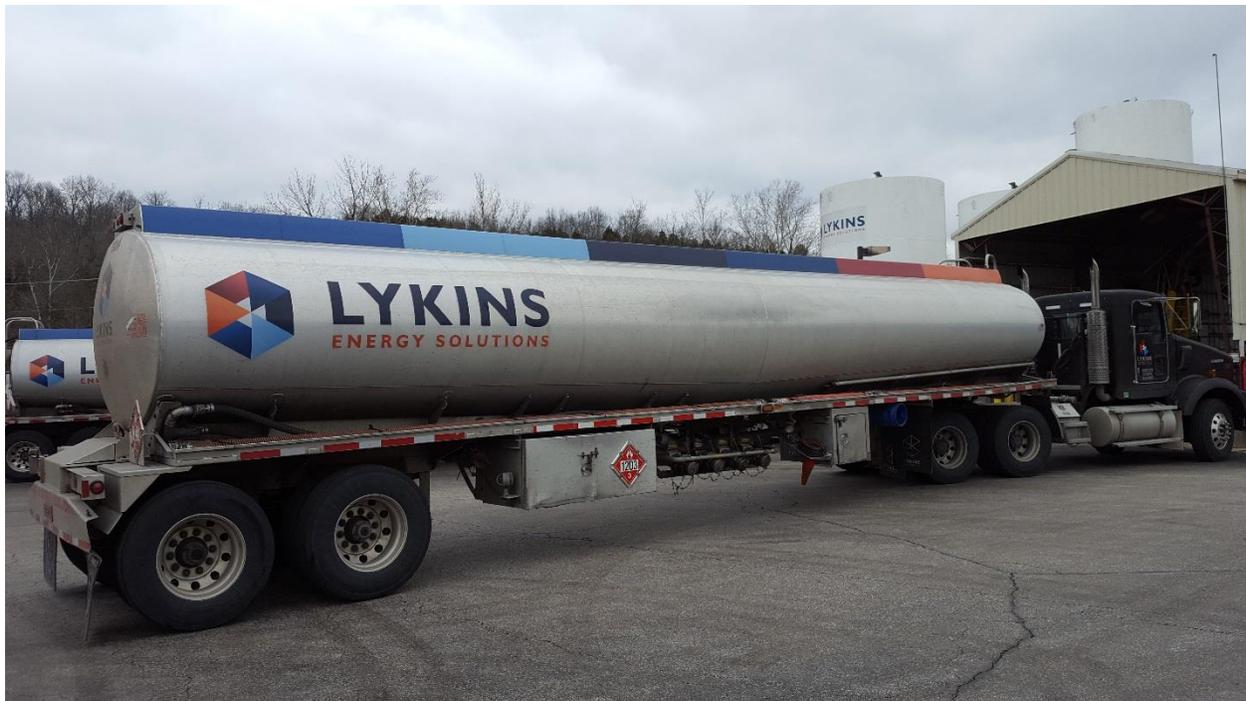
Exemplar tanker photo

The 1996 Heil trailer is a four-compartment liquid hauler with a central distribution point at the passenger side. The shell appears to be made of aluminum. Each compartment is separated by a welded dead space bulkhead perpendicular to the linear axis of the next adjacent compartment. The capacities are #1-3500 gallons, #2-2300 gallons, #3-1100 gallons and #4-2600 gallons. These capacities are marked individually on the fuel manifold outlets. The compartments are from front to rear. The tanker has a vapor capture system. There are two rectangular aluminum boxes on the passenger side below the tanker; one in front of the rear wheels and one in front of the fuel manifold behind the landing gear. There is one box on the driver's side just in front of the rear wheels.

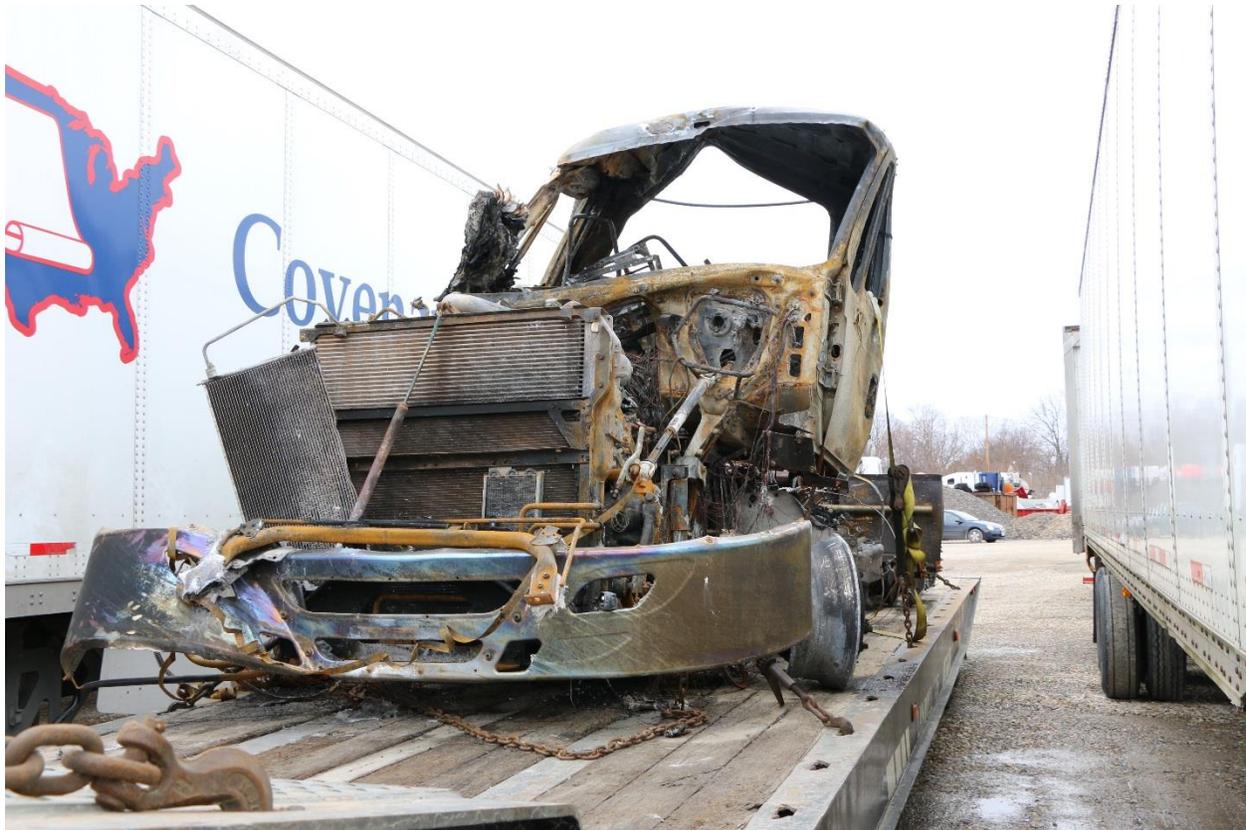
I also inspected the tractor at the Rusty's drop yard. The steering linkage to include the steering shaft, steering box, Pittman arm and links and shafts appear to be intact. All the visible lugs from all three axles appear to be intact. The Transmission linkage appears to be intact. The braking system and wheels were destroyed in the fire. The damage on the right front of the bumper is caused by the vehicle's removal as it is not apparent in the original scene photos. The passenger side step does not have any apparent front to back damage. The outside of the 2nd axle passenger wheel rim is intact and has no visible impact damage. The castle nuts and cotter pins on the steering wheels are intact. The leaf springs appeared to be intact and connected. The Engine Control Module appears to have been destroyed in the fire.
