**SELECTIVE DEMOLITION REVIEW
5927 RINGS ROAD, DUBLIN OHIO**

SULLIVAN BRUCK ARCHITECTS
NELSON YODER, ARCHITECT
ELIZABETH YODER, ARCHITECT

8/21/2017

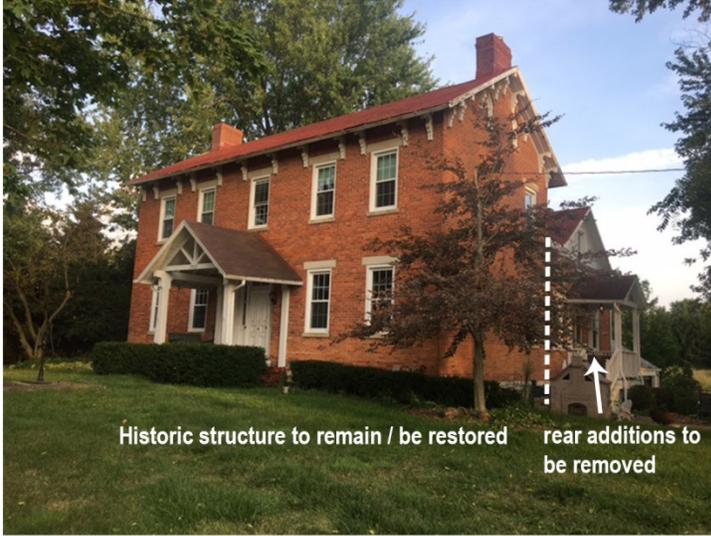
View from the Northwest near Rings Road showing both the historically significant structure to remain in front and the later additions to be demolished in the rear.

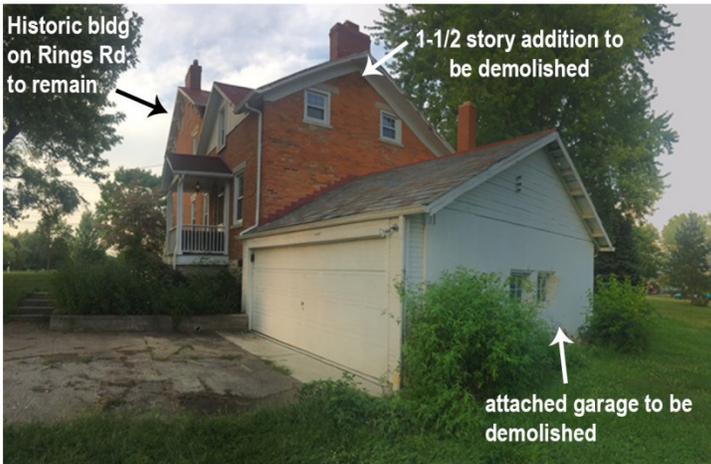
View from the private yard looking Northeast showing the later additions to be removed in the foreground including the garage and story and a half building with modern porch. Note the 1-1/2 story only has 1 floor of occupiable space.

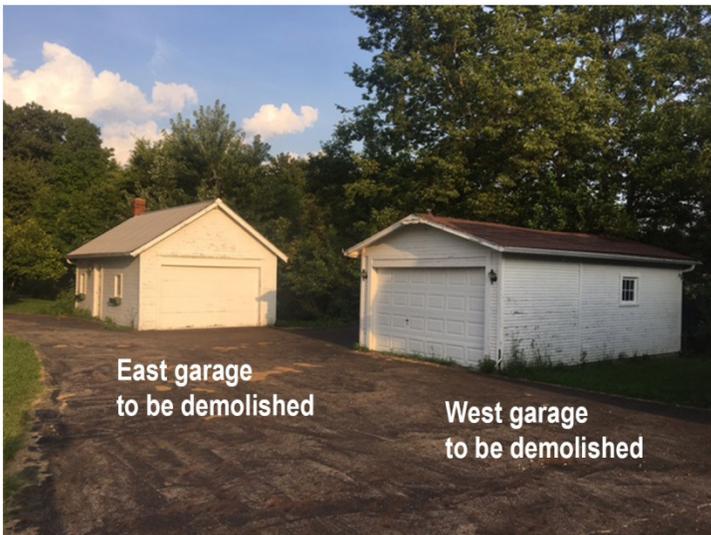
The demolition request also includes two existing detached single car garages. Both structures are in the floodway (note floodway, not floodplain) and experience water infiltration during heavy rain events. Neither is in good condition. Removal of both of these structures will provide a benefit, not detract to the quality and value of the property and the City.

View from private yard looking Southeast of the two detached garages to be demolished. Both are located in the floodway.

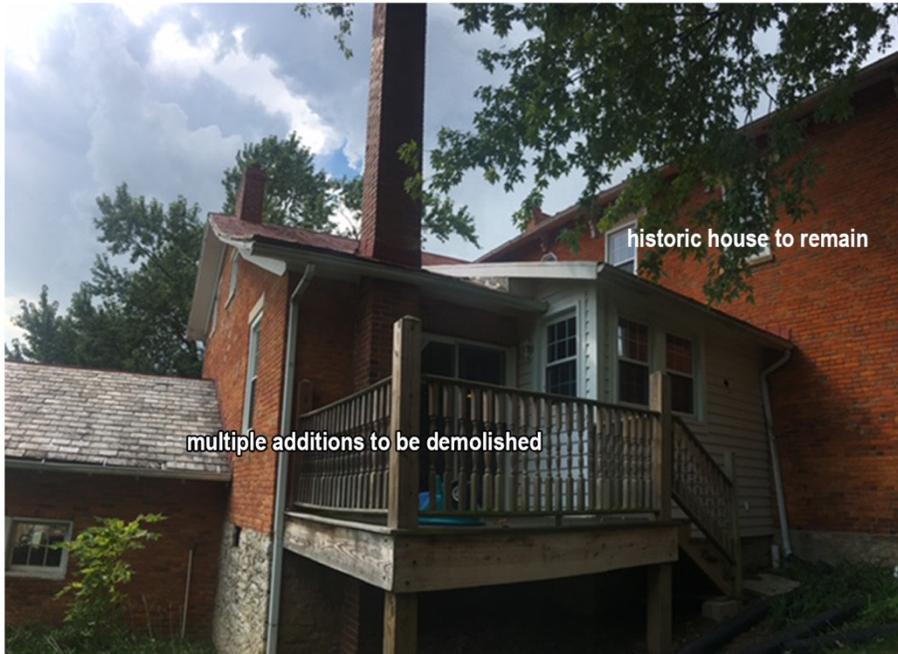
**Southeast elevation - brick structure at far right & rear to remain
additions in foreground to left to be demolished**

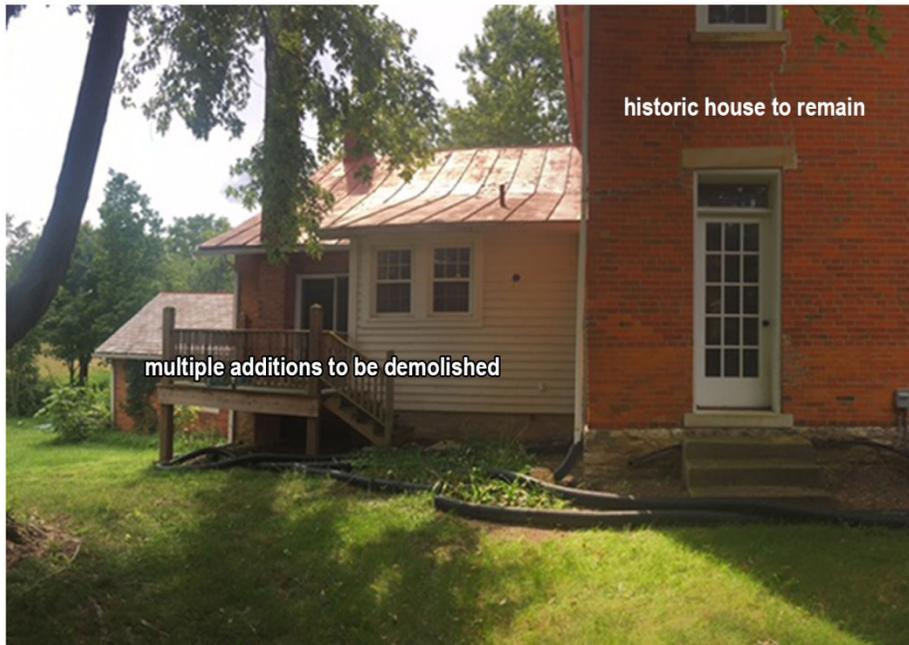
**East elevation - brick structure at right to remain
series of additions to left to be demolished**

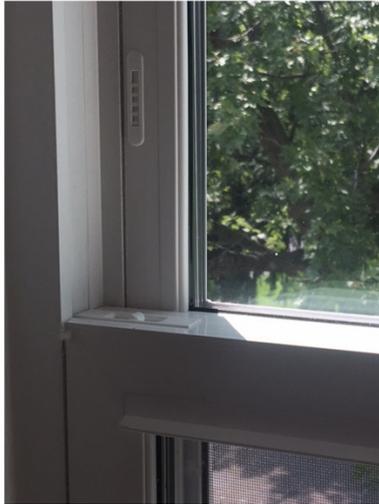
- Every single window and door to be demolished is a modern replacement window or door. Exhibit 4 shows a picture of a typical window and a door that will be demolished and contrasts those with the historical front door that will be preserved by the project.

Close-up of existing vinyl replacement window. Typical of all windows in the area proposed to be demolished.

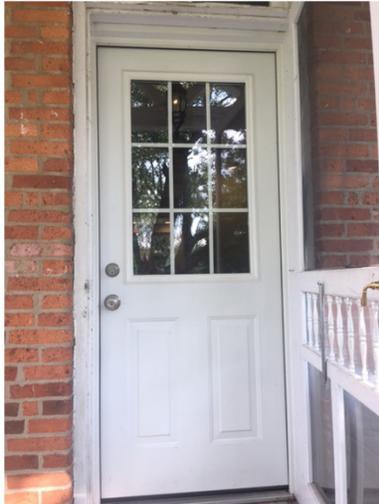
Existing modern steel entry door on rear addition area to be demolished.

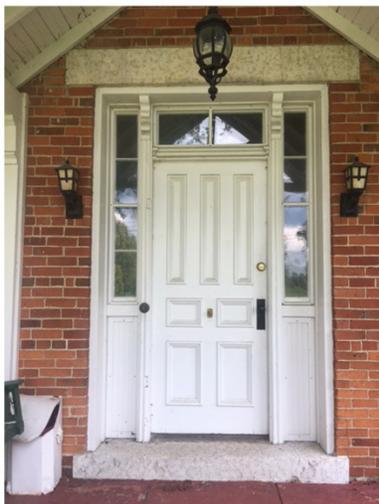
Historic wood door and sidelights to be preserved on front section of house that is to remain.

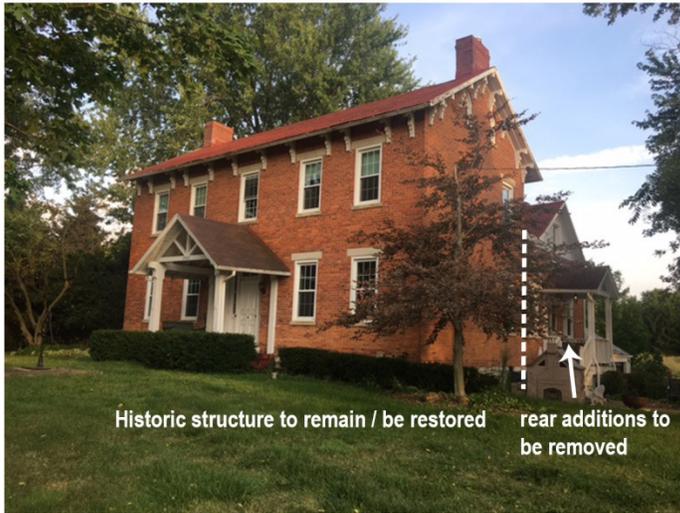
Historic structure to remain / be restored

rear additions to be removed

The front structure to remain displays significant historical architectural detailing including large ornamental brackets and six-paned arched windows.

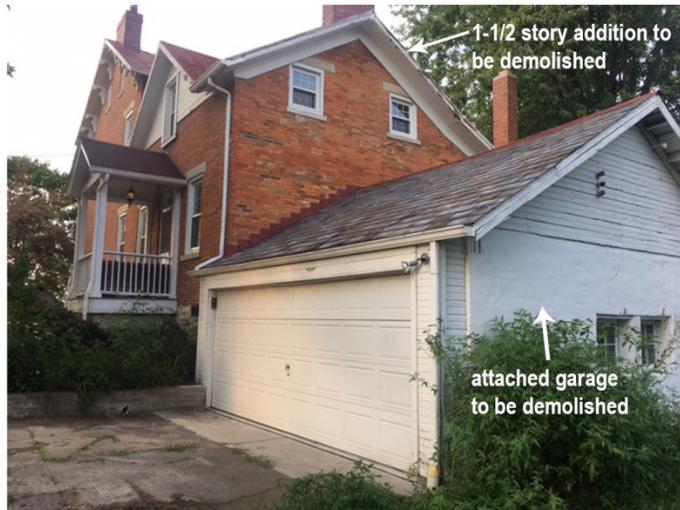
1-1/2 story addition to be demolished

attached garage to be demolished

The rear additions to be demolished, however, do not include any of architectural features, only common 20th century contractor construction details.

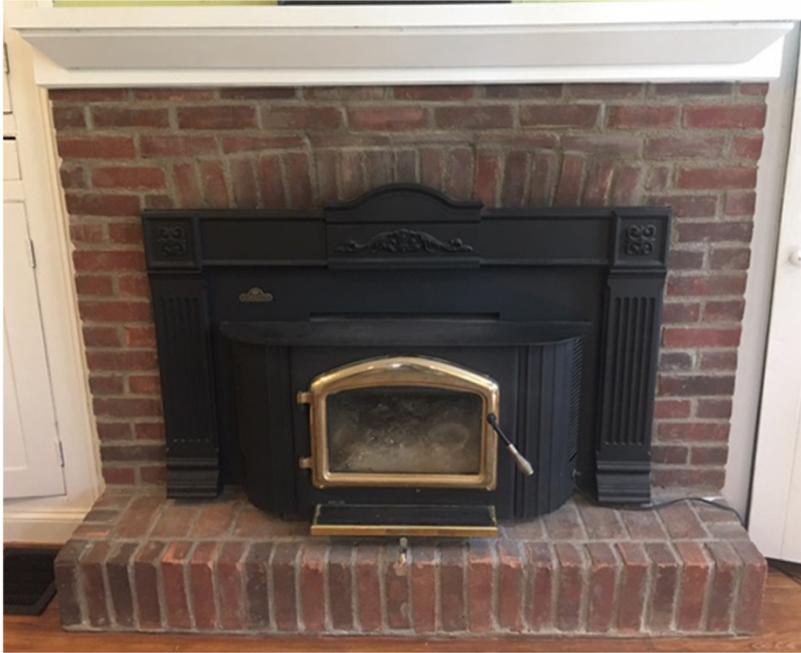
- Only one fireplace remains in the portion to be demolished, and it was rebuilt with modern materials in the 1980's. See exhibit 6, which contrasts the fireplace to be demolished with the beautiful 1850's plaster fireplaces that will be preserved in the front house.

A picture of the only hearth in the area to be demolished . The hearth was rebuilt in the 1980's. No architectural significance.

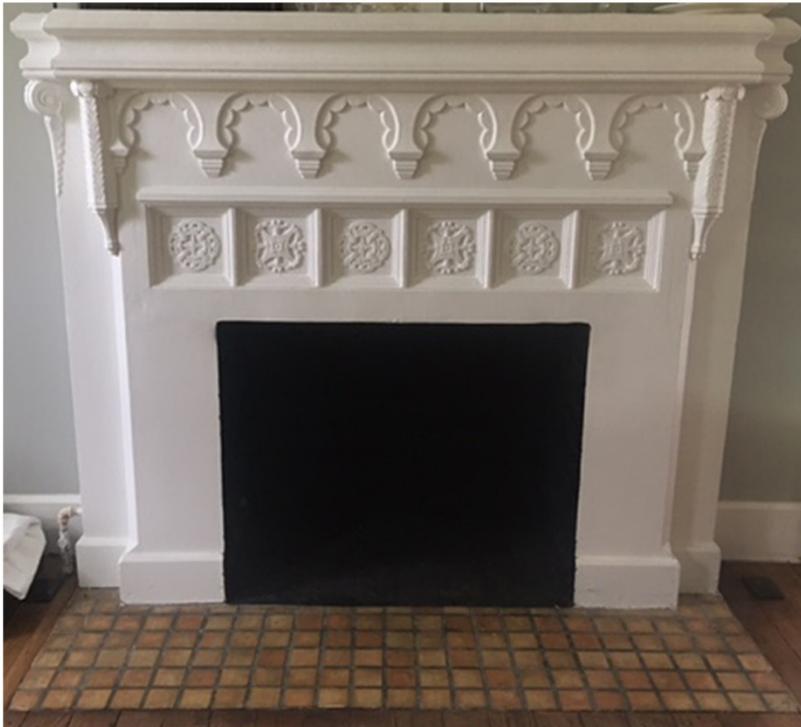
A picture of one of the two identical beautiful artisan plaster fireplaces to be preserved in the front historic house.

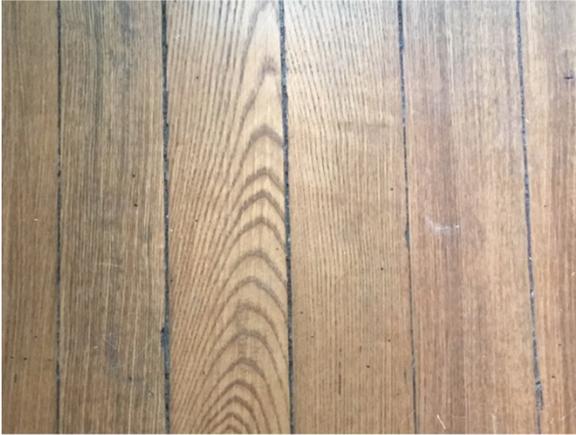
Original wood plank flooring remains throughout the front historic home. This will be preserved by the project.

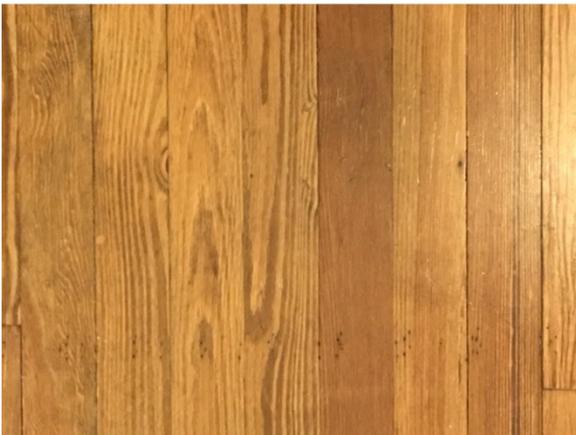
Modern Pine flooring exists in the Western half of the area to be demolished.

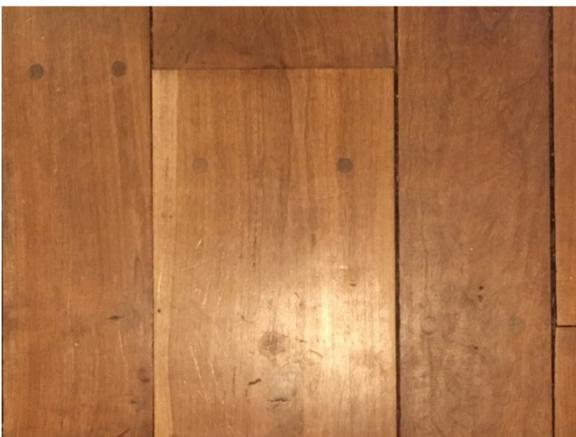
Modern Cherry plan flooring over OSB subfloor exists in the Eastern half of the area to be demolished. This was installed during the 1990's addition.

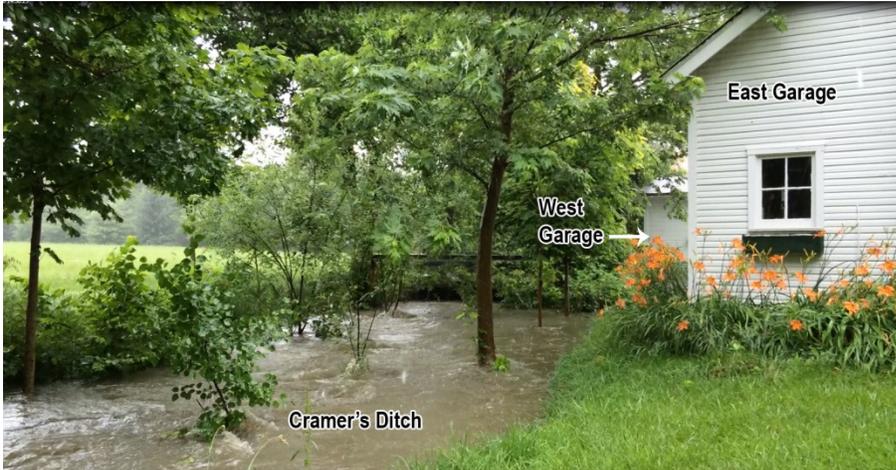
Flood Hazard: The East and West existing detached garages that are proposed to be demolished are both located in the floodway (see demolition plan in Exhibit 1). Floodwaters enter these structures during heavy rains and their presence in the floodway presents a hazard to residents upstream (due to potential for restricting water flow) and downstream (due to potential for washout). See exhibit 8 for documentation of conditions during a heavy rain event.

The East and West detached garages to be demolished are seen in this photo taken during a heavy rain event in 2015.

- The detached garages area also located in the floodway, a situation which presents a hazard to those buildings and to other property owners in the City. In addition to facilitating improvement of the architectural quality of the district, the demolition of those structures will also remedy the existing flood hazard.

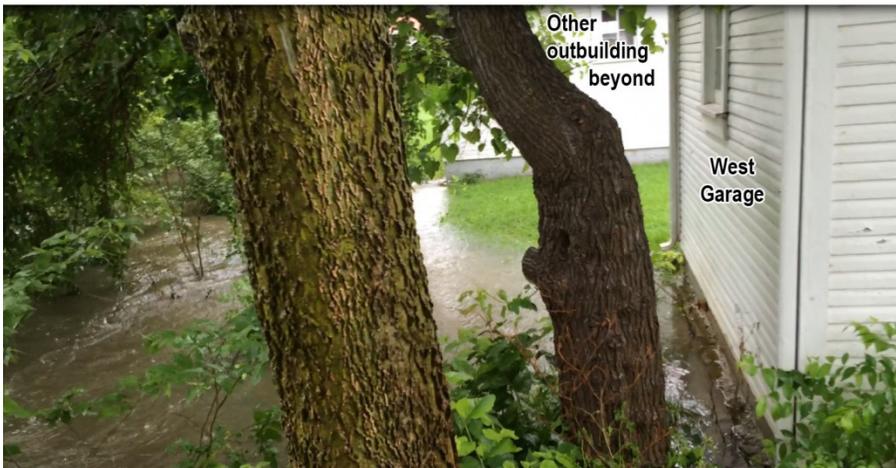
Here the stream flow can be seen washing against the foundation of the West detached garage building.

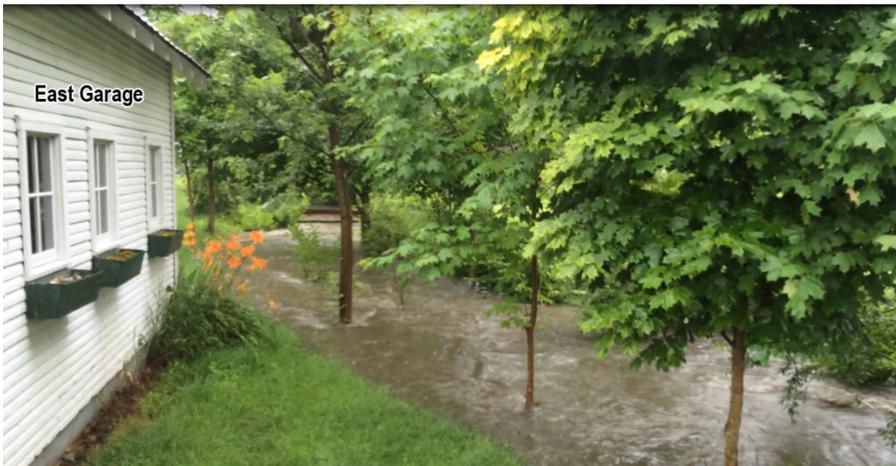
Here the stream flow is less than 3 feet away from the edge of the East detached garage, and only a few vertical inches of rise away from washing against the structure.
