SR 161/RIVERSIDE DRIVE ROUNDABOUT OPERATIONS REVIEW APPENDIX

Introduction

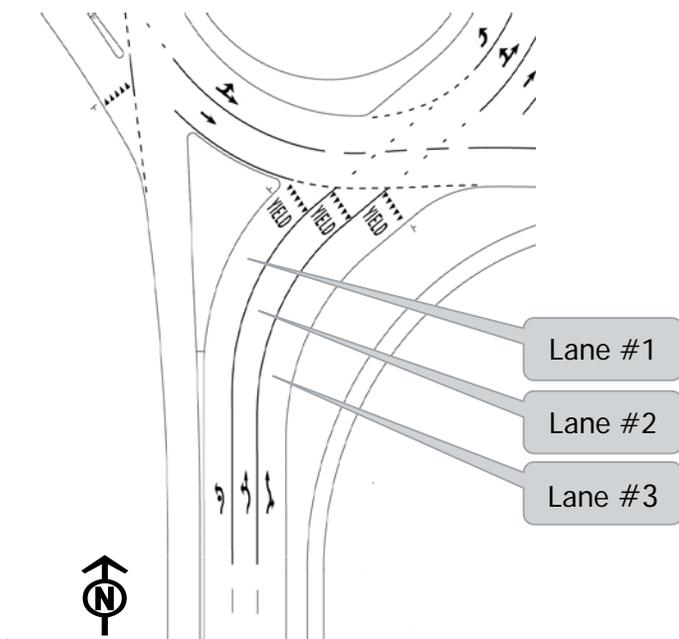
Figure 1: Existing NB Lane Assignments

Figure 1 depicts the existing lane assignments for the northbound approach, and the lane numbering nomenclature used. As Figure 1 shows, Lane #1 is a Left Only lane, Lane #2 is a shared Through/Left lane, and Lane #3 is a shared Through/Right lane. Based on field observations, the current lane assignments do not distribute traffic flow evenly across all approach lanes. Lane #1, or the Left Only lane, is underused, which is pushing the movements with the highest volume into Lanes #2 and #3.

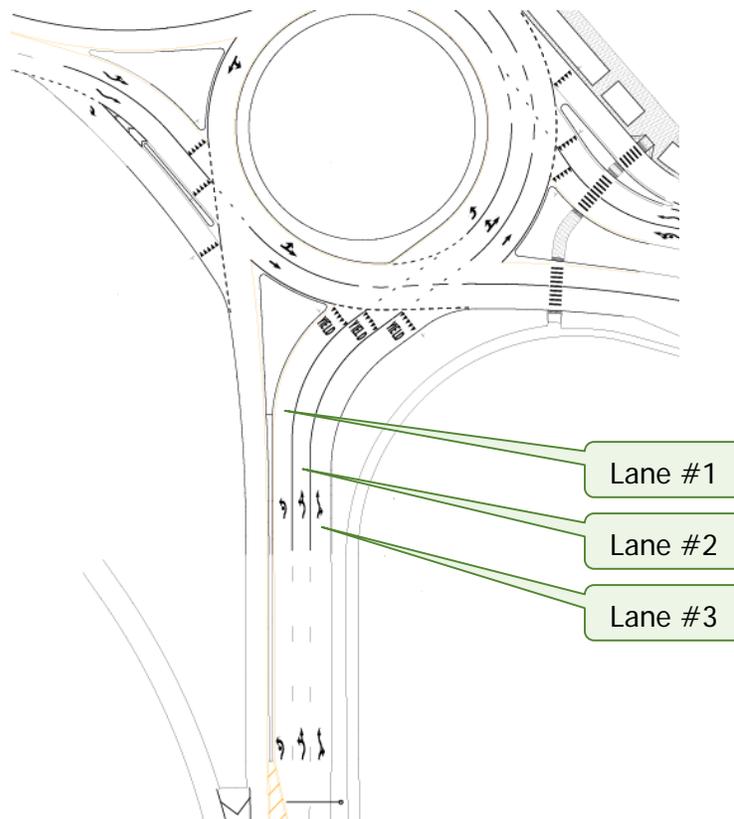
Figure 3: Existing Northbound Pavement Markings

In addition to revising the lane assignments on the northbound approach, several revisions to the pavement markings at the roundabout are necessary. Figure 3 below depicts the existing pavement markings in place for the roundabout northbound approach.

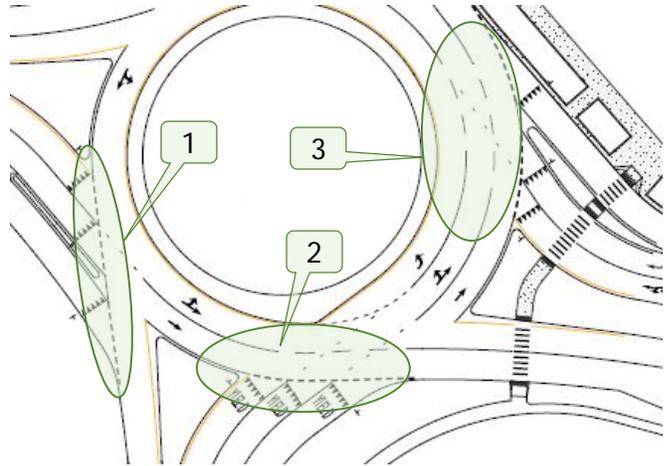
Figure 4: Existing Pavement Markings

Several pavement marking elements will be modified with the intent to improve driver comprehension relative to the crashes that are occurring. The existing pavement markings that will be improved are listed below and shown on Figure 4:

1. Dotted edge line extended tangent to downstream exit leg contributes to a poor left view angle for Lanes #2 and #3 for the northbound, westbound and eastbound approaches, confusing the priority message of who yields to whom
2. Multiple line types at entry creates information overload and reduces comprehension
3. Varying lane marking types in the circulatory roadway reduces driver recognition of correct lane assignment
