To: Members of Dublin City Council

Re: SR 161/Riverside Drive Traffic Operations Follow Up

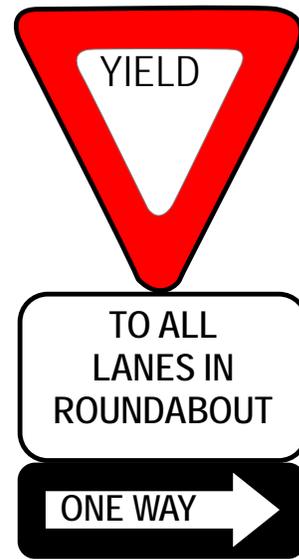
Figure 1: Revised YIELD Sign Assembly

One of the essential operating characteristics of a roundabout is the yield on entry concept. Since three of the four approaches to the roundabout have multiple lanes in the circulatory roadway on entry, it should be emphasized that the yield condition applies to all lanes in the roundabout. Therefore, the YIELD signs at the yield bar will be modified to read: YIELD TO ALL LANES IN ROUNDABOUT, as shown in Figure 1 on the next page:

This sign assembly will be added to the driver's left to emphasize the yield condition. To the driver's right, the sign assembly will be added, but without the ONE WAY placard beneath TO ALL LANES IN ROUNDABOUT sign.

This sign assembly will be added on the northbound, westbound, and southbound approaches for consistency and because there are multiple lanes in the circulatory roadway at these entrances. On the eastbound approach, there is only one lane in the circulatory roadway, so the existing sign arrangement will remain. The sign faces will also be lowered for easier viewing at the yield bar. There is a three to four week lead time to have the signs and backings fabricated and installed after final direction is given to the contractor.

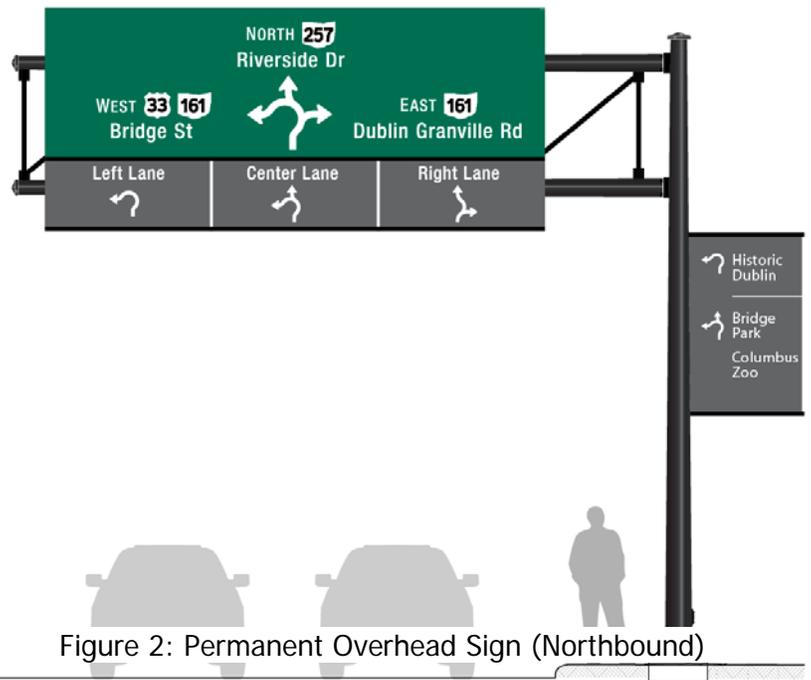
Figure 2: Permanent Overhead Sign (Northbound)

Staff has also heard concerns from drivers regarding the size of the overhead signs being too small. These are temporary signs and will be replaced with much larger signs that will be lit. The temporary overhead signs are about 4-feet wide by 4-feet tall. The permanent overhead signs will be 19-feet wide by 8.5-feet tall, as pictured in Figure 2 on the right. Staff expects the permanent signs to be installed mid to late September.

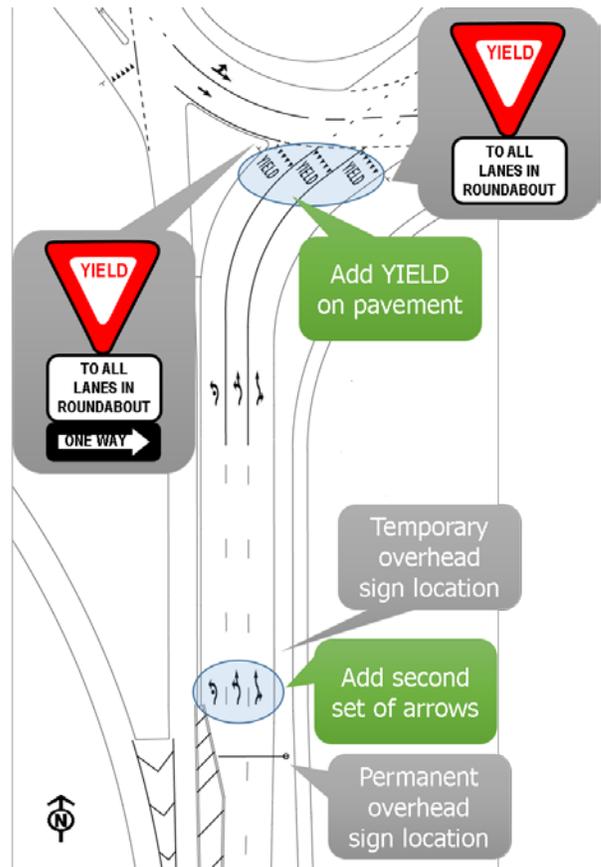
Figure 3: Proposed Changes to the Northbound Approach

Since the yield on entry concept is essential to the operational success of any roundabout, staff determined there should be more emphasis placed on the yield condition, particularly in the northbound direction. As such, the word YIELD was added to the pavement in each lane at the YIELD bar, as shown in Figure 3 below. While observing the intersection operation, staff also noticed that another set of lane arrow markings on the northbound and southbound approaches, and an additional right turn arrow for the westbound approach, would give more advance notice of which lane to choose prior to entering the roundabout. All of this work was completed on August 29, 2016.

Figure 3 to the right provides an overview of the changes to the northbound approach.

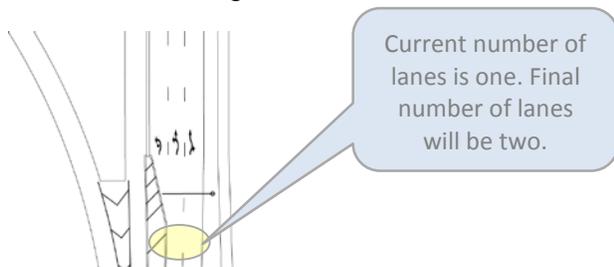
Figure 4: Number of Northbound Lanes Available

It should also be noted the current maintenance of traffic phase only has one northbound lane with the roadway opening up to the three lanes approaching the roundabout. The final condition will have two northbound lanes opening up to the three lanes approaching the roundabout so there will be more opportunity for drivers to choose the proper lane for their intended destination. This is shown in Figure 4 below.

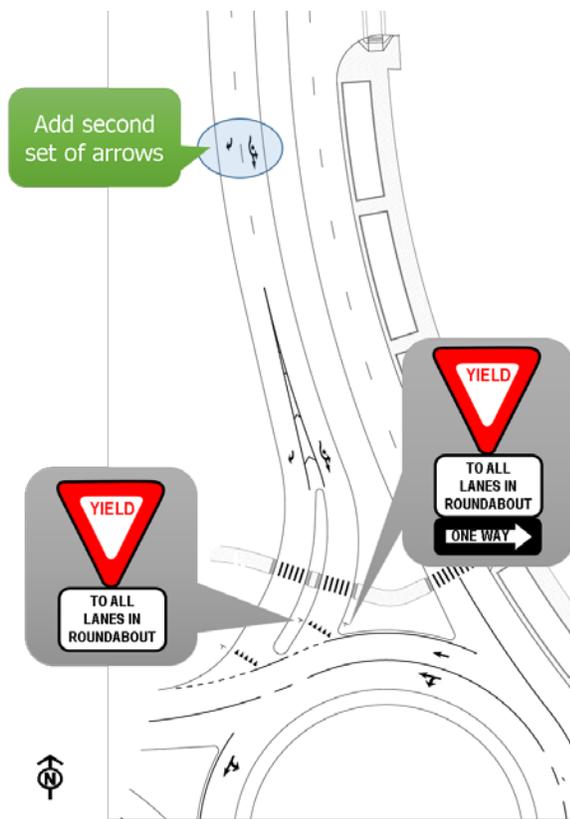
Figure 5: Proposed Changes to the Southbound Approach

Figure 5 provides an overview of the changes to the southbound approach and Figure 6 shows the changes to the westbound approach.
