**CITY OF DUBLIN**  
**REQUEST FOR QUOTATION**

**DEMOLITION AND RE-ESTABLISHMENT**  
**6611 LIGGETT ROAD, DUBLIN OH**

# CITY OF DUBLIN – REQUEST FOR QUOTATION

**Re: Asbestos-Containing Materials (ACM) Assessment Report**  
Commercial Building and Telecommunications Building - 6611 Liggett Road  
Dublin, Franklin County, Ohio

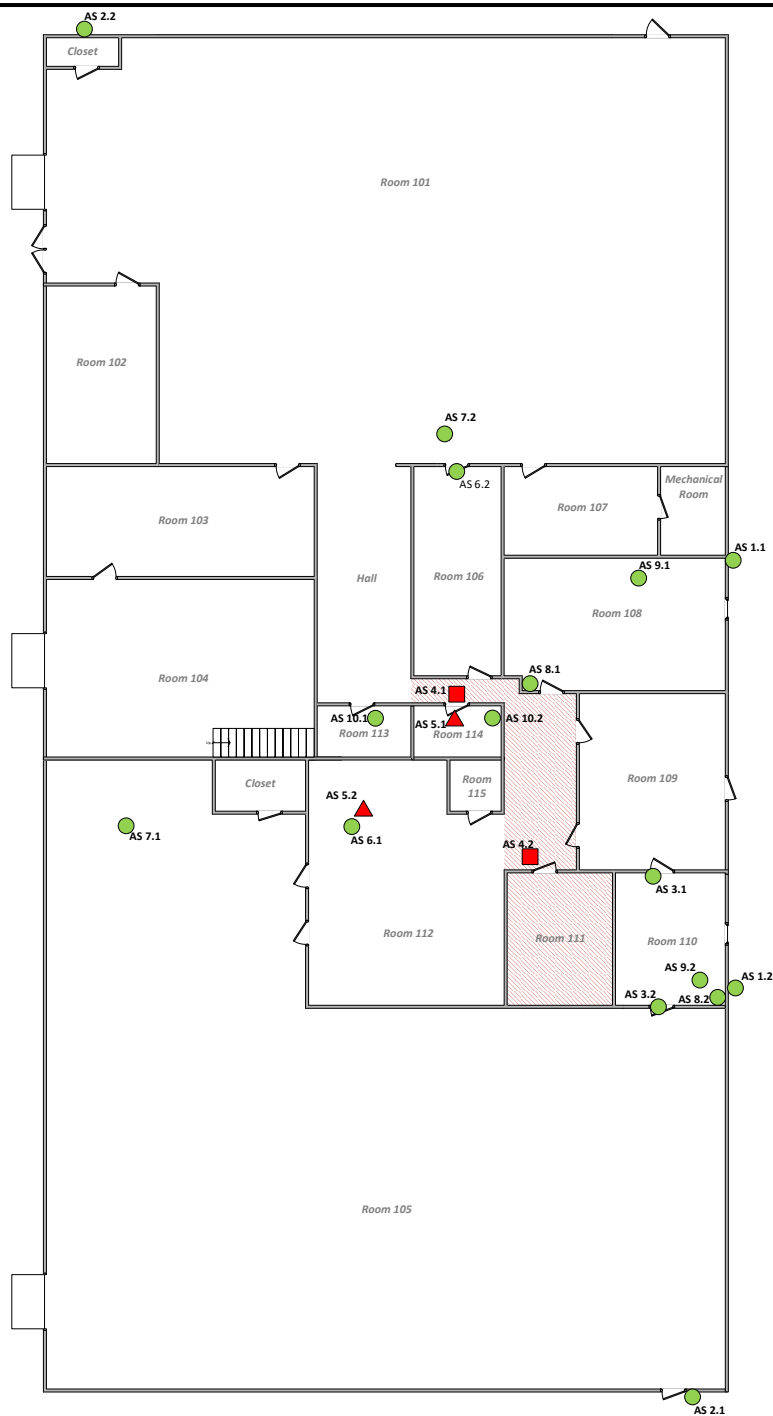
**Figure 2**

The bulk sample locations are illustrated on the Sample Location Diagram (Figure 2). Representative photographs of the HAs are included on the attached Photograph Log. The bulk analysis laboratory report and chain-of-custody documentation are attached.

ACM Floor Cover

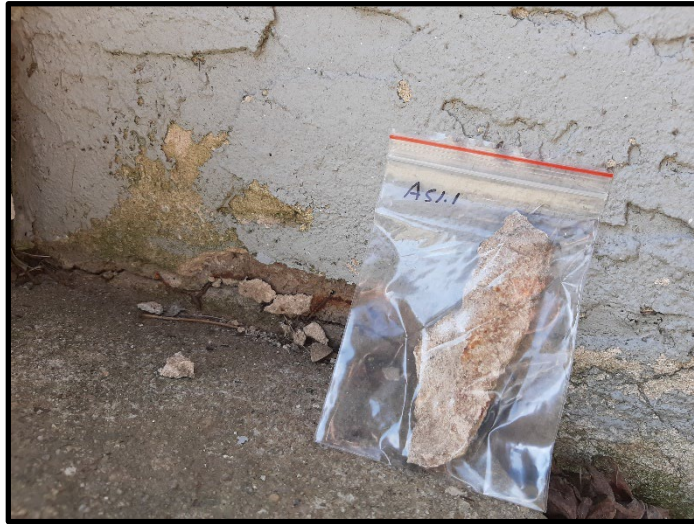
**1** – HA 1 – Stucco (Gray)

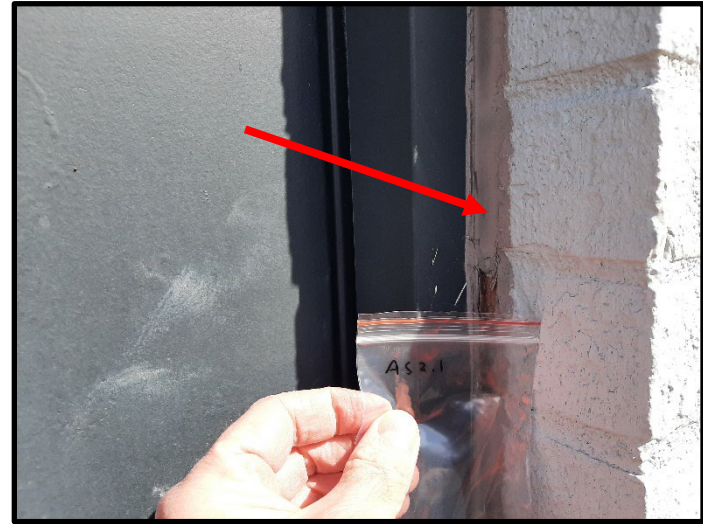
**2** – HA 2 - Caulk (Gray)

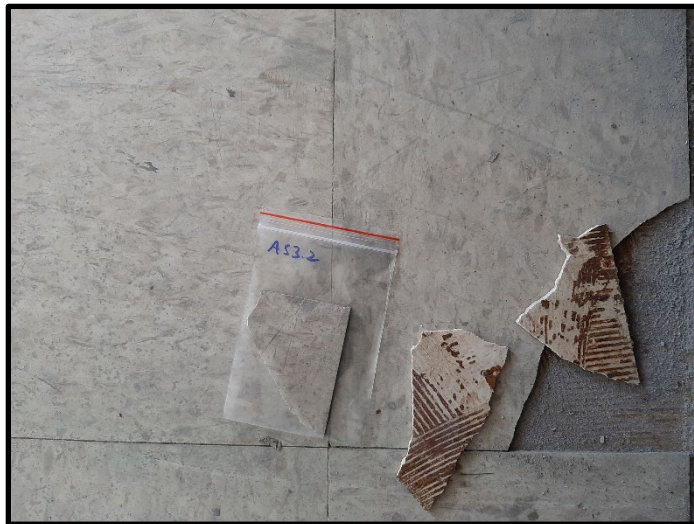
**3** – HA 3 - Vinyl Floor Tile (White with Gray Mottles, 12"x12") with Mastic (Tan)

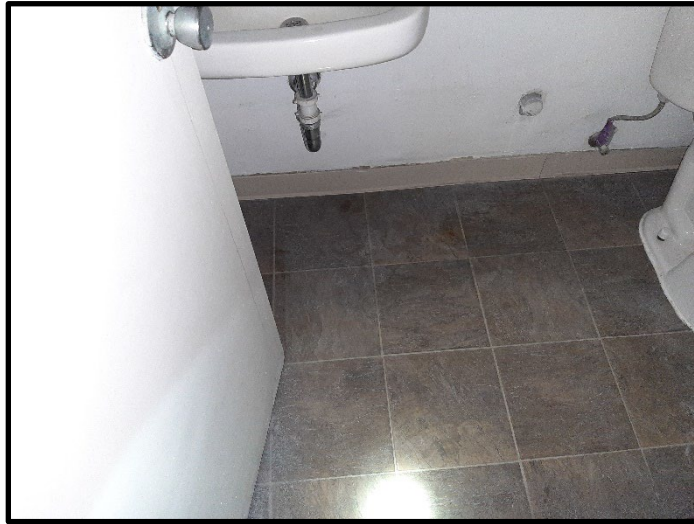
<b>TABLE 2 – MATERIALS CONTAINING LESS THAN 1% ASBESTOS</b> <b>6611 LIGGETT ROAD</b> <b>DUBLIN, FRANKLIN COUNTY, OHIO</b>		
Homogeneous Area	Location	EPA Category & Type
Linoleum (Gray, 12"x12" Ceramic Tile Pattern) (Photo 5)	Restrooms (Rooms 113, 114, and 115) and N Side of Room 112	Non-Friable I/ Miscellaneous

**5** – HA 5 - Linoleum (Gray, 12"x12" Ceramic Tile Pattern)

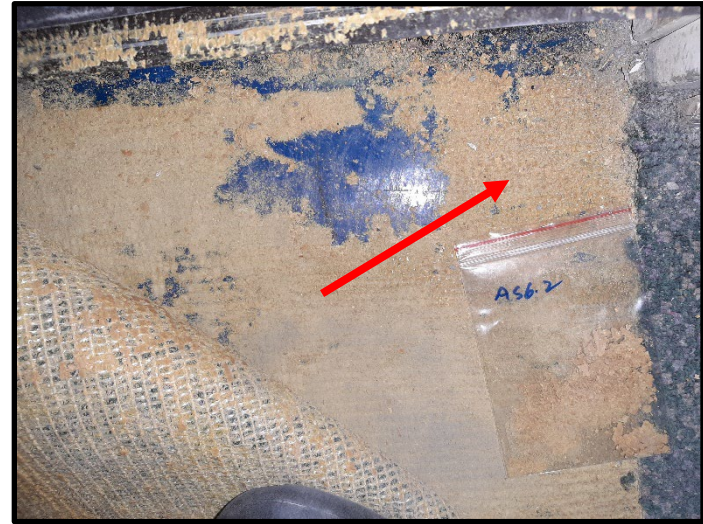
**6** – HA 6 – Carpet Mastic (Tan)

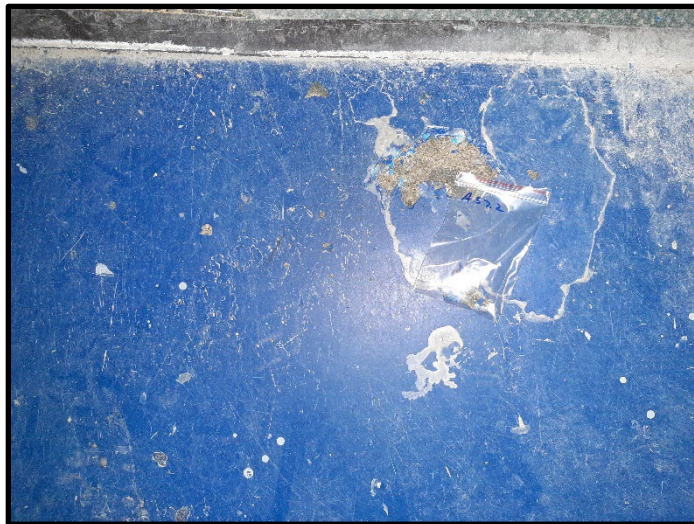
**7** – HA 7 – Floor Coating (Blue)

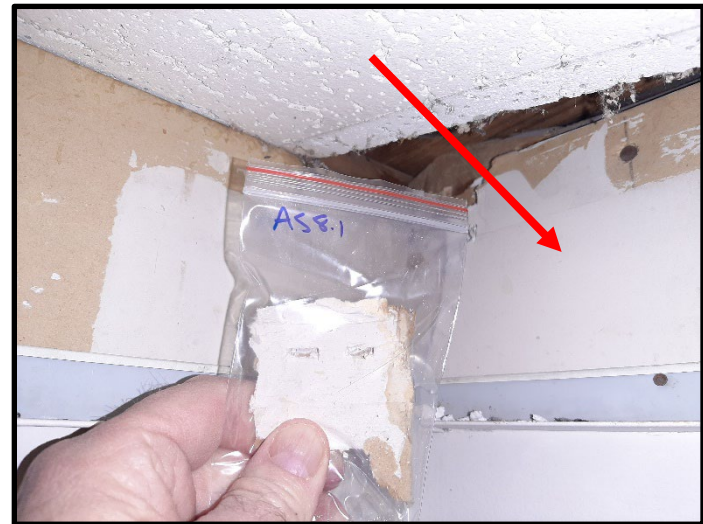
**8** – HA 8 - Drywall (White) with Joint Compound (White)

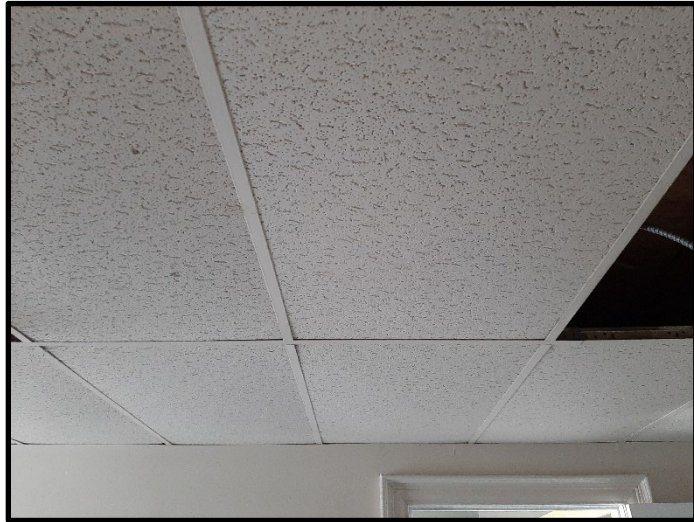
**9** – HA 9 – Drop Ceiling Tile (Gray with White Surface, 2'x4')

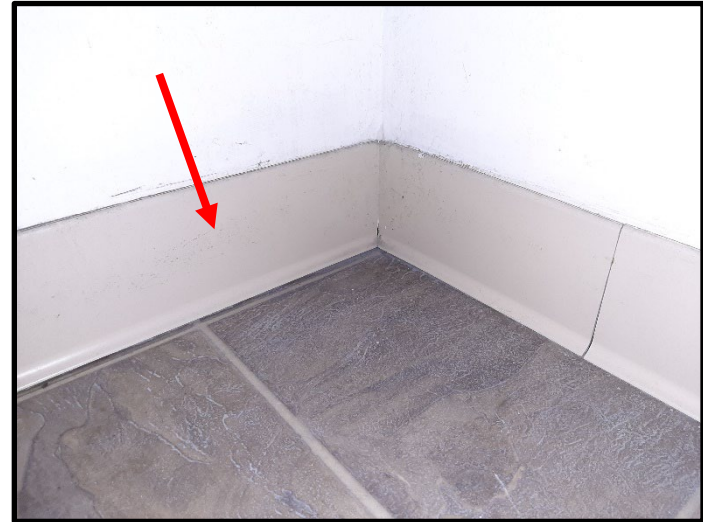
**10** – HA 10 - Cove Base (Beige, 4") with Mastic

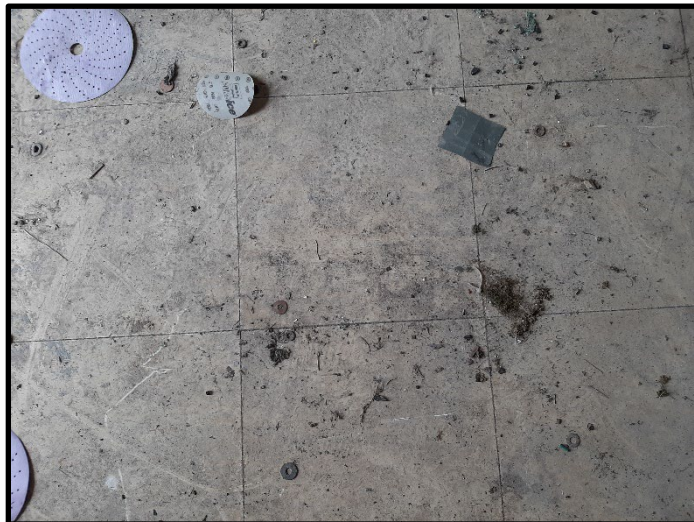
**11** – HA 11 - Vinyl Floor Tile (Gray, 12"x12") with Mastic (Tan)
