RE: 40 North High Street
Korda File: 2021-1006.15

At your request, I performed a structural assessment of the existing retaining wall behind the structure at the above stated location on Friday, February 26, 2021. The structural assessment was requested to evaluate the structural integrity of the existing field stone retaining wall located along the Eastern side of the property with the main retaining wall built towards the North and a return wall towards the West.

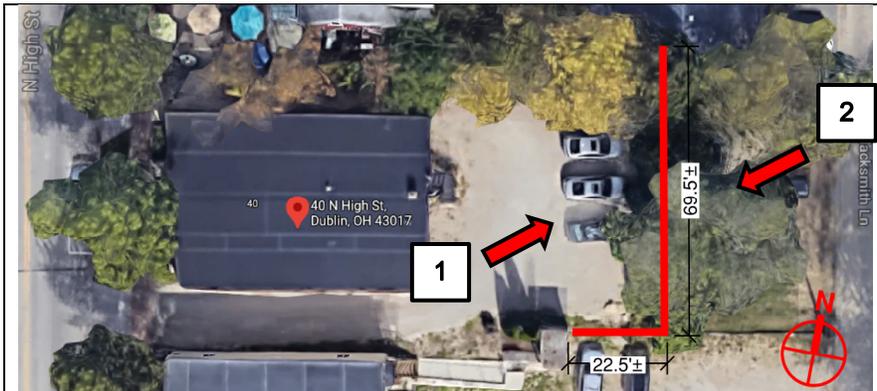
Overall plan view of property

The wall is approximately 69.5' long x 22.5' deep x 6.25' tall and is constructed of fieldstone. The upper portion of the retaining wall is used as a gravel parking lot (#1) while the lower portion is unoccupied and does not have any construction (#2). There are several coniferous trees and other vegetation that line the top of the retaining wall (#3). There are several visible roots and vines that are coming through the cracks at the top several layers of the wall (#4). There is a sewer line that penetrates the retaining wall at the North side of the corner and turns down below grade (#5).

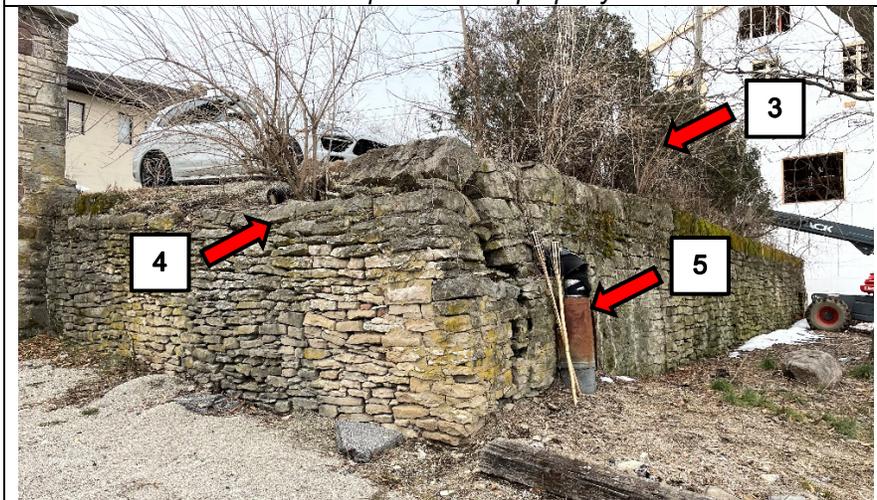
Overall view of wall

In general, the stone wall is held together by interlocking stones that resist the lateral pressure behind the wall. This type of wall is called a dry stone wall and was a viable option for building a wall in the 1800's and early 1900's. The intent for the wall is to retain the soil while letting water circulate through and beside the wall. This was generally achieved by providing free draining material behind the wall to allow for this to happen. Mortar was not typically used to interlock these stones as it prohibits water from passing through. If water is present behind the retaining wall, it increases the lateral pressure exerted onto the wall, and compromise the walls structural stability.

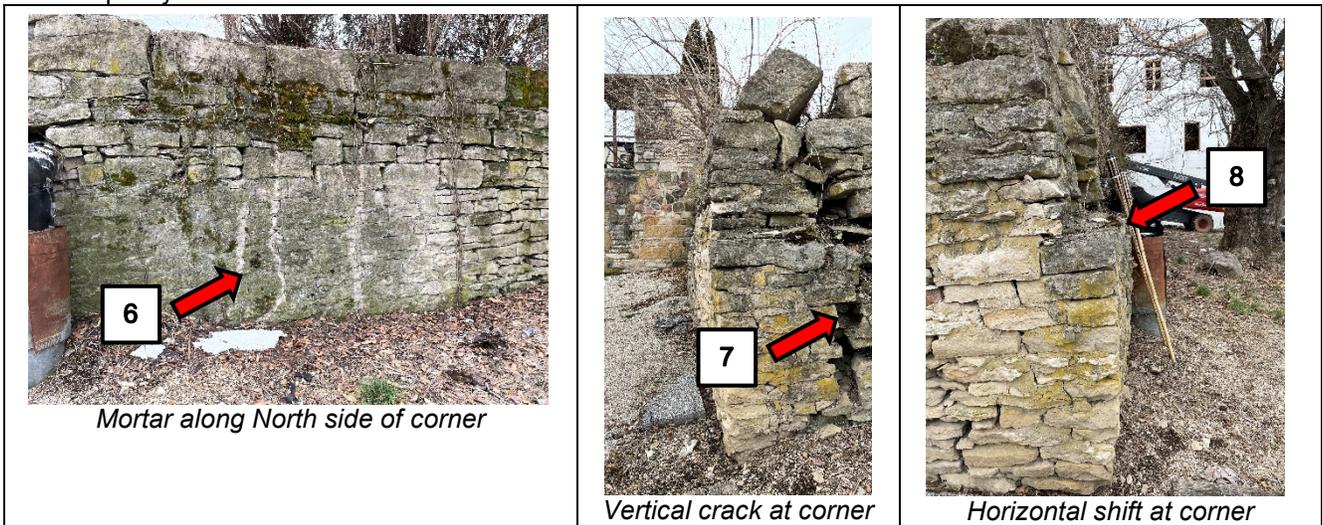
There are several locations where it appears that mortar has been placed between the stones on the outside face of the wall along the North side of the corner by the sewer line (#6). This was likely done to allow for the sewer line to pass through without undermining the integrity of the wall at the time of installation, however this has also prevented water from getting through. There are several significant areas of concern, a vertical crack located on the North side of the corner that shows several inches of separation (#7), a horizontal shift at half height of the wall at the corner location (#8) and further, the top portion of the wall at this corner has broken off. This indicates that there is swelling of the soil at the bottom of the wall and that the pressure has exceeded the shear capacity of the wall.

- The wall will need to be deconstructed and re-built to ensure proper stability.
- The soil behind the wall will need to be removed at a 2:1 ratio and backfilled with free draining fill to ensure that the soil's lateral pressure does not increase due to water saturation.
- An appropriate drainage system will be required to mitigate the water build up behind the wall.

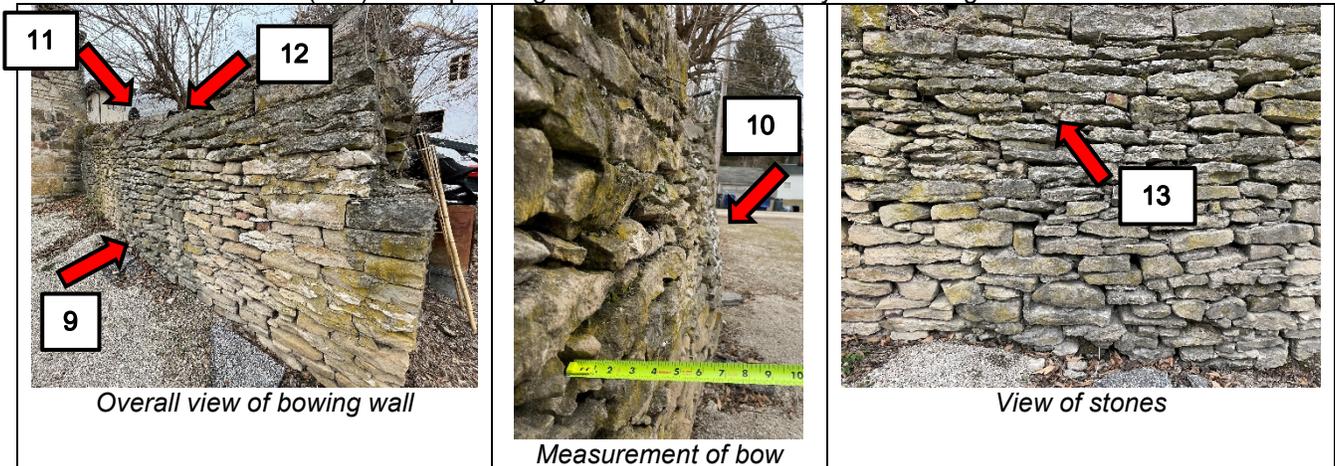
The return wall West of the corner is also showing signs of bowing at the mid-length of the wall (#9). The bowing occurs at the bottom 1/3 height of the wall and is bowing approximately 7" from plumb (#10). The top of the wall has settled downward at approximately the same location of the bow (#11). This location aligns with a corrugated pipe that is draining the parking lot over the wall instead of letting the water saturate the soil behind the wall. The bow in the wall has caused the stone to spread outward on the outside therefore pinching the back side of the wall (#13). This pinching of the back side is likely contributing to more water retention.

The retaining wall's overall stability has been compromised at the Southwest corner of the wall, the South side of the wall, and approximately 20' along the Eastern length of the wall. There are many factors that likely contribute to the current wall's condition including the change in grading, rain water management, nearby construction, tuckpointing the stones in select locations, tree/shrub roots, potential thermal expansion of the wall and modifications to its structure over time. Significant corrective measures are required to bring the wall back to its proper integrity, address the compromised portions, and plumb the wall and include the following measures:
