# MEMO

Date: November 7, 2022

Re: Stone Retaining Wall located on 40 N High and partially on 38 N High;  
Informal Review of Submittals, Preservation POV

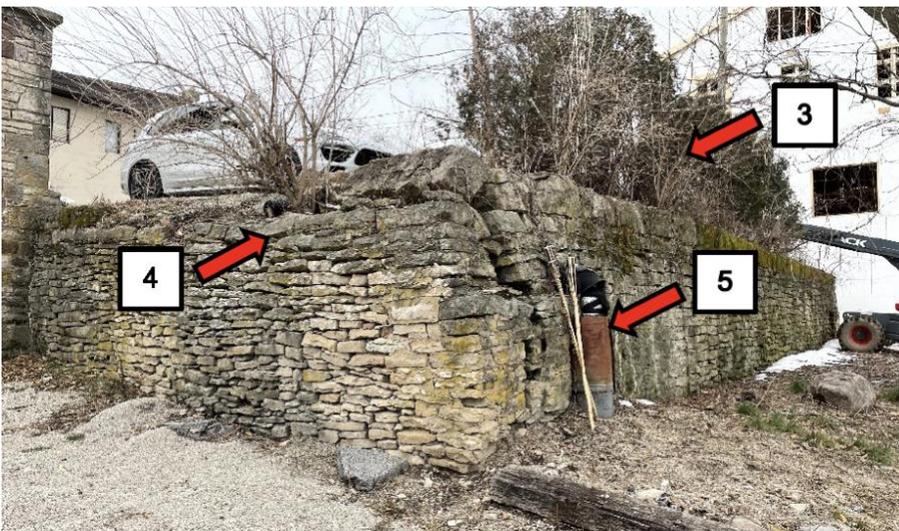
Fig. 2: View of retaining wall, looking northwest at the southeast corner (Kooi, Bernie. *Overall view of wall*. 2021. 40 North High Street, Korda/Nemeth Engineering, Inc. 2021, p.1).

draining material fill lay behind the interlocking stones which retain the soil, allowing water to percolate through and beside the wall to prevent a build-up of pressure behind the wall. Both assessments noted the wall bulge on the southern portion of the wall (4), likely caused by channeled drainage runoff above, as well as a crooked, vertical crack or “wall separation” just north of the southeast corner (near 5). Korda’s report attributed the bottom half of the east wall at the southeast corner being pushed further east by trapped, swelling soil, causing the bump out visible in the center of Fig. 2. Korda’s assessment also noted the deterioration due to vegetation, including roots and vines at the top of the wall (3 and 4).

- Regarding the exposed sewer pipe penetrating the east wall (see note 5 in Fig. 2), please provide information on how rebuilding the wall would be best accomplished, also taking into account if the sewer pipe were to stay as-is, or if the sewer pipe could be moved westward, inside the eastern wall during the rebuild (the preferred option). If the sanitary pipe were to stay as-is, what additional work is needed, including mortaring, sanitary repairs, etc? Please provide any details of this work if this work is approved.

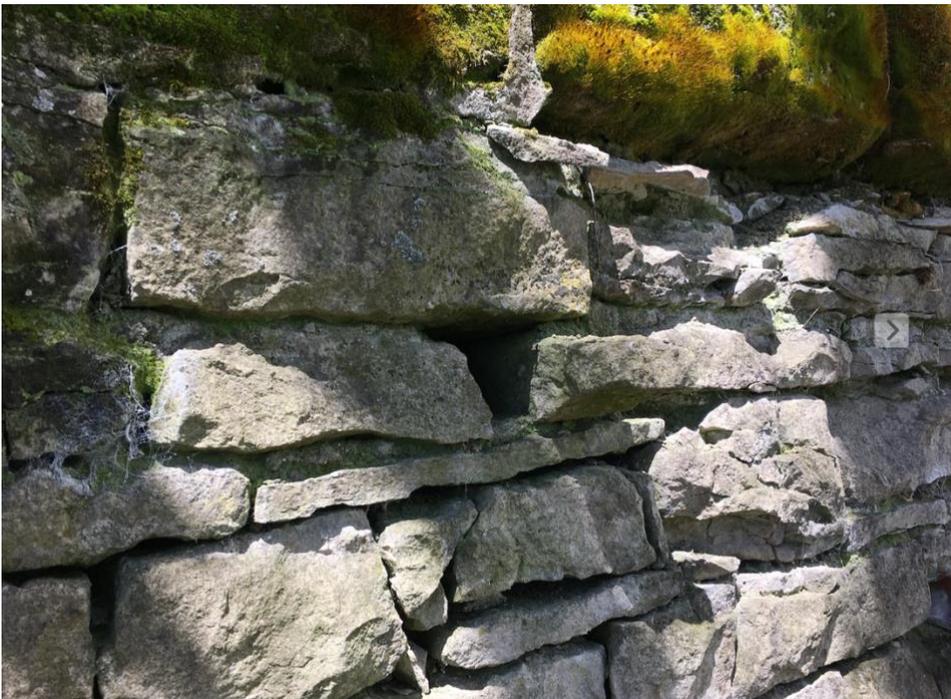
PHOTO 2: Possible original drainage outlet found on the eastern retaining wall (Preservation Designs, May 2021).

- Osborn Drawings: the perforated pipes exit the east wall, but there is no detail on their exterior appearance. Ideally, having white PVC sticking out of the wall does not lend itself to a historic look. Instead, the exterior appearance should reflect what the original masons used on this wall for drainage points, provided the historic appearance would not inversely impact the wall’s structural integrity. (See PHOTO 2 for what may be such a drainage exit point). If no existing historic drainage point can be used as a reference, the next best way would be terminating those pipes so no PVC is visible and then using a termination device appropriate to c.1900, provided the design would not interfere with the wall’s structural integrity.

- Regarding the drainage of the new perforated PVC to be installed (see notes regarding Osborn Drawings), if Vic Art Masonry has any familiarity with what a drainage point would have looked like historically, whether similar to what is seen in PHOTO 2 or is typical historically for Central Ohio, please provide this information for review and the project's potential use.

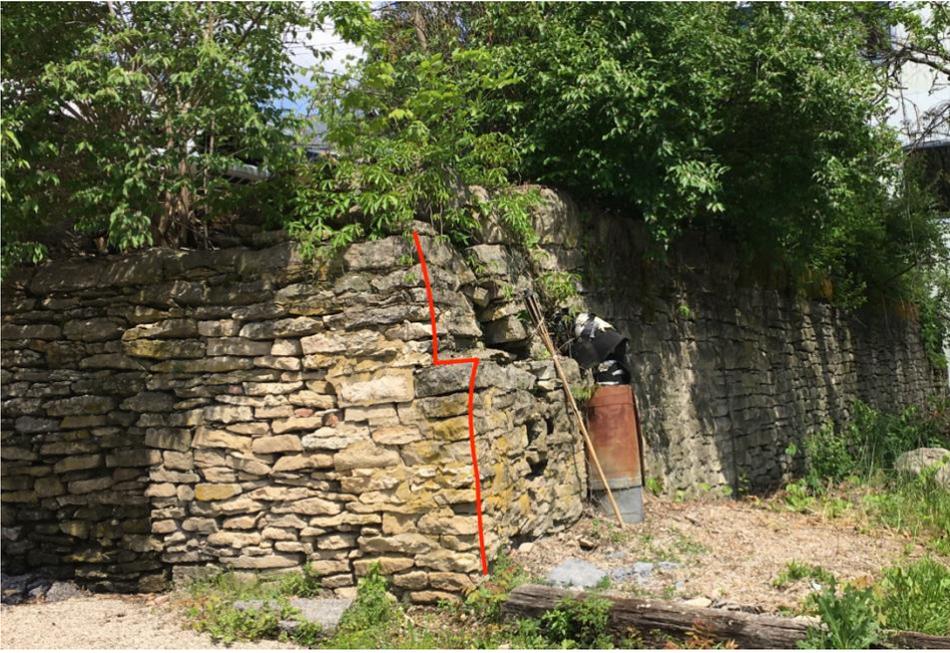
- The Korda report noted that a lower segment of wall, corresponding to the southern-most portion of the east wall (see PHOTO 3), had shifted east. The Osborn report does not note this shift east. (See also the additional request for information below regarding the wall's northeast corner having an apparently similar condition.)

**PHOTO 3:** Photo of southeast corner of the retaining wall, with a red line highlighting the eastern shift of the lower portion of that wall (Preservation Designs, May 2021).

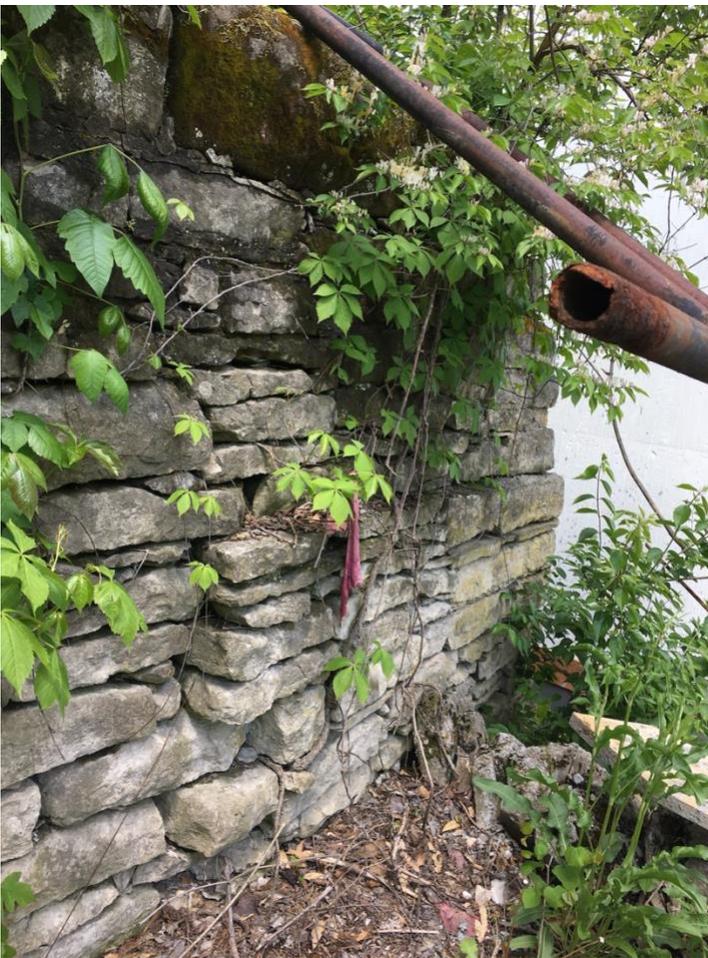
- In May 2021, Preservation Designs conducted a brief site visit, taking photos including of the northeast corner of the stone retaining wall, where it appears to have some lateral shifting similarly to that at southeast corner (see PHOTO 4). Preservation Designs asks for the structural engineer(s) to review this portion of the wall and devise any additional work, if necessary.

**PHOTO 4:** Observed concern a few feet south of the northwest corner of the wall where stone appears to be shifting out, bowing similarly to the east wall immediately north of the southeast corner (Preservation Designs, May 2021).

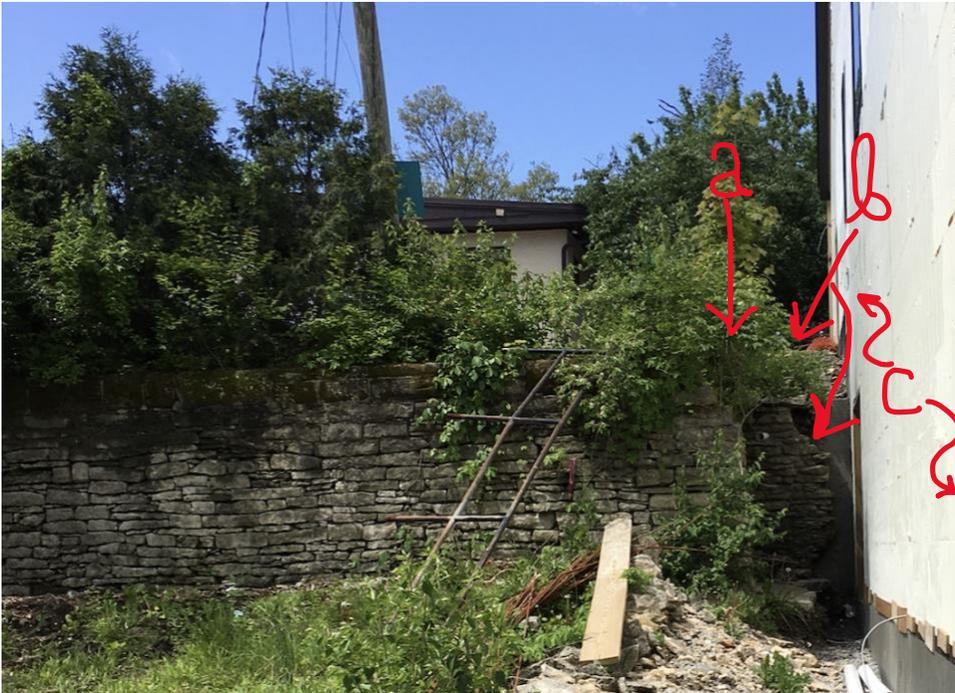
- The construction of the new COhatch building north of the eastern half of 40 N High's lot appears to have affected a segment of the retaining wall, showing a small leg of the wall roughly disassembled per PHOTO 5. Please confirm if work is needed to stabilize the northern retaining wall and/or the stub retaining wall that is perpendicular to 25 North Street's building (COhatch).

PHOTO 5: Photo of northeast corner (a) of the retaining wall, looking west. From this northeast corner, the wall jogged about twenty some-odd feet west and then turned north. At the time this photo was taken, the retaining wall return was broken (b) just short of then under-construction COhatch building (c) at 25 North Street (Preservation Designs, May 2021).

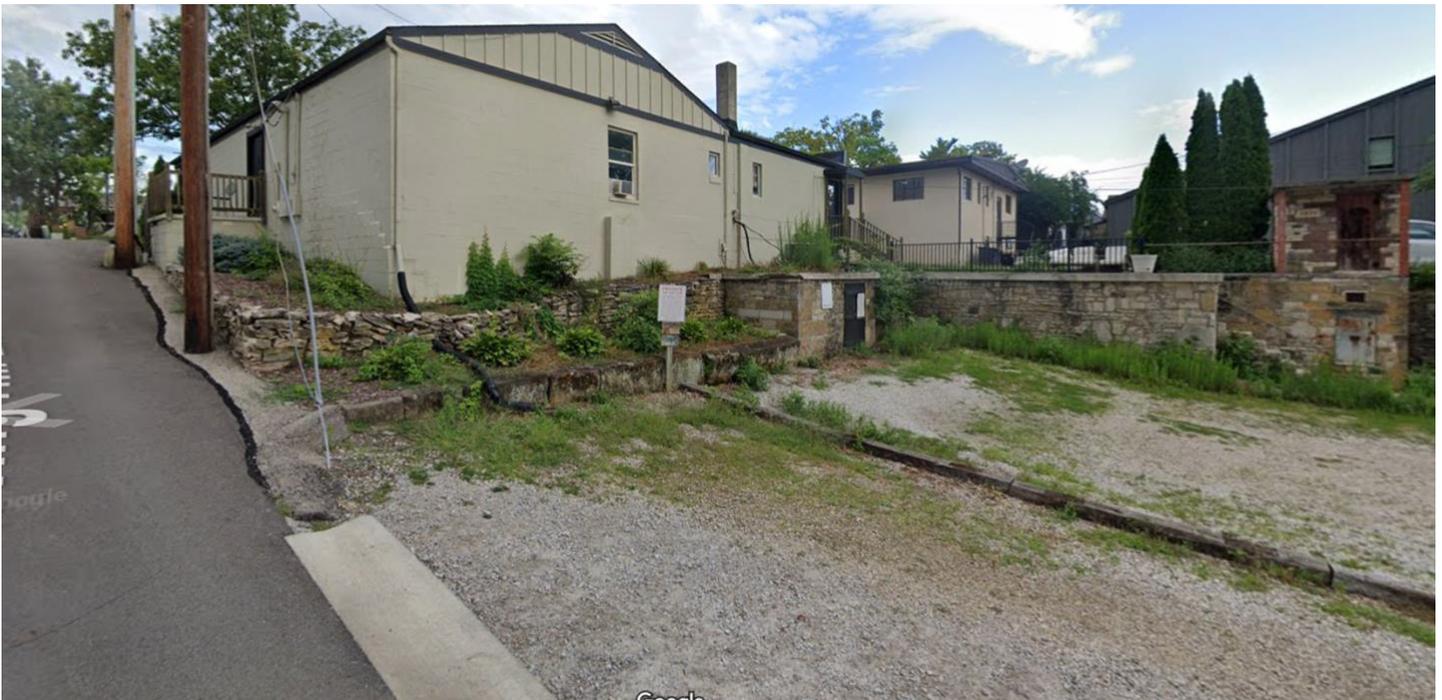
- Also, regarding the 1950s retaining wall located behind 36 N High, a row of large, rectangular dressed stones, similar to the ones used on top of the retaining wall, sit a few feet east of the 1950s wall (see PHOTO 6). Please ensure these stones are to remain, ideally in their existing locations, unless there is evidence that they are the stones missing from the top of the southern portion of the retaining wall.

PHOTO 6: Panoramic Photo taken from Wing Hill Lane, looking west up the hill on the left side of the photo, and north at the two-story privy. Please note the large rectangular stone blocks on the west end of the parking area. (Photo downloaded from the Google Maps website, 'Street View', accessed November 6, 2022, at <https://www.google.com/maps/@40.1002473,-83.1134869,3a,90y,318.1h,85.74t/data=!3m6!1e1!3m4!1sjHX9cg-o3rY8YmFHI1nl7Q!2e0!7i16384!8i8192> ).
