53 N. RIVERVIEW STREET, DUBLIN, OH 43017

Historical Survey, Property Condition Assessment, MEP Survey, HazMat Survey

CTL Project No. 20070043COL
December 23, 2020

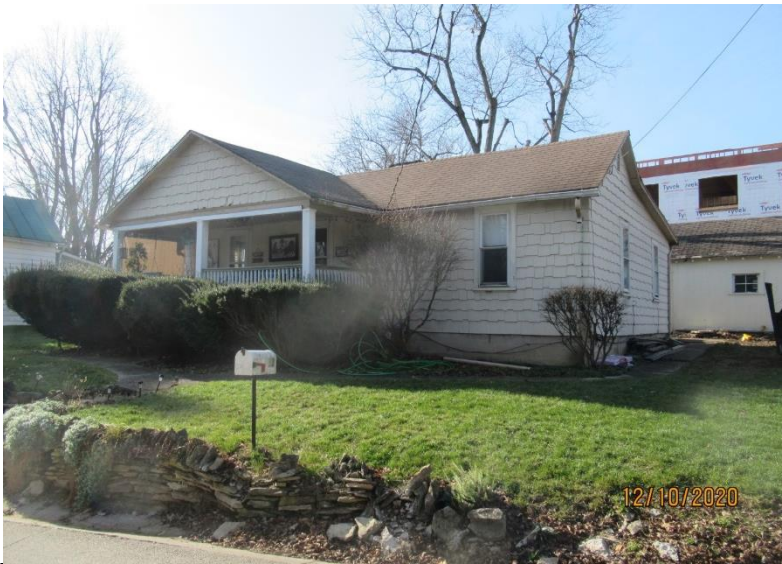
Overall the site is in fair condition. An overview of the front and back of the residence can be seen in Photo 1 and Photo 2, respectively.

Photo 1 – View of the residence Front (Looking West)

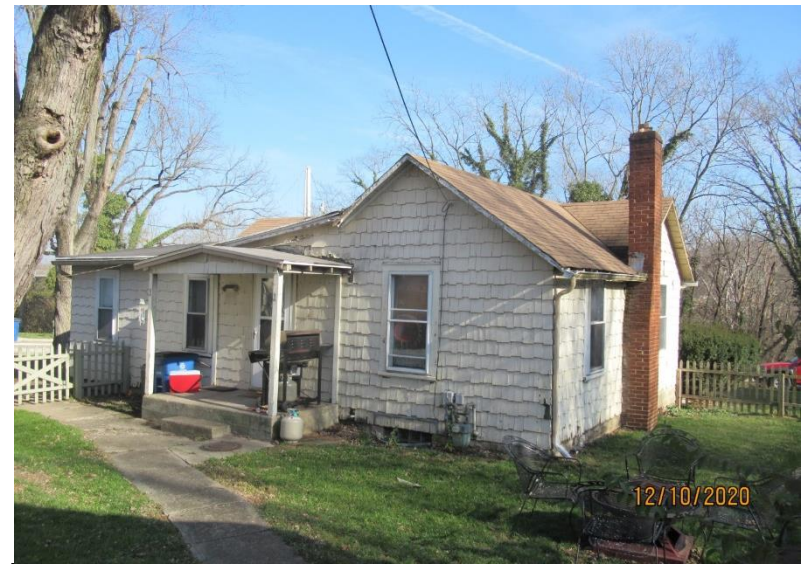
Photo 2 – View of the residence Rear (Looking Northeast)

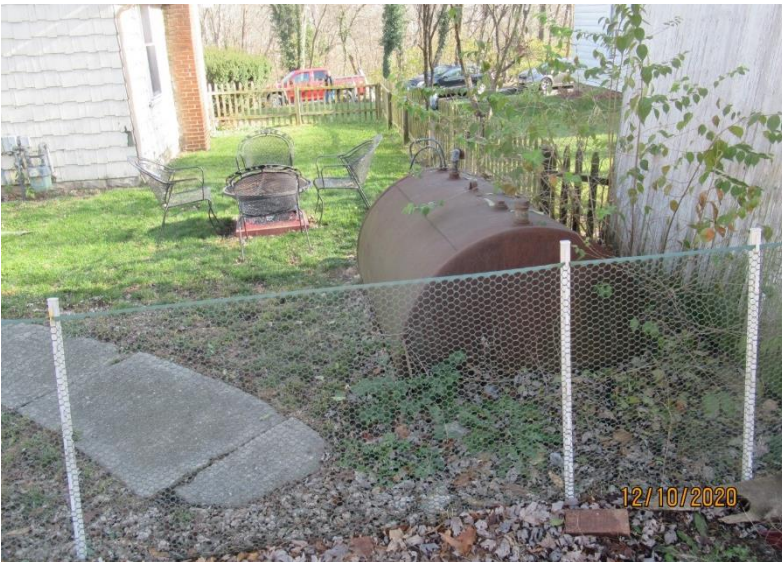
Concrete walkways and steps are located at the front and rear of the residence for access. These concrete walkways are in fair condition, with minor deterioration signs such as cracking and abrasion (See Photo 3).

Photo 3 – View of property from behind rear fence (Looking East)

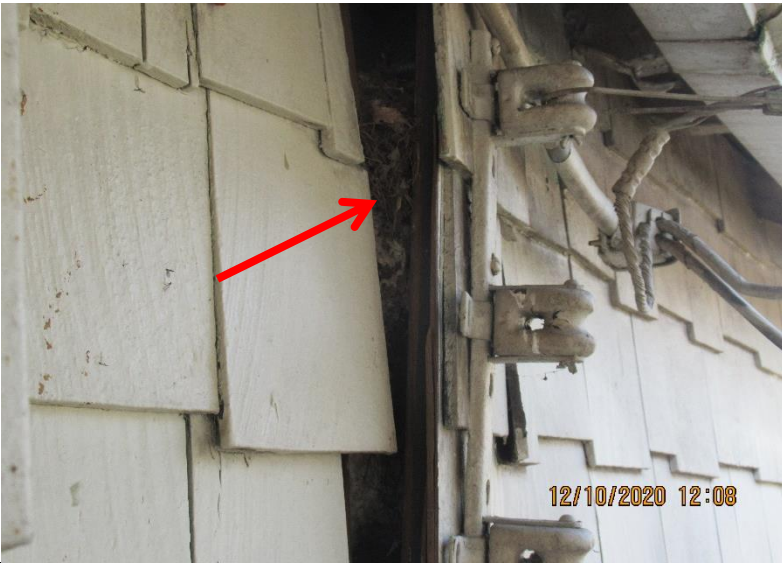
Overall the wood shingle siding is in poor condition and replacement is recommended. On the front porch the siding is pulling away from the structure due to the main electric line attached to the exterior wall (See Photo 5). The shingles area deteriorated and it appears that moisture is trapped behind the paint finish. (See Photo 6).

Photo 5 – Main electric line pulling siding off residence

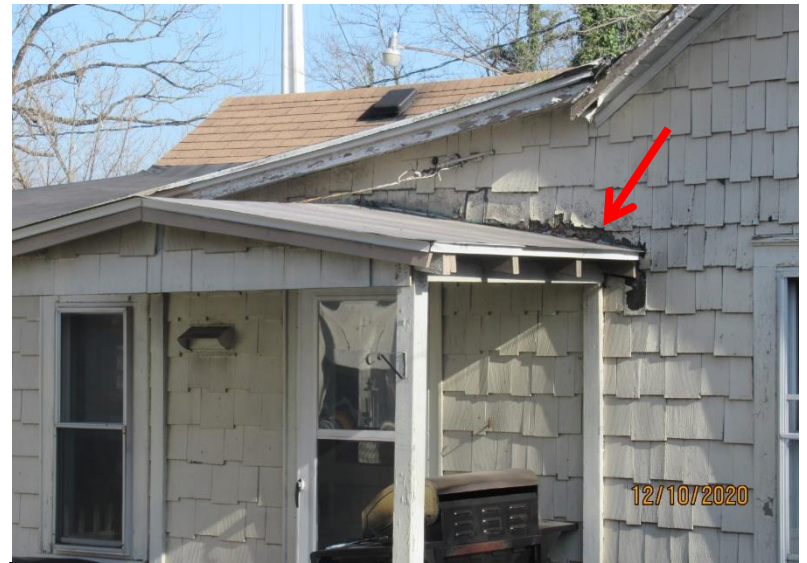
Photo 6 – View of deteriorated shakes on rear of residence

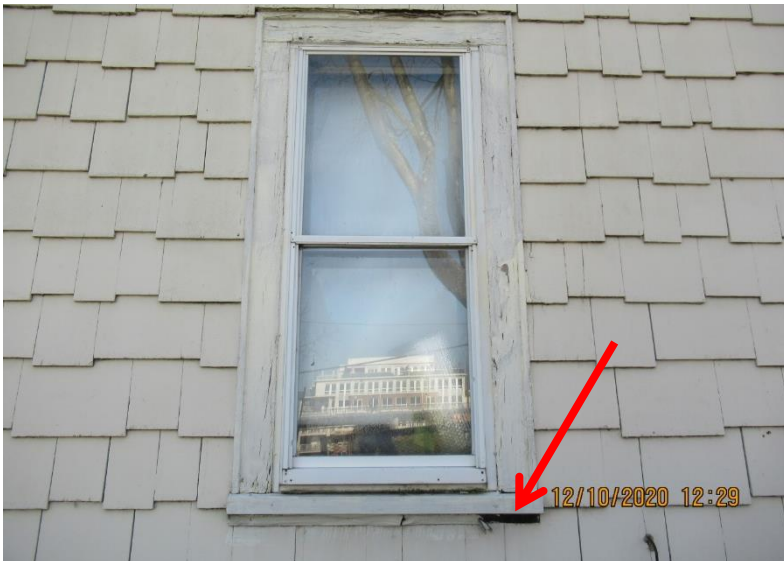
The windows are replacement single pane windows with storm window covers and need to be re-sealed (See Photo 7). Basement windows are single pane only and the sealant is in poor condition (See Photo 8).

Photo 7 – View of residence window

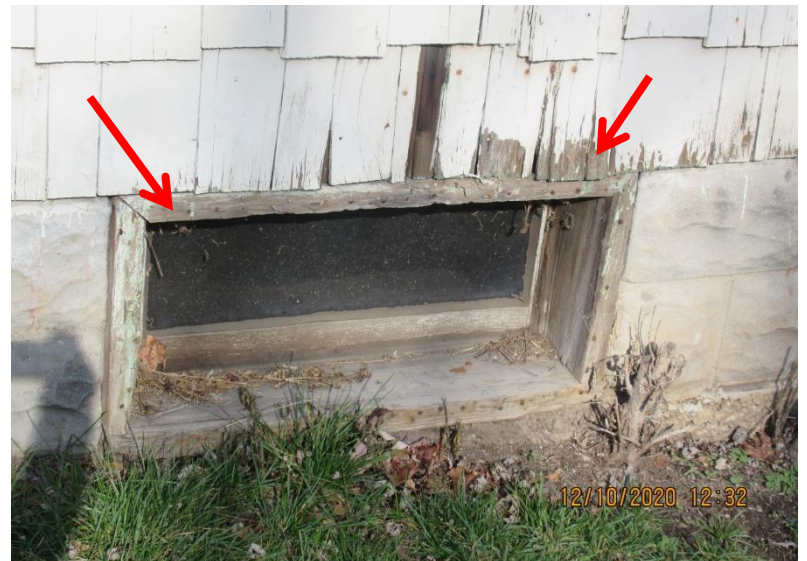
Photo 8 – View of basement window showing deteriorated siding and window frame

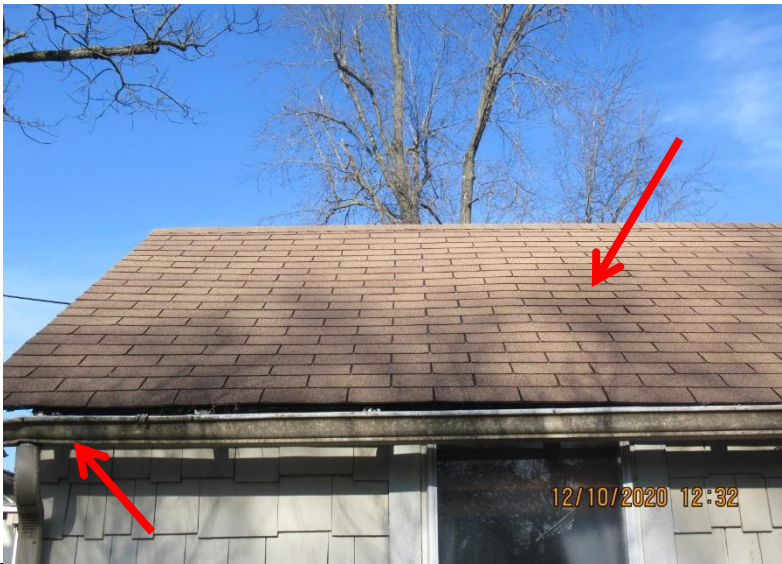
The residence has a shingle roof that is in fair condition (See Photo 9). The gutters and downspouts are in poor condition and need to be replaced. Photo 10 shows deteriorated soffit boards near the chimney. A failed flashing condition at the chimney can also be seen in Photo 11. The chimney needs tuck-pointed.

Photo 9 – View of residence shingle roof and deteriorated gutter

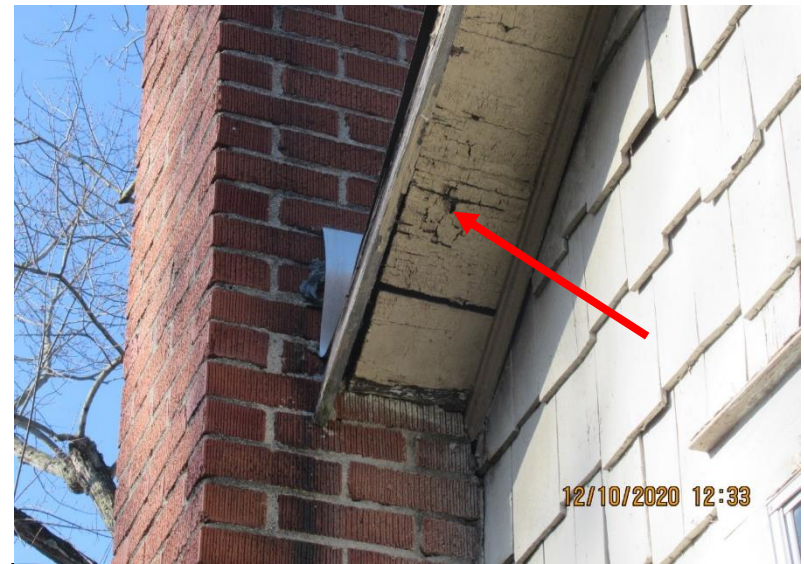
Photo 10 – View of deteriorated wood soffit panels

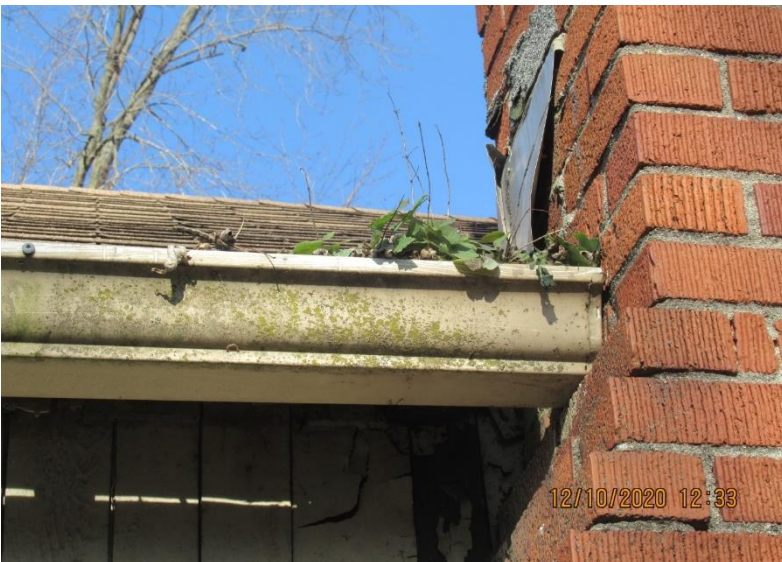
Photo 11 – View of improperly installed chimney flashing

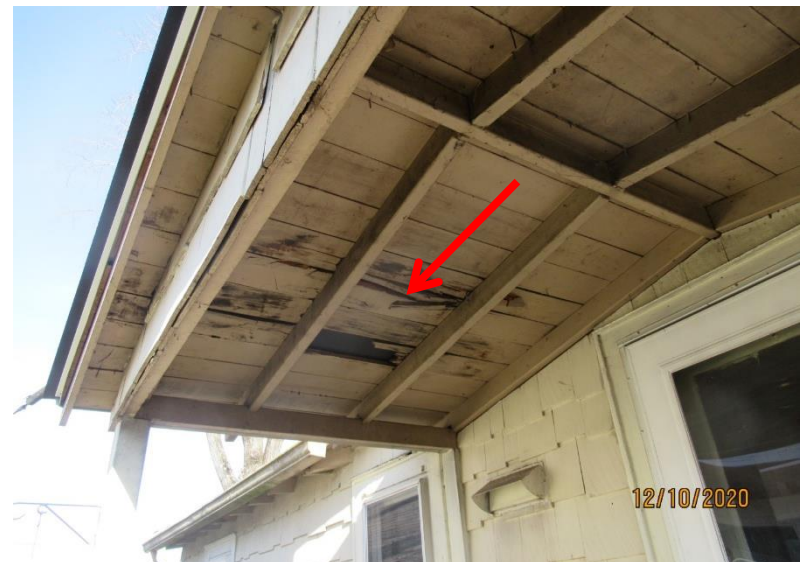
A porch is located at the front and rear of the residence and is in fair condition. Photo 12 shows the back-porch roof decking that is deteriorated and replacement is recommended.

Photo 12 – View of the back porch roof decking showing signs of wood rot

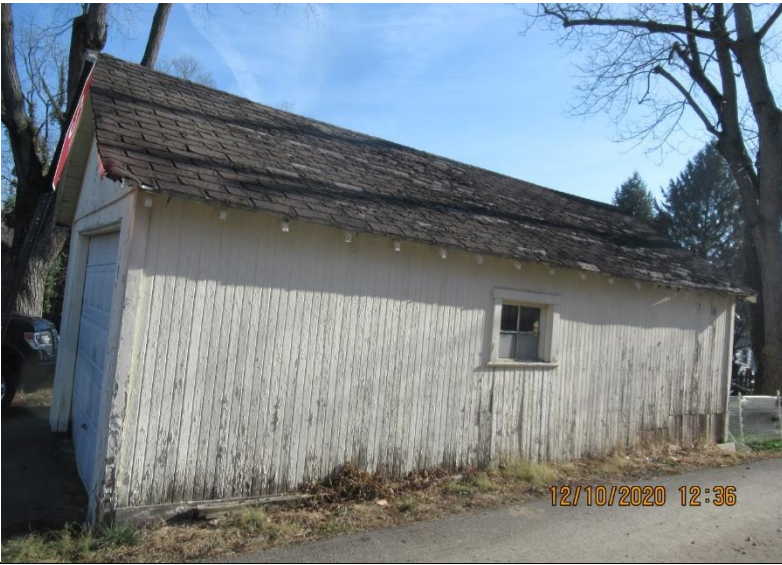
The storage garage is in poor condition. See Photo 13 through Photo 16.

Photo 13 – Overview of the garage (Looking Southeast)

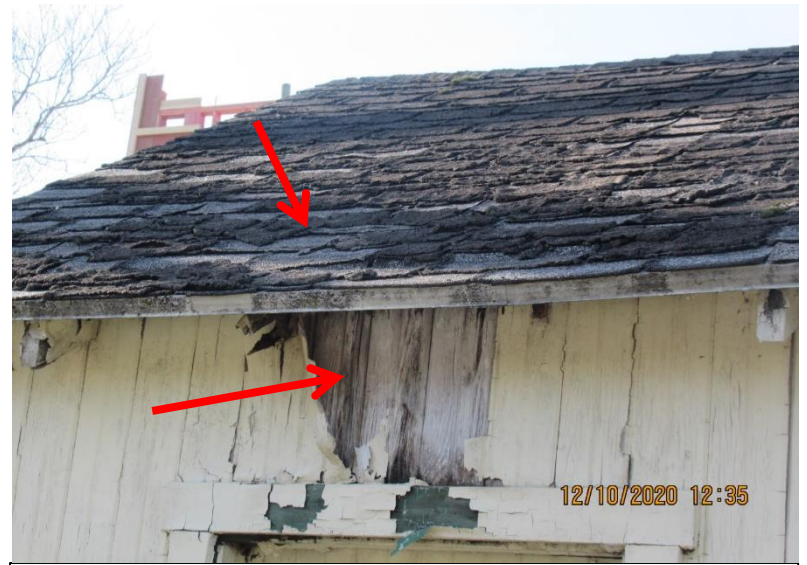
The shingle roof and the wood panel siding is in poor condition and needs to be replaced (See Photo 14). The garage doors are operational and the concrete finished floor is in fair condition. Some of the roof decking shows signs of deterioration; a water stained and wood section loss were noted with red arrows (See Photo 16).

Photo 14 – View of the garage roof and deteriorated siding and shingles

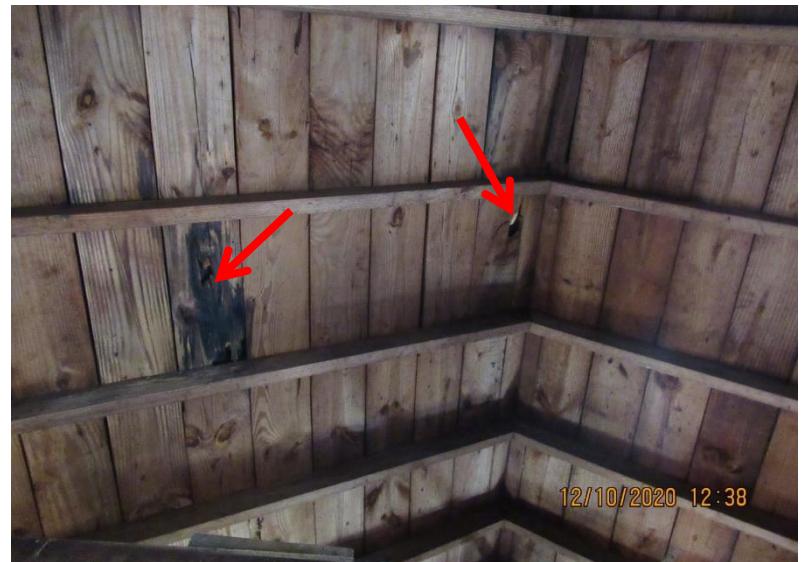
Photo 16 – Interior view of roof decking showing signs of water staining and holes in wood sheathing

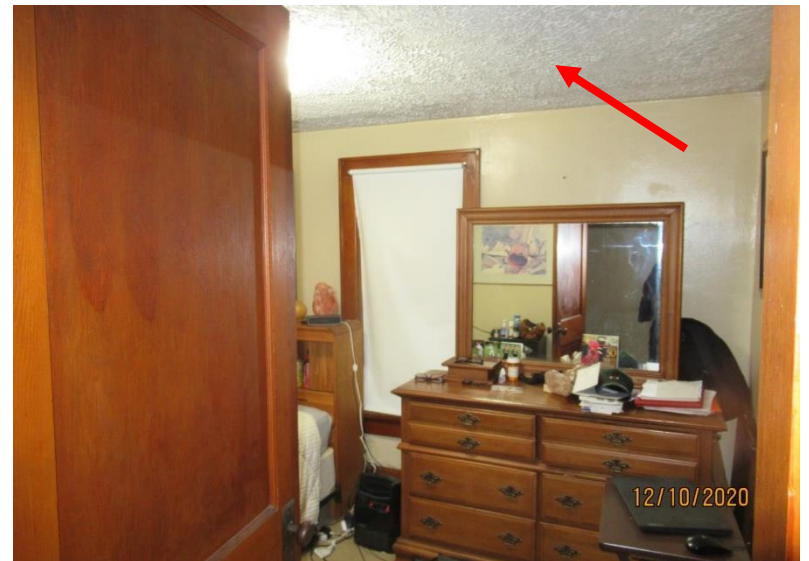
Photo 20 – View of bedroom. This photo also shows a drywall mud topping coat on the ceiling with a swirl pattern.

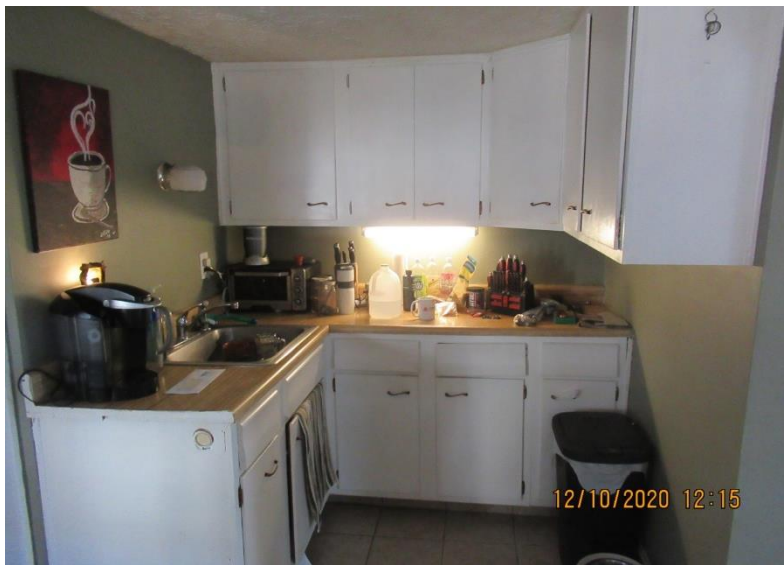
The kitchen cabinets and fixtures are in good condition (See Photo 21).

Photo 21 – View of kitchen

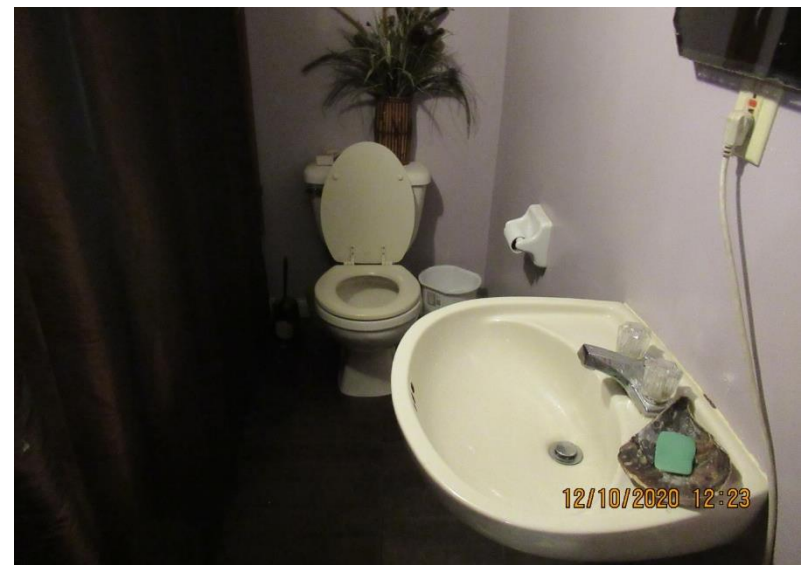
The bathroom is in good condition (See Photo 22). A toilet, sink and bathtub with shower were present.

Photo 22 – View of bathroom

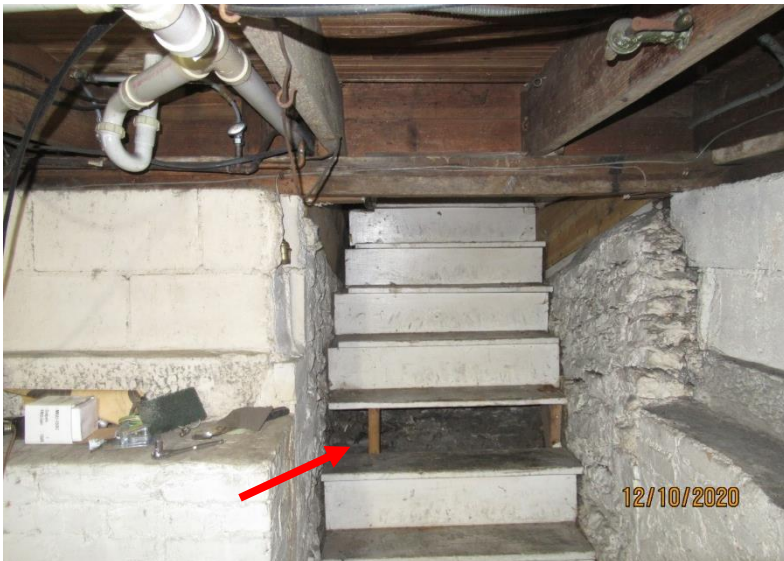
The basement is accessed by wood stairs with the riser missing from one of the stairs. The basement walls are a combination of stone, poured in place concrete and concrete block.

Photo 23 – View of basement entrance steps showing a missing riser face and no hand rails

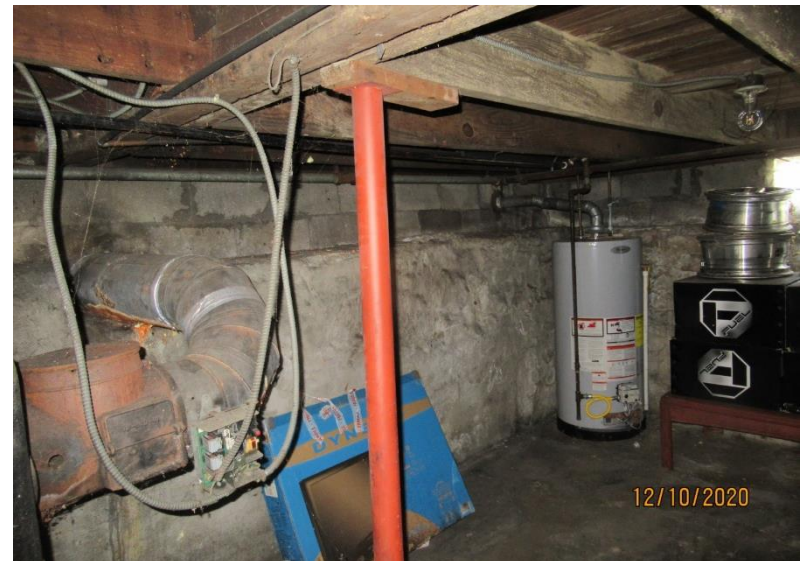
Foundation walls that can be seen in the basement are a mix of stone, poured concrete and block (See Photo 23 and 24). A concrete finished floor is present. There were some signs of moisture intrusion from the concrete block foundation mortar joints but nothing significant.

Photo 24 – Overview of basement area

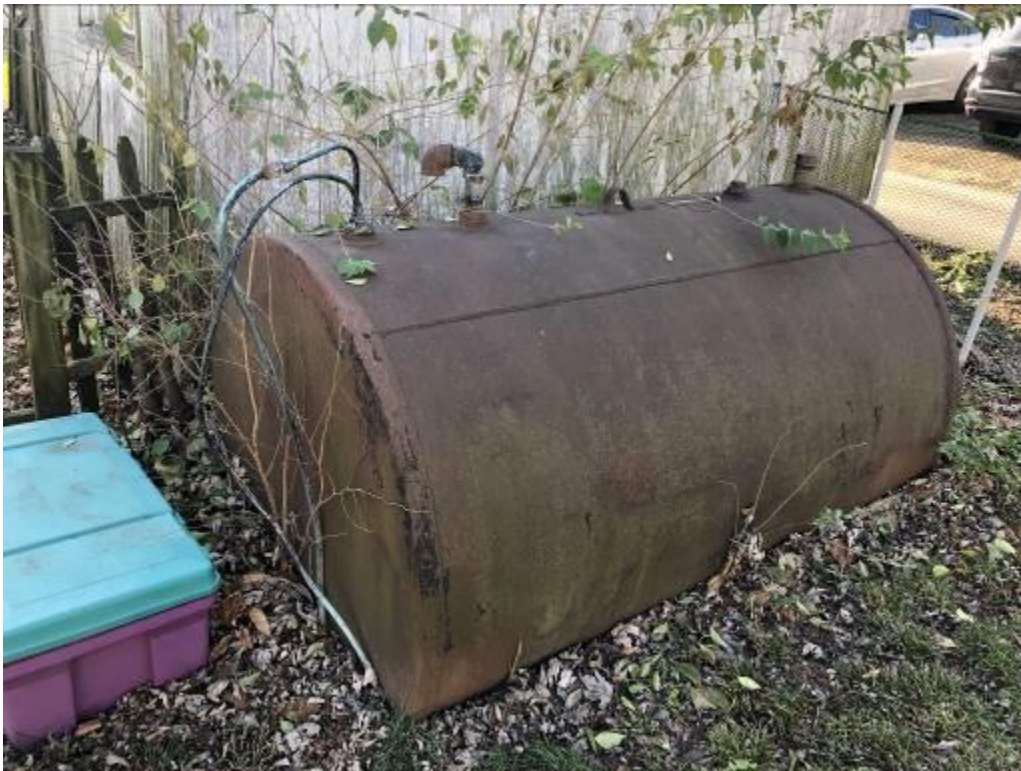
It is unclear as to whether or not any fuel oil remains in the tank, but the tank should be emptied and removed from the site to prevent any future leaks. The boiler could be removed from the basement, but these are heavy and bulky, and are often abandoned in place. The boiler is a potential source of asbestos gaskets and packings. The main floor radiators could be removed, which will open up some wall areas in this small house.

Photograph 2 – A heating oil tank remains in the southwest corner of the back yard and should be removed.

1. Empty and remove the fuel oil tank in the southwest corner of the back yard. (Photograph 2).
2. The two gas fired wall heaters on the main floor may be a safety factor if there are small children in the house. You may wish to replace these with a conventional gas fired furnace and duct system which could be located in the basement. (Photographs 3 & 4).
3. Resecure the main electric service to the front of the house. (Photograph 5).

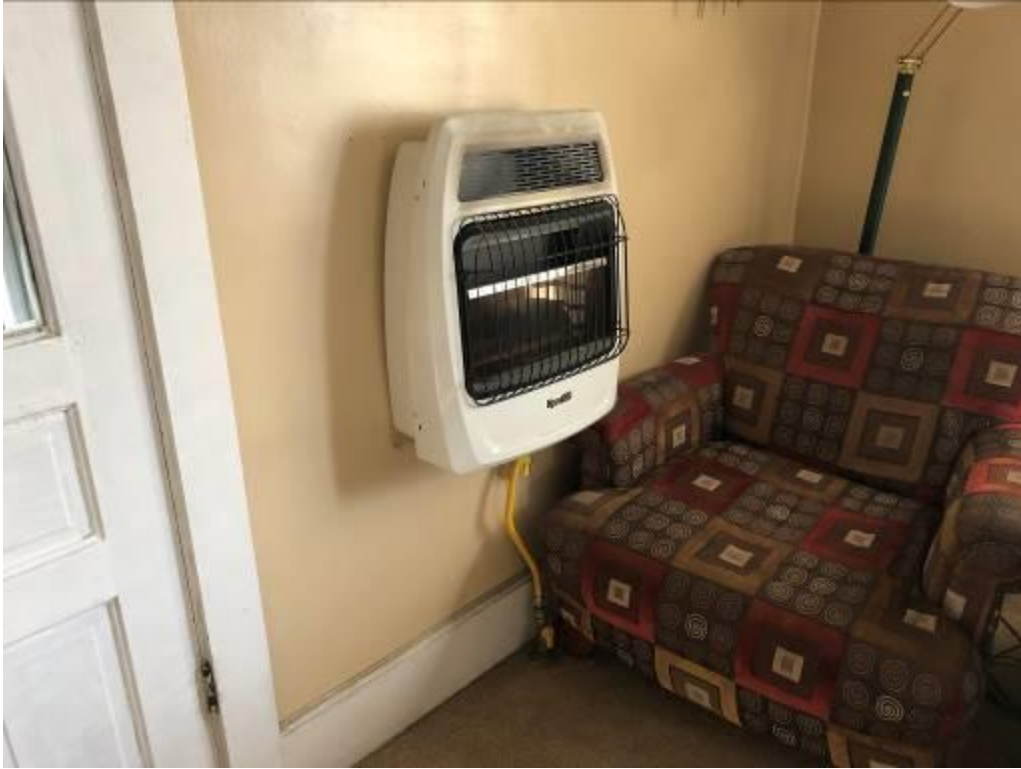
In regard to the current heating system, the two gas fired units may provide adequate heat to keep the house inhabitable, there is heat in only two areas in the house. The heat will be uneven as some areas have no direct heat. The two heating units are located low on the walls. These present a risk for being touched by children in the house. Any placement of furniture or storage next to the units could be a fire hazard. We would recommend that the heating units be replaced with a furnace and duct system in the basement.

Photograph 3 – A gas fired wall heater by the front door heats the living room.

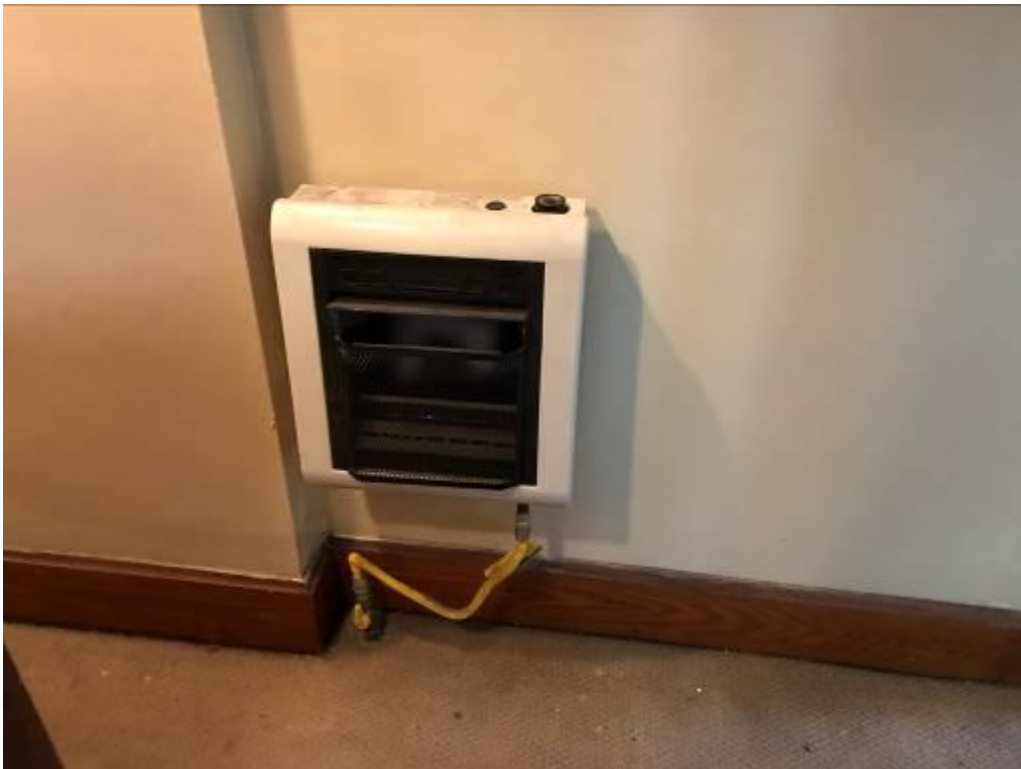
Photograph 4 – A gas fired heater in the rear hallway heats the northwest section of the house.

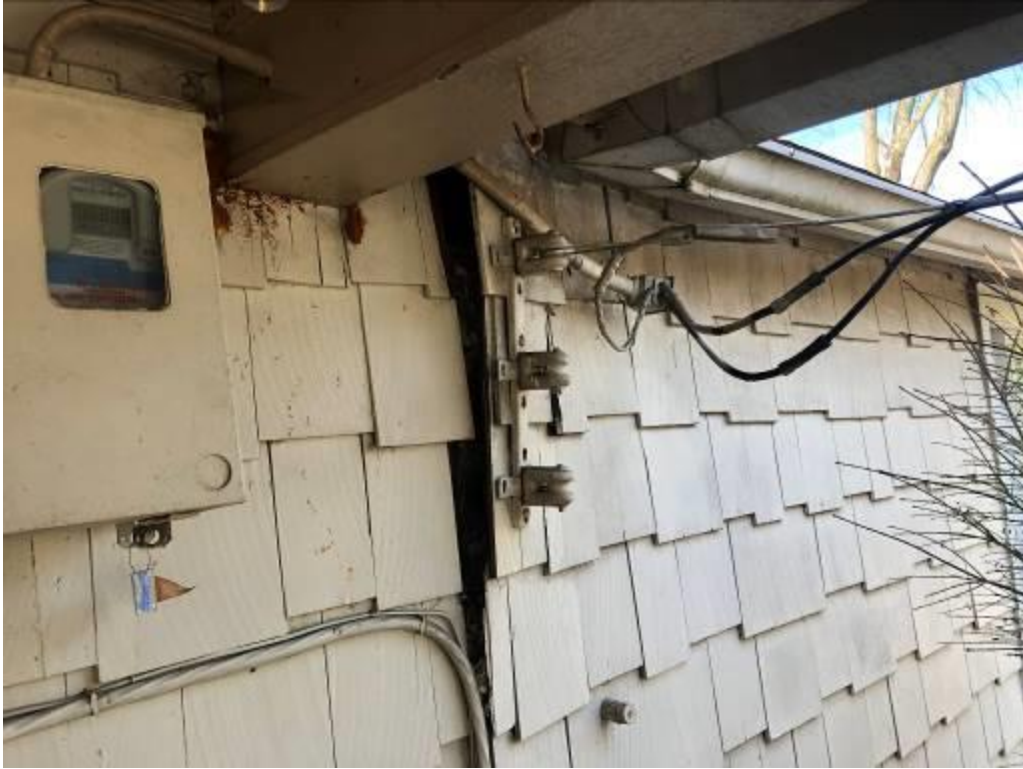
The service is barely adequate for the house. There was most likely a fuse box in the front porch location that was replaced by the current breaker box. One issue with the system is that the connection is pulling away from the front wall of the house. This is a safety concern, and needs to be repaired immediately.

Photograph 5 – Secure the main electric service which is pulling loose from the front of the house.

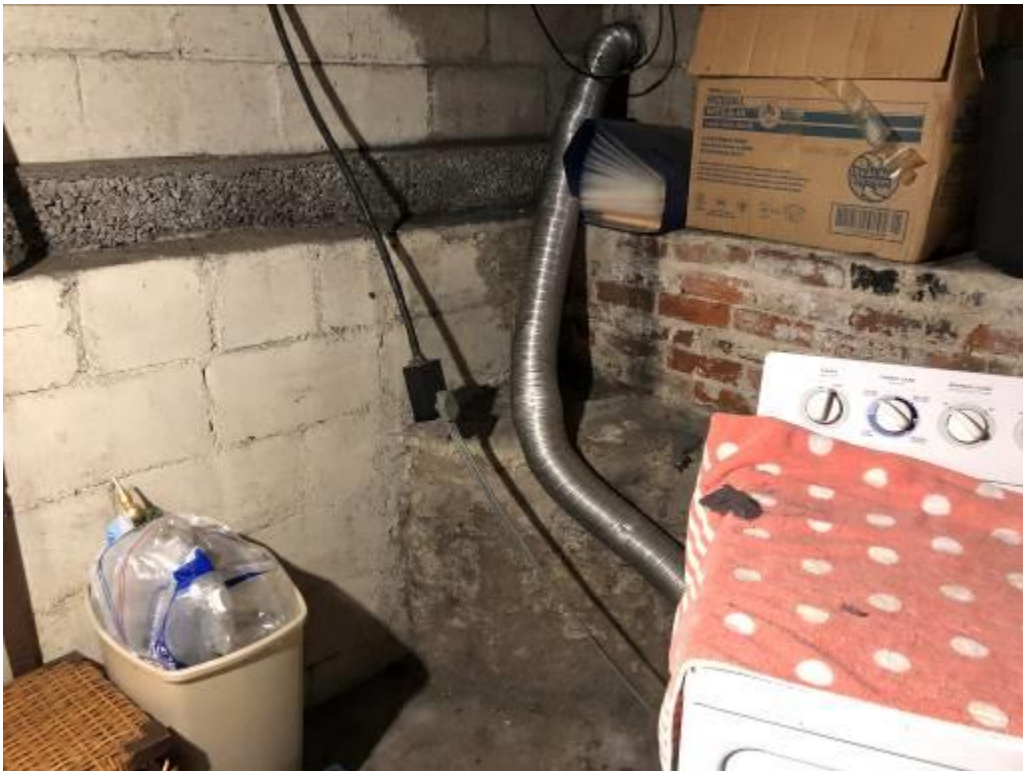
Photograph 6 – The electric dryer outlet is not property secured to the wall.

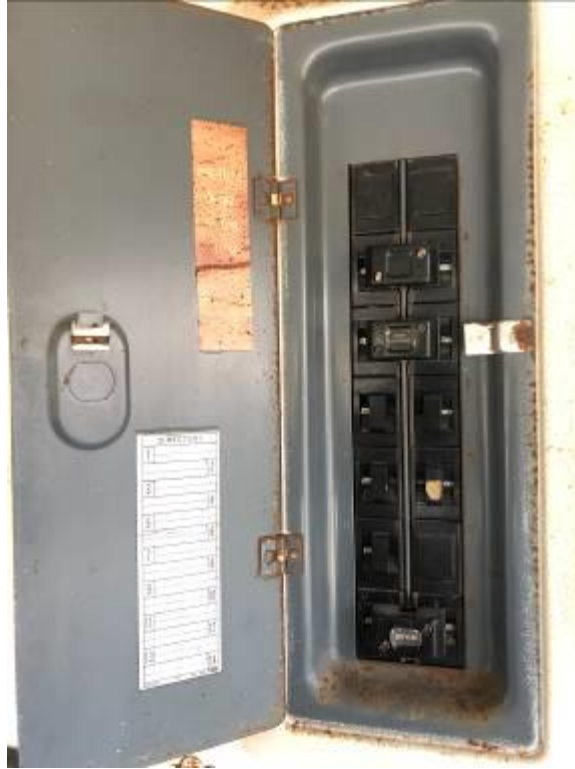
The size of the box may be a little small for the building. No missing or damaged breakers were observed. The circuit breaker box is a Gould Pushmatic breaker box. These were popular in the late 1950's and early 1960's, and the box probably dates from that period. Pushmatic breakers function well, but it is becoming increasingly difficult to find replacements, and they are

Photograph 7 – An older Pushmatic breaker box is located on the front porch and should be replaced or moved.

1. Plan on replacing the Pushmatic circuit breaker box and the original electrical disconnect box in the next few years based on the difficulty in finding replacement breakers (Photograph 7).
