## HISTORICAL ANALYSIS AND DESIGN REVIEW:

**Property Address:** 119 S High  
Dublin, Ohio 43016

**Owner/Applicant:** Richard J Toberen

### HISTORICAL ANALYSIS:

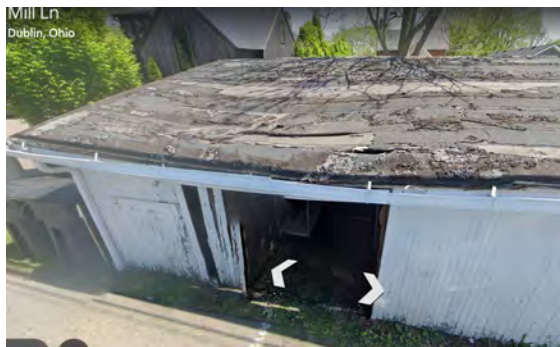
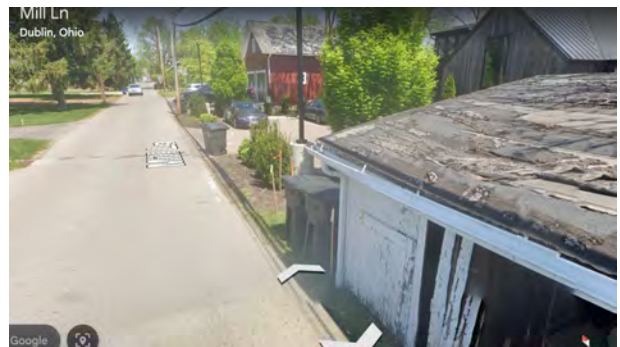
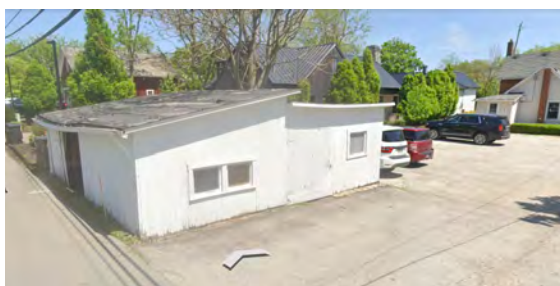
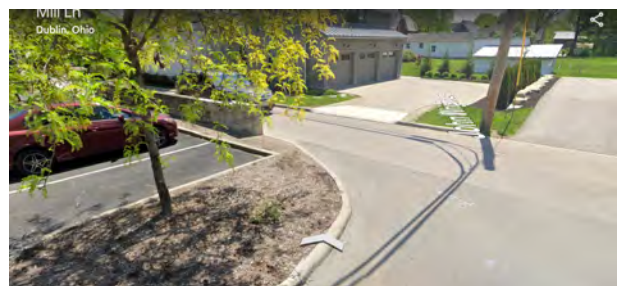
The condition of this utility shed is poor and most of the materials would need to be replaced rather than repaired. Most of the trim work and window detail is uneven and out of alignment. Doors are made of pieces of siding and secured with padlocks. There appears to have been a large opening on the Mill Street side that has been sealed shut with painted plywood.

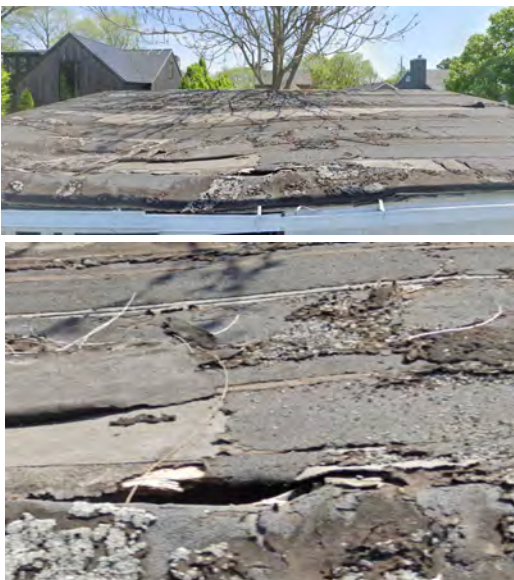
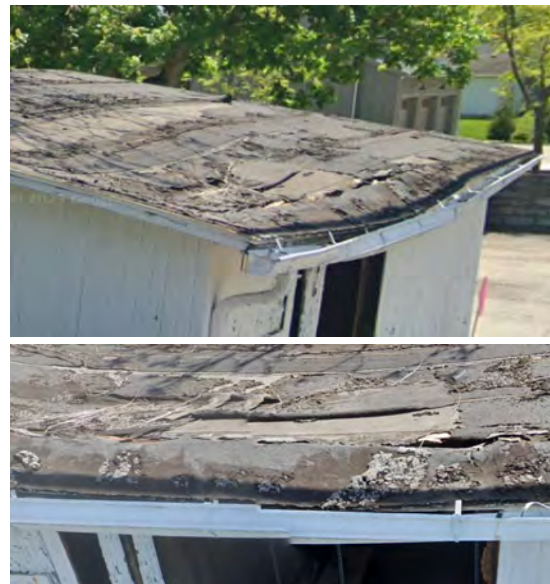
Roof details:

The roof appears to be an asphalt/rubber combination that has been repaired and replaced in pieces over time. Although all evidence and documentation indicates that the entire structure was built in 1900 the shed roof portion was likely constructed first with the flat roof portion added. There does not appear to be any flashing or water protection where the different roofs meet.

The photos from 2021 on the auditors website show significant sagging of the roof in the 2 year time period indicating structural failures that require replacement rather than repair.

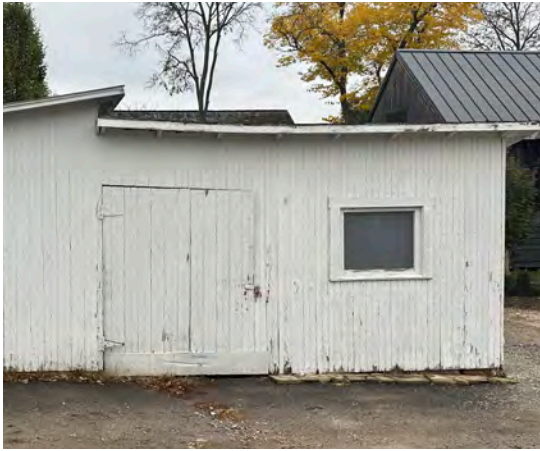
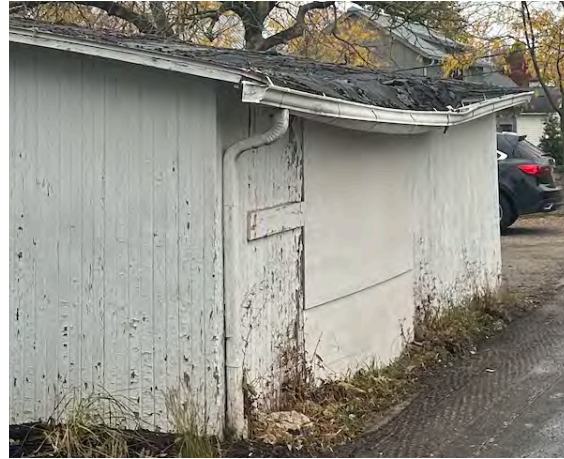
Exterior walls:

The rotten wood is an occurrence with natural wood siding. Wood is difficult siding to maintain and susceptible to a lot of damage. This structure shows signs of many kinds of damage including water, sun, wind and ground movement. I would defer to a structural engineer for specific structural dangers but it is apparent from a visual examination that there is instability in the roof structure, damaged and rotten wood members both inside and out, misalignment of windows and doors, uneven floors and cracked masonry from settling and/or tree root uplift.

Restoring or replacing vintage wood siding is a done frequently because wood siding requires a lot of attention to keep it in pristine shape and is often not cared for over the years. This particular wood restoration project would require intensive repair and replacement of much of the deteriorated materials. For much of the structure it will be more practical and even essential to replace old wood siding, roofing and foundation, with new. All of the materials, or extremely similar materials, are available and the structure could be rebuilt to represent the original structure.

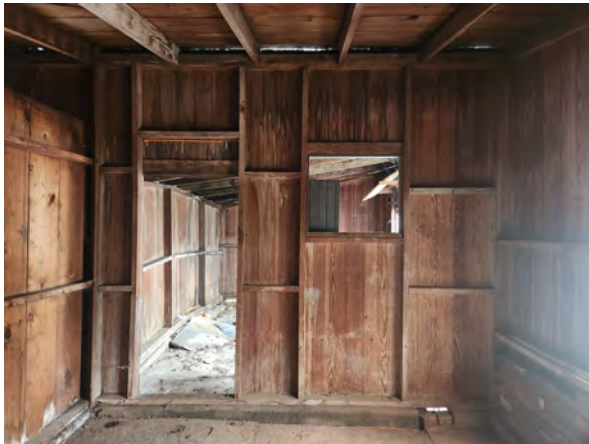
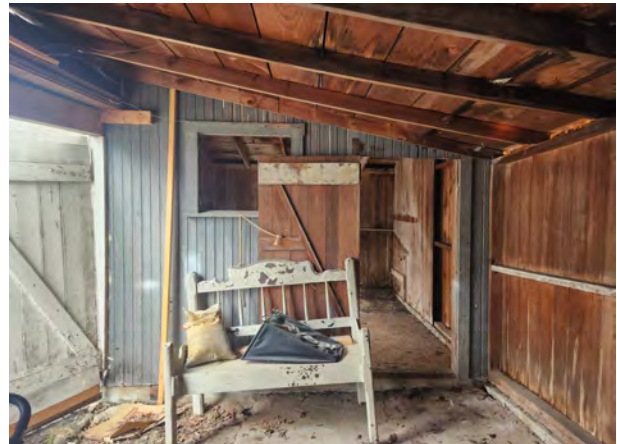
Interior space:

Additionally, if there is a decision to retain the structure much of it will need to be replaced. There is significant water damage, rotted rafters and framing, , deteriorated roof sheathing, uneven and uplifted slab, painting, gutters and regrading will need to be done.
