## HISTORICAL ANALYSIS AND DESIGN REVIEW:

**Property Address:** 119 S High  
Dublin, Ohio 43016  
**Owner/Applicant:** Richard J Toberen

### HISTORICAL ANALYSIS:

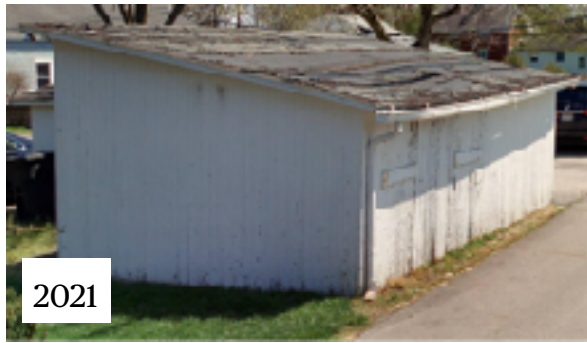
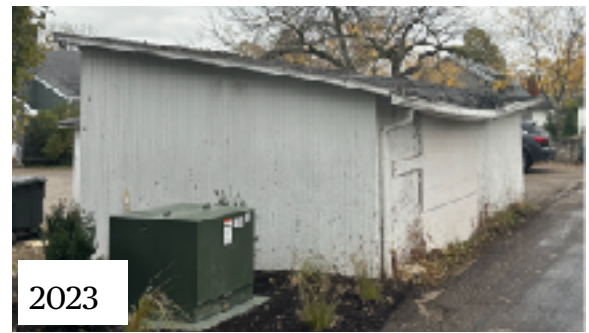
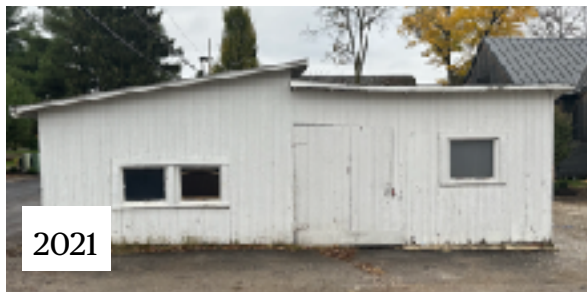
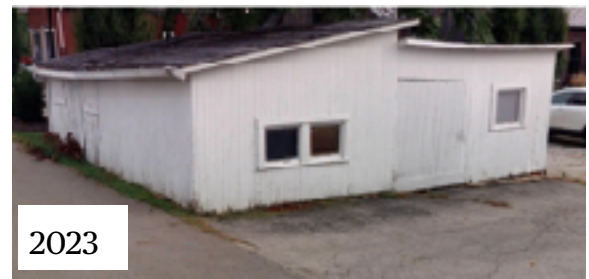
View of the structure from right and left sides :

The condition of this utility shed is poor and most of the materials would need to be replaced rather than repaired. Most of the trim work and window detail is uneven and out of alignment. Doors are made of pieces of siding and secured with padlocks. There appears to have been a large opening on the Mill Street side that has been sealed shut with painted plywood.

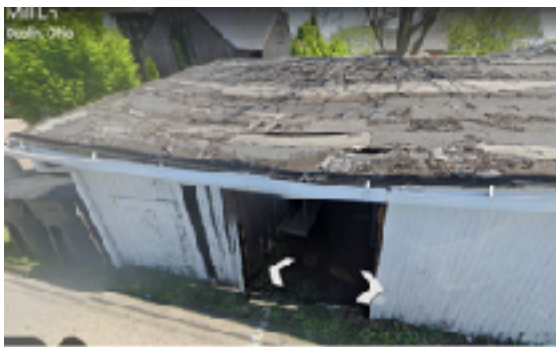
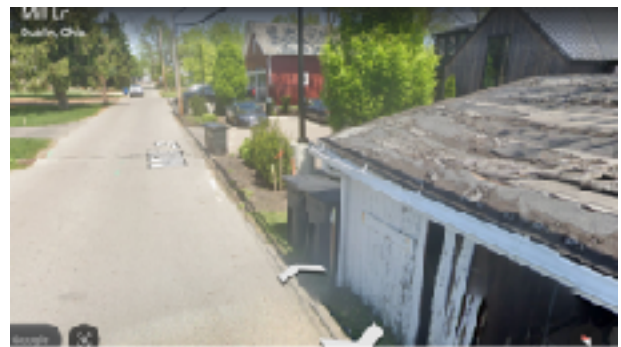
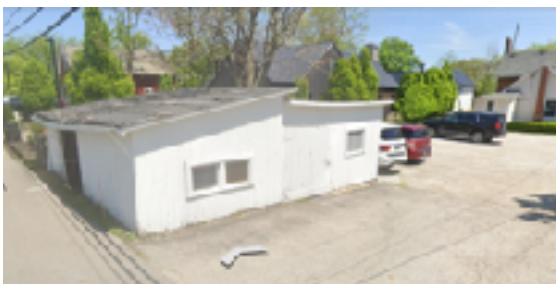
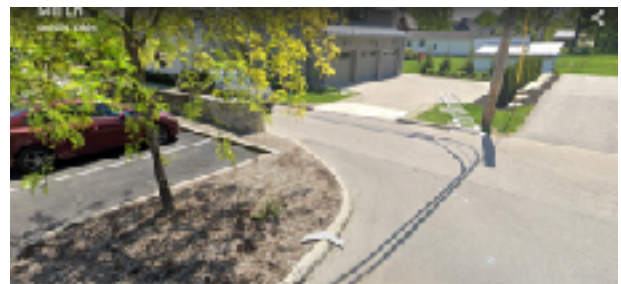
The roof appears to be an asphalt/rubber combination that has been repaired and replaced in pieces over time. Although all evidence and documentation indicates that the entire structure was built in 1900 the shed roof portion was likely constructed first with the flat roof portion added. There does not appear to be any flashing or water protection where the different roofs meet.

The photos from 2021 on the auditors website show significant sagging of the roof in the 2 year time period indicating structural failures that require replacement rather than repair.

While accessory structures that pay homage to and represent the history of the neighborhood are encouraged to be preserved and honored, this particular structure is in such disrepair that the replacement or removal of it would be more beneficial to the streetscape of Mill Lane and to the neighborhood.
