February 27, 2024

HISTORICAL ANALYSIS AND DESIGN REVIEW:

Project: COhatch Riverview Village
Property Addresses: 37 N Riverview Street,
45 N Riverview Street,
53 N Riverview Street,
62 N Riverview Street
Stone structure south of 62 N Riverview
Dublin, Ohio 43016
Owner: COhatch
Applicant: Tim Lai ArchitecT

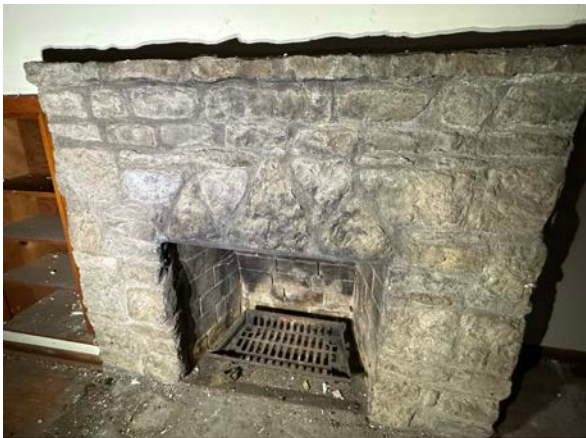
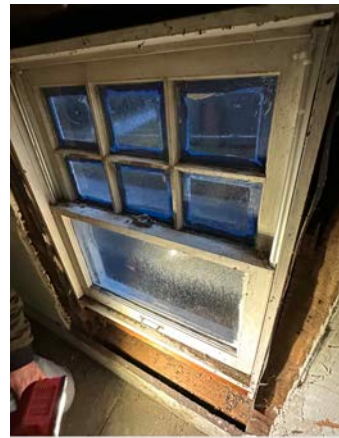
37 N Riverview Street::

There is a variety of thickness of timber that is throughout the structure on the inside and structurally that is not atypical to the time period but, upon further investigation, may tell more of the story of its construction. There is the possibility that this was built originally as a log structure based on the thicknesses of the wood, notches found in some structural timbers and the construction technique of the staircase. These questions may be answered by removing siding, plaster and opening ceilings. In addition to variations in the structure timbers, floorboard and wall thicknesses there is also a variety of different wood siding with different lap sizes and types used. The north elevation has narrower siding and is beveled. There is also some indication that the front masonry stoop with wrought iron railing may have been added on top of an original stone stoop at the same time that the structure was resided. This was visible at the exterior stone stair at the northeast corner of the home by peeling back the siding.

The interior features that will be worth using in the new project include the stone fireplace which is characteristic of the late 1890s and found in many log homes. Window sizes and patterns should be maintained and restored and repaired where possible.

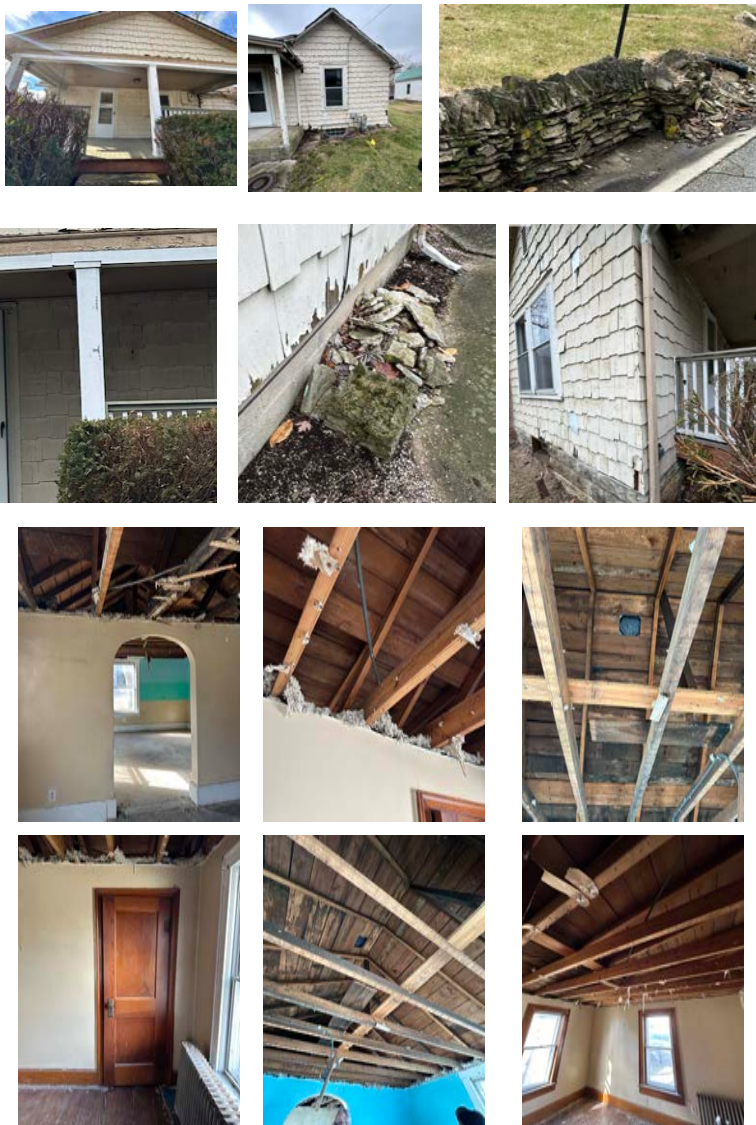
53 N Riverview Street:

This one-story house salt box ranch style with a front porch built in 1932 rests on a concrete block foundation. The exterior walls are clad in shingles that appear to be replaced on the north and east facades (with newer shingle) and the roof is sheathed in asphalt shingles. An open front-gable porch with wood posts and balustrade is on the south half of the façade. Within the porch is the front door. Windows are one-over-one replacements and poorly installed. The home requires repair and restoration. A detached garage is west of the house and is non-contributing.

There was an opportunity to look inside this structure after the ceiling and walls were removed and the open ceilings revealed trusses that are worthy of preservation and nice, open, usable spaces by today's standards. The stone formations and Dublin wall remnants around the property that are important historical structures and should be maintained. Some of the stone structures immediately around the structure are worthy of exploring and could be used in the park or garden plans of the new development.

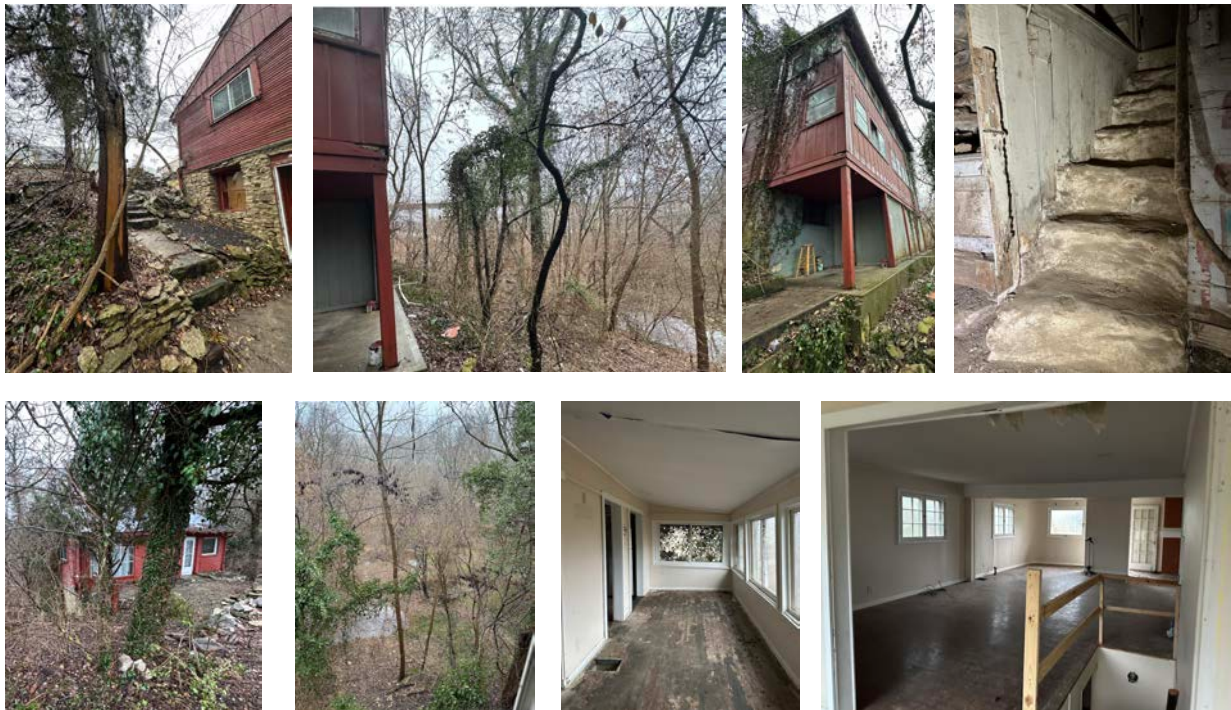
62 N Riverview Street:

Appearing as a single story as you approach the structure from Riverview on the east side, it reveals itself as a multi level structure that offers incredible views and spaces overlooking the river. The home has a stone foundation and wonderful stone steps that lead down to the wooded porches and backyard. The 2- story enclosed overhang may have been an open porch at some point on the top level. There is a mix of a variety of window styles and types indicating a haphazard replacement although it appears as though some of the original casements remain and may have been reused. In a redevelopment repair and restoration of all windows should be the goal with any replacements needed mirroring the originals in size, materials and proportions. The front window does not seem original or has been significantly altered as there are no grids on the exterior. The back porch was likely enclosed at some point in the homes early history with like casement windows which are still very nice and should be retained in some locations and should be a good model for new ones to replicate where necessary.

The floor plan allows for amazing views and access to the landscape down to the river and will be a delightful location for the planned cafe. The basement has a fantastic exposure of bedrock and the stairs down to the lowest level are beautifully sculptural and should be preserved within the allowance of code. Exterior stone steps lead down to the woods.

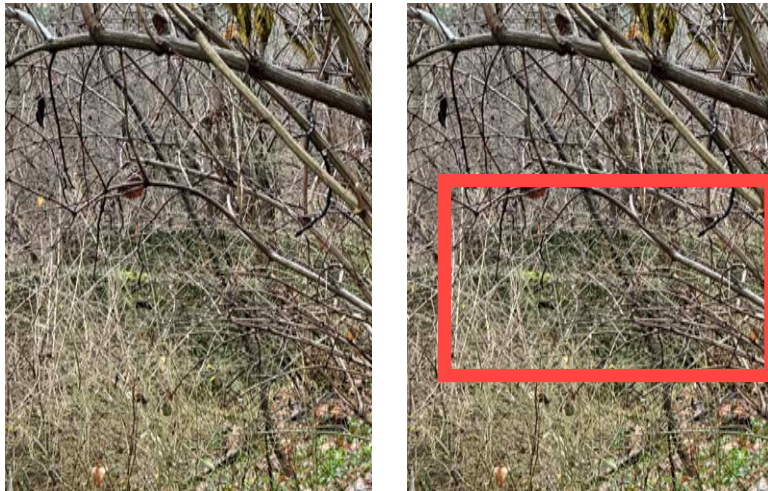
Stone structure south of 62 N Riverview:

There are remains of an old stone structure on the east side of N. Riverview Street. This structure is approximately 50'-60' south of 62 N. Riverview (the red house).

Research has suggested that this may be the remains of an early tannery. The siting of and the shape of the remains would correlate with the tanneries in the 1800's. Tanneries were built near dense tree growth (hemlocks because of their tannins) and close to water ways. While tanneries were not great for the environment and released tannins into the air, polluted water and eroded the forest slopes, they were often the beginning of villages and homes were built around them. Hardwood forests often grew in the wake of the closing and end of the life of a tannery. This is all speculation but a strong possibility of the stone remains.

Although these remains appear to be in the way of the proposed new building and are not incorporated in the plans, the applicant should consider using them or repurposing them in the new structure or in another part of the site to pay homage to the history.
