Parcel 273-000042 **Address** 37 N Riverview St **OHI** FRA-2545-1

OHIO HISTORIC INVENTORY

Wall Identifier W068

Wall Identifier W069

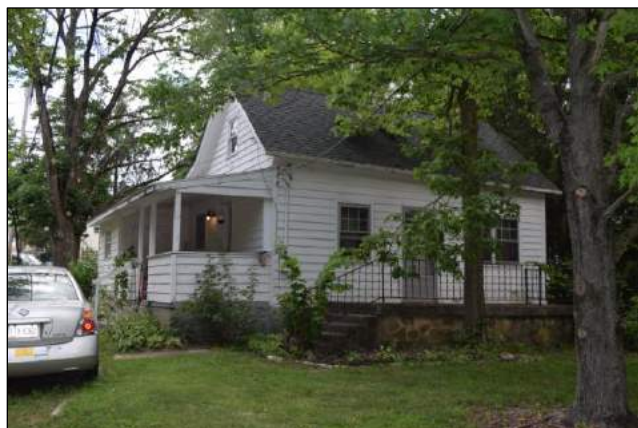
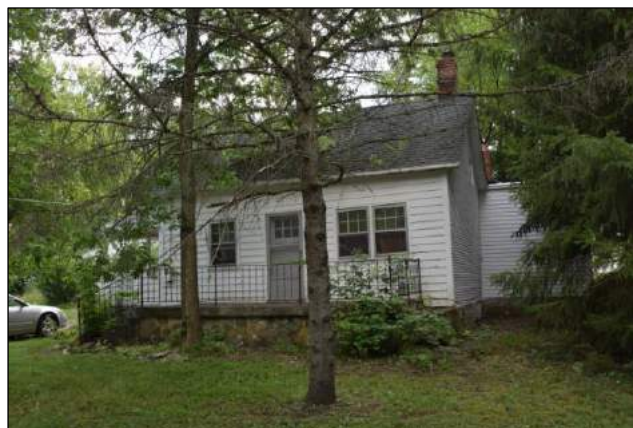
Condition: Good

Integrity Notes: The building has good integrity, diminished some by replacement materials.

37 N Riverview St, looking northwest

37 N Riverview St, looking west

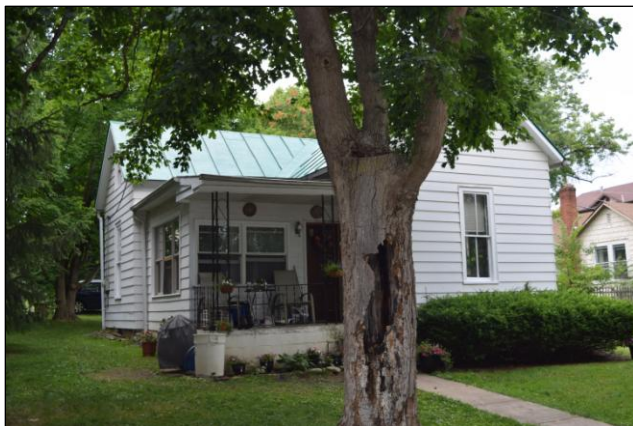
Condition: Good

Integrity Notes: The building has good integrity, diminished some by replacement materials.

45 N Riverview St, looking northwest

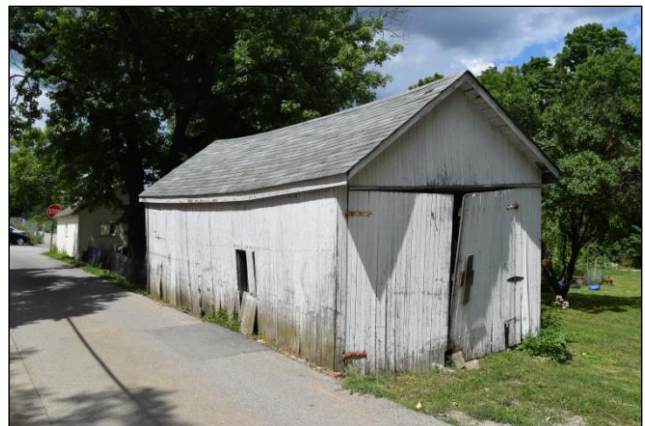
45 N Riverview St, ancillary structure, looking northeast

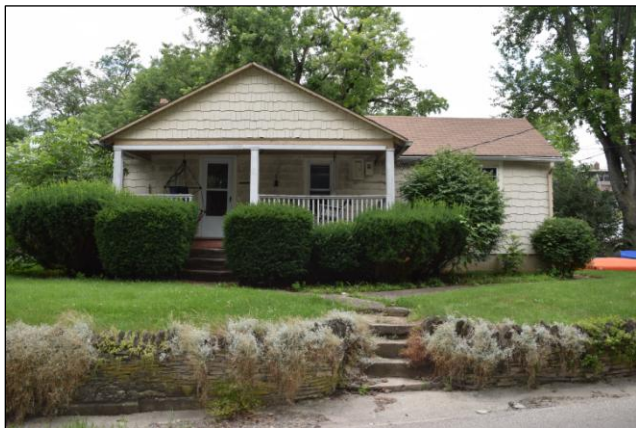
Condition: Good

Integrity Notes: The building has good integrity, diminished some by replacement materials.

53 N Riverview St, looking southwest

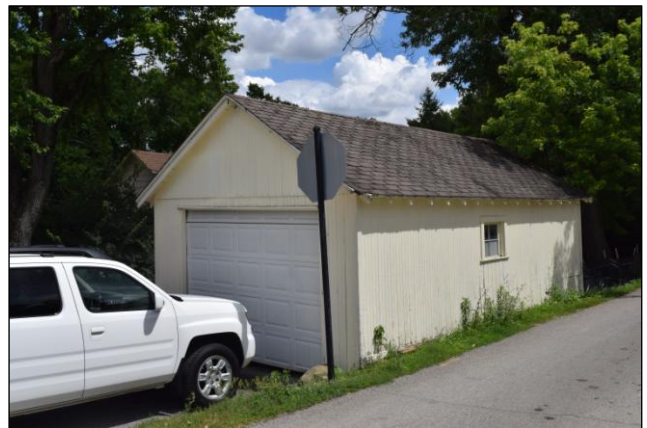
53 N Riverview St, garage, looking northwest

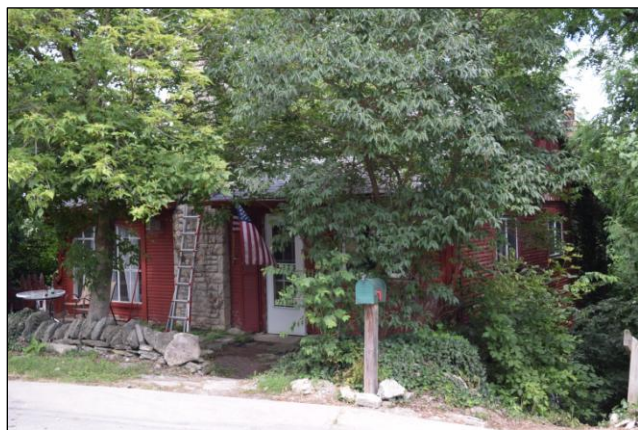
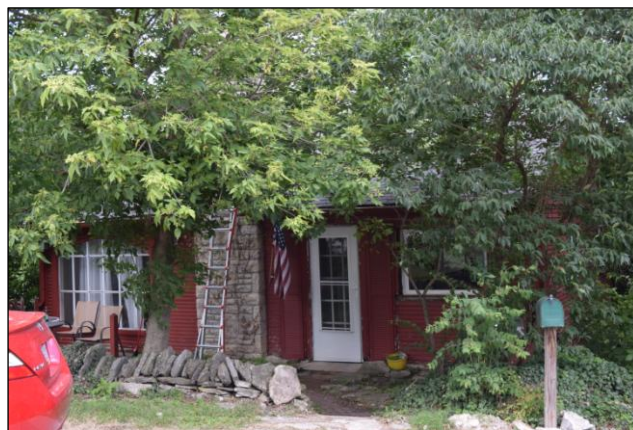
Condition: Good

Integrity Notes: The building has good integrity, diminished some by replacement fenestration.

62 N Riverview St, looking southeast

62 N Riverview St, looking northeast

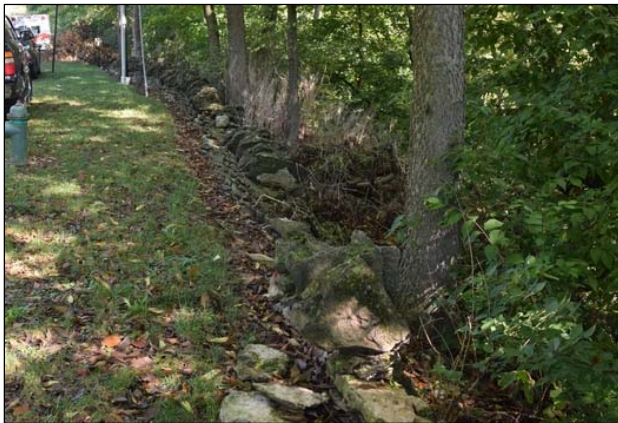
Condition: Good, Fair, Deteriorated/Poor, Ruinous

Integrity Notes: The wall has fair integrity. The wall appears to retain its original location and design although some materials may be non-original.

Overview of wall, looking north

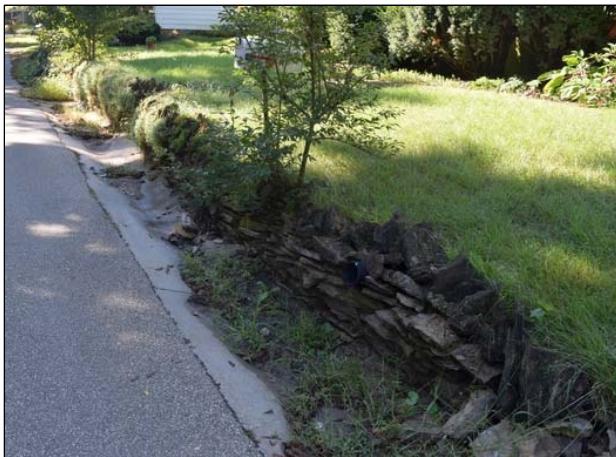
Condition: Good, Fair, Repaired

Integrity Notes: Wall has fair integrity because it appears to retain integrity of location and design, but has been repaired with some non original materials.

Overview of wall, looking south
