Parcel 273-000042 **Address** 37 N Riverview St **OHI** FRA-2545-1

Parcel 273-000073 **Address** 45 N Riverview St **OHI** FRA-8836-1

Parcel 273-000098 **Address** 53 N Riverview St **OHI** FRA-8837-1

Parcel	273-005565	Address	62 N Riverview St	OHI FRA-8839-1
---------------	------------	----------------	-------------------	-----------------------

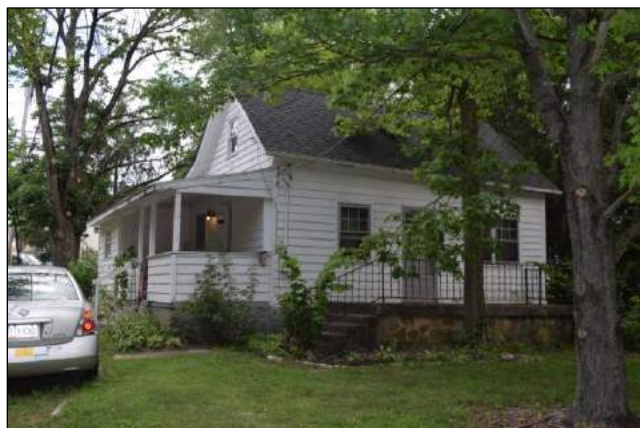
Condition: Good

Integrity Notes: The building has good integrity, diminished some by replacement materials.

37 N Riverview St, looking northwest

37 N Riverview St, looking west

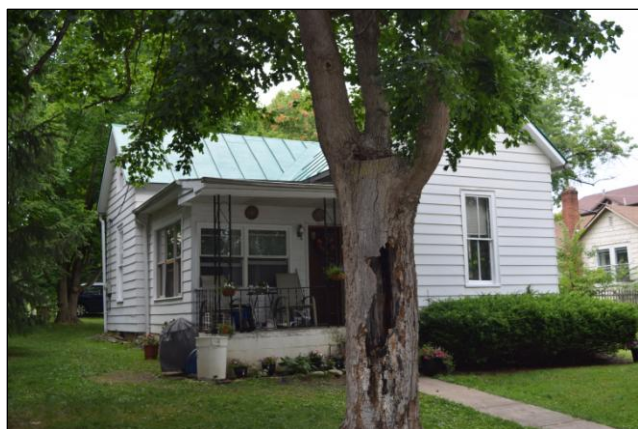
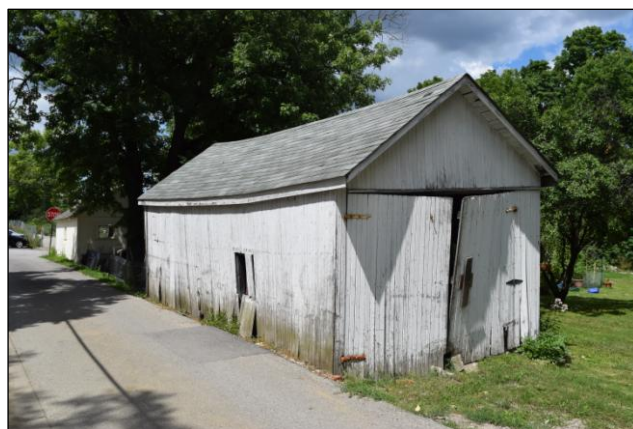
Condition: Good

Integrity Notes: The building has good integrity, diminished some by replacement materials.

45 N Riverview St, looking northwest

45 N Riverview St, ancillary structure, looking northeast

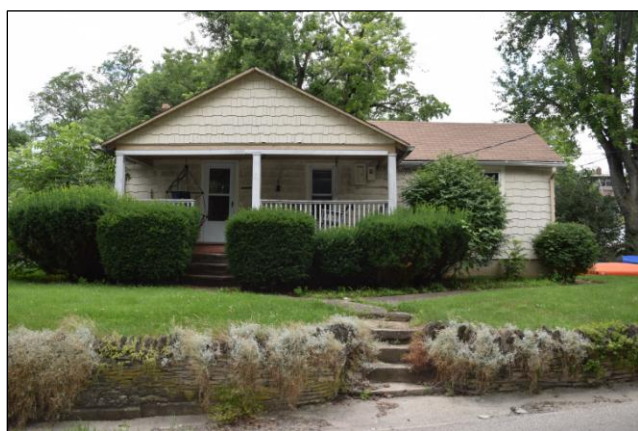
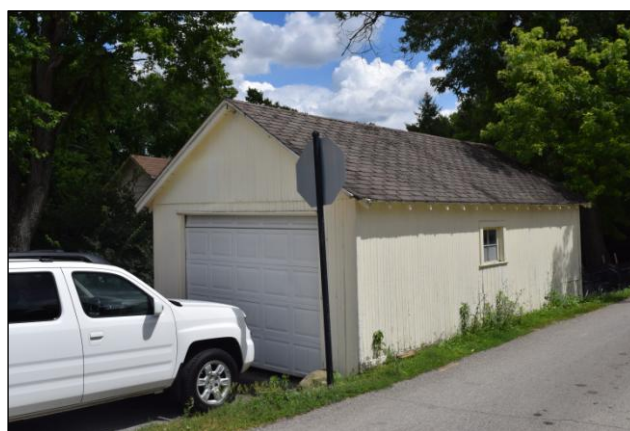
Condition: Good

Integrity Notes: The building has good integrity, diminished some by replacement materials.

53 N Riverview St, looking southwest

53 N Riverview St, garage, looking northwest

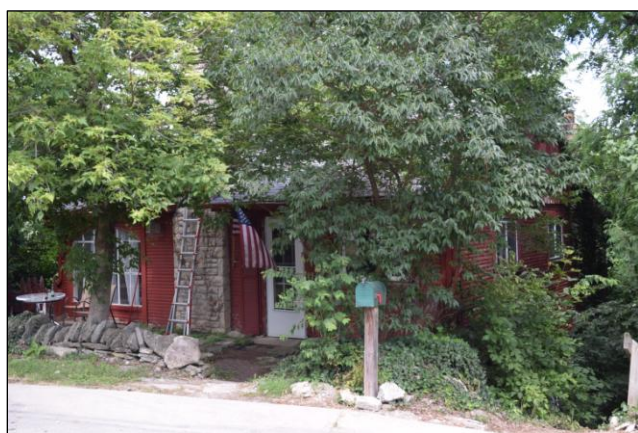
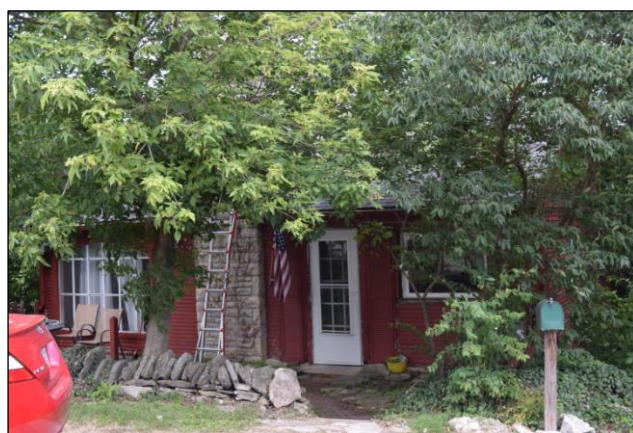
Condition: Good

Integrity Notes: The building has good integrity, diminished some by replacement fenestration.

62 N Riverview St, looking southeast

62 N Riverview St, looking northeast

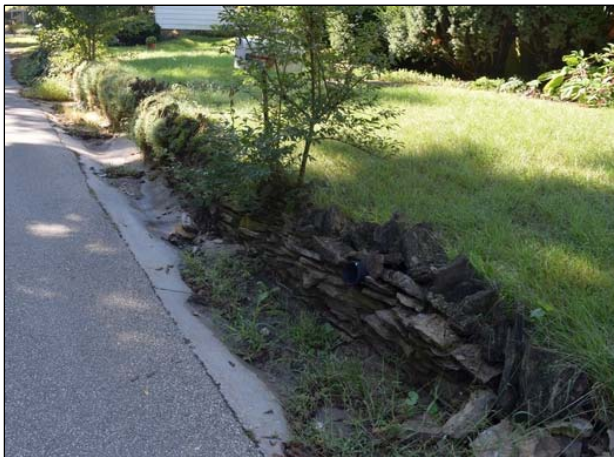
Condition: Good, Fair, Repaired

Integrity Notes: Wall has fair integrity because it appears to retain integrity of location and design, but has been repaired with some non original materials.

Overview of wall, looking south
