**COHATCH RIVERVIEW VILLAGE**  
**RED CABIN DEMOLITION**  
**09.16.2026**  
© Tim Lai ArchitecT

**Project Narrative for Demolition:**

Re: 62 N. Riverview Street (COhatch Riverview) Existing Building Condition Assessment  
Schaefer # 23-1574

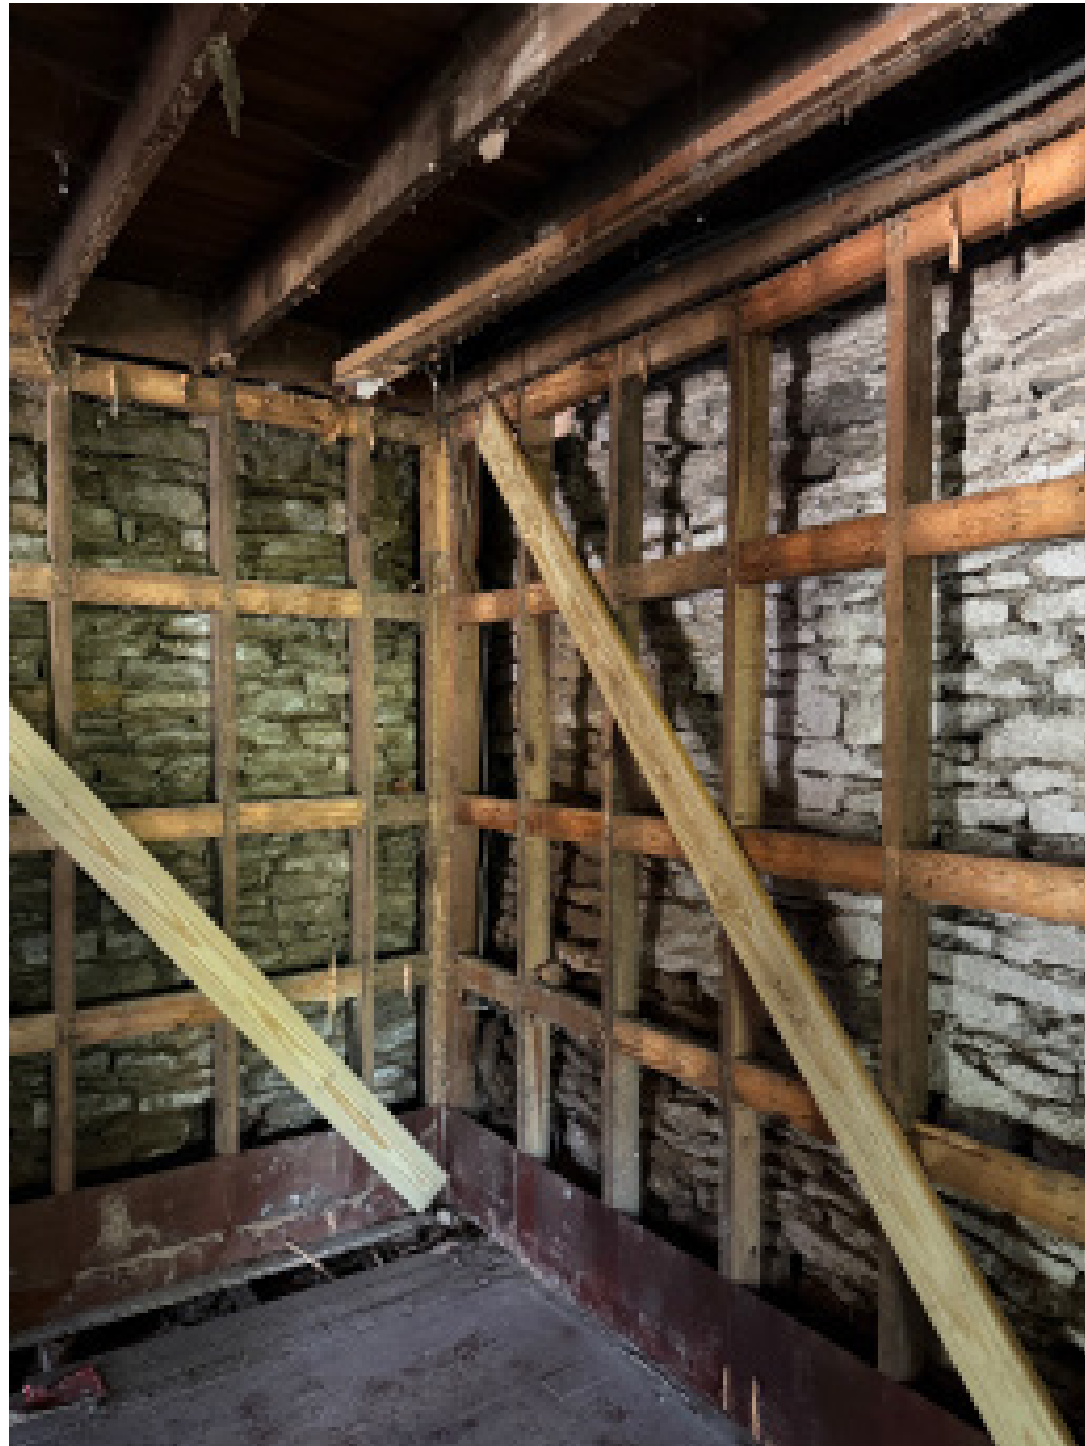
Extensive rotting at the bottom of wall framing against stack stone foundation wall, with groundwater coming in through the gap.

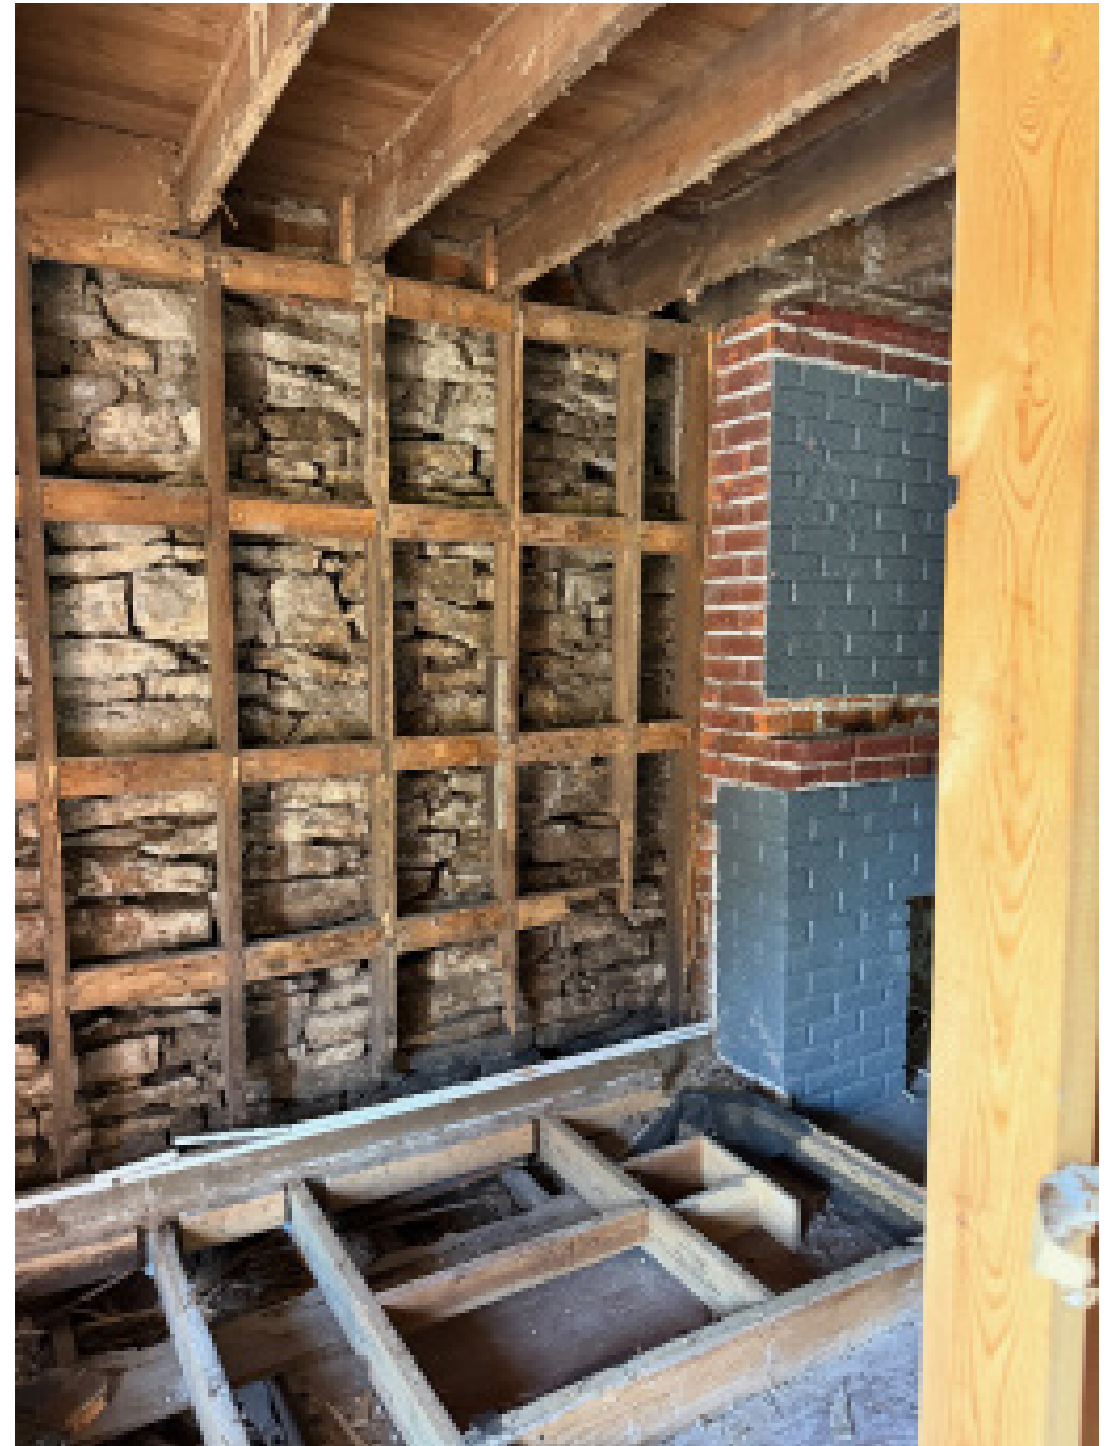
There is no easy way to add drainage or water proofing to the stone without excavating from behind, which will destabilize the wall and the wood frame structure above it.

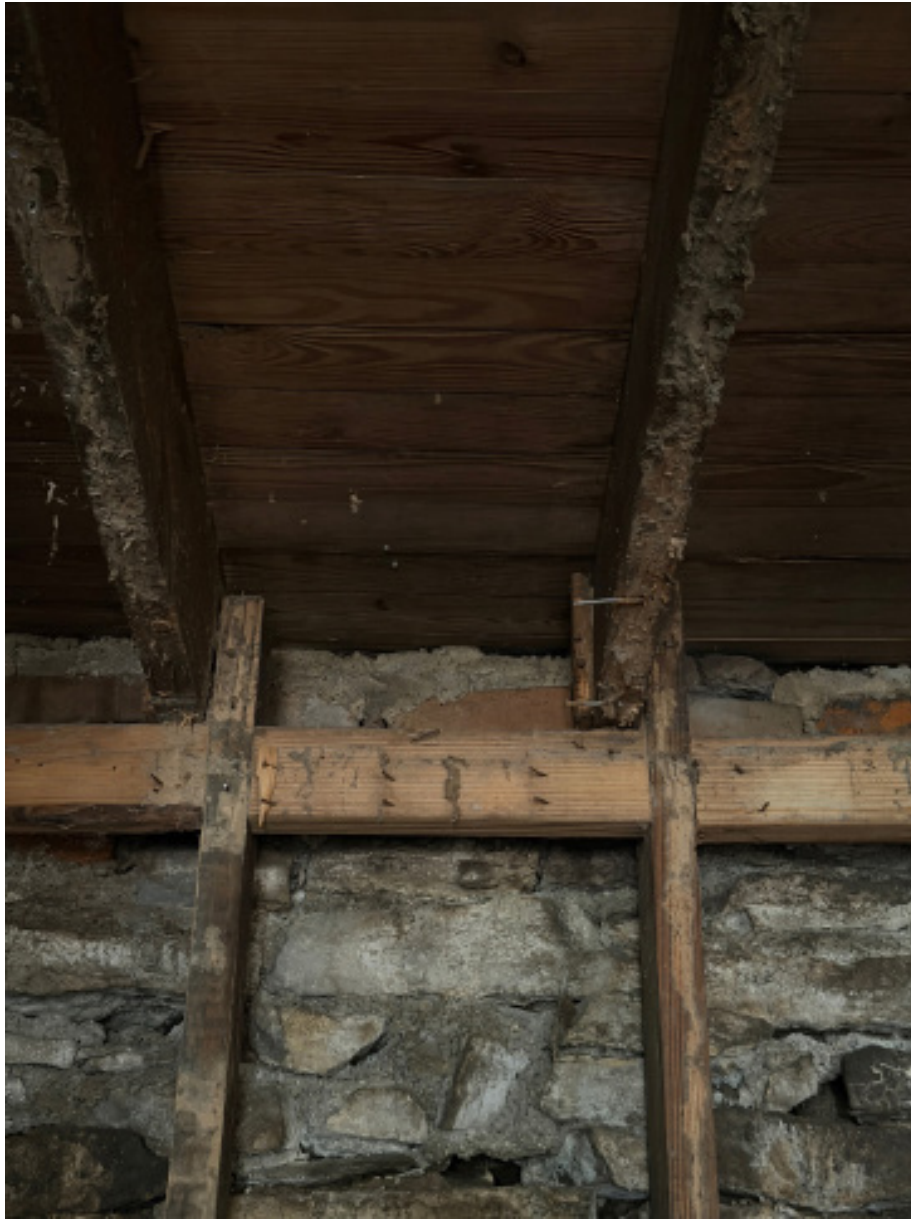
Wall framing is hung from the floor joist above, while the bottom all rotten away and nothing to bear on.

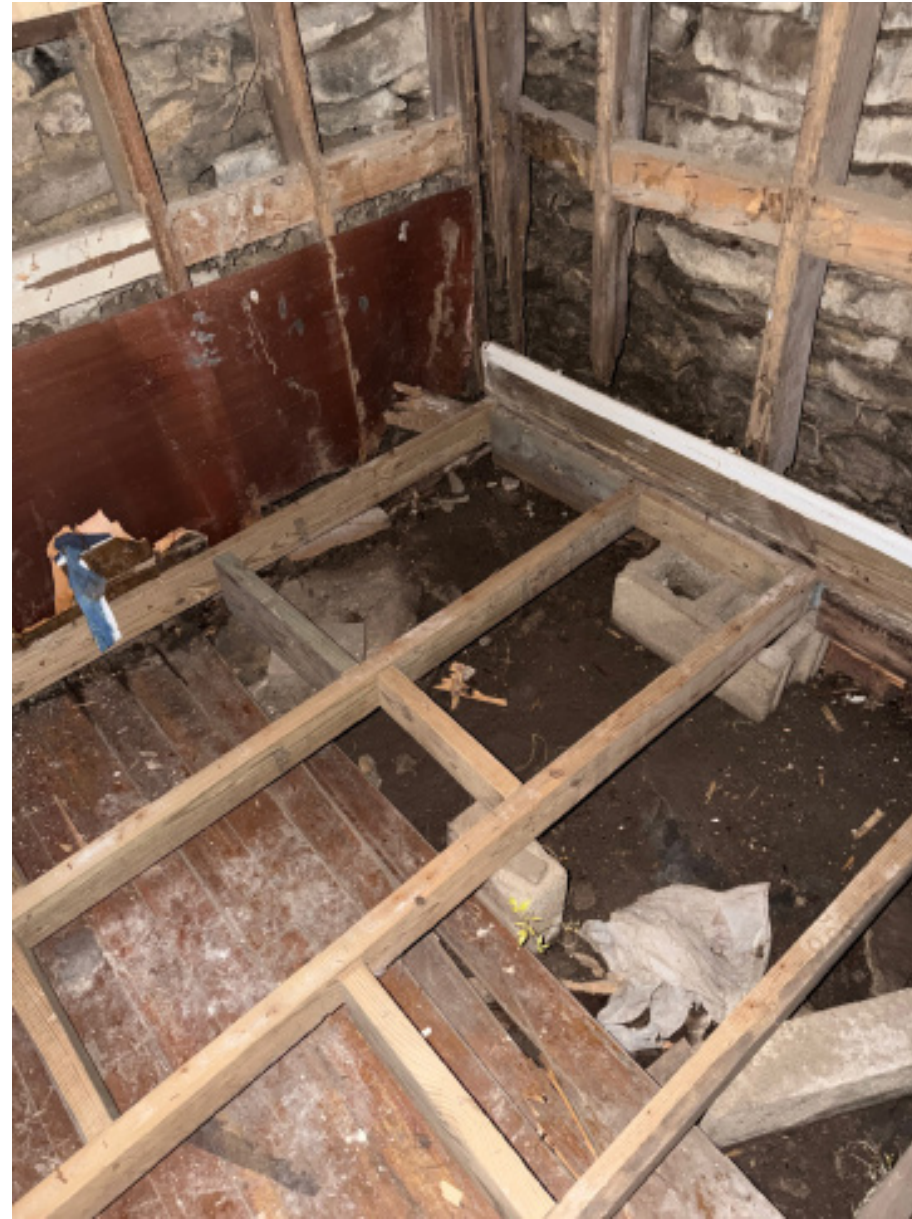
Floor joists are without proper support. Crawl space below shows deposit of soil and shattered rock.

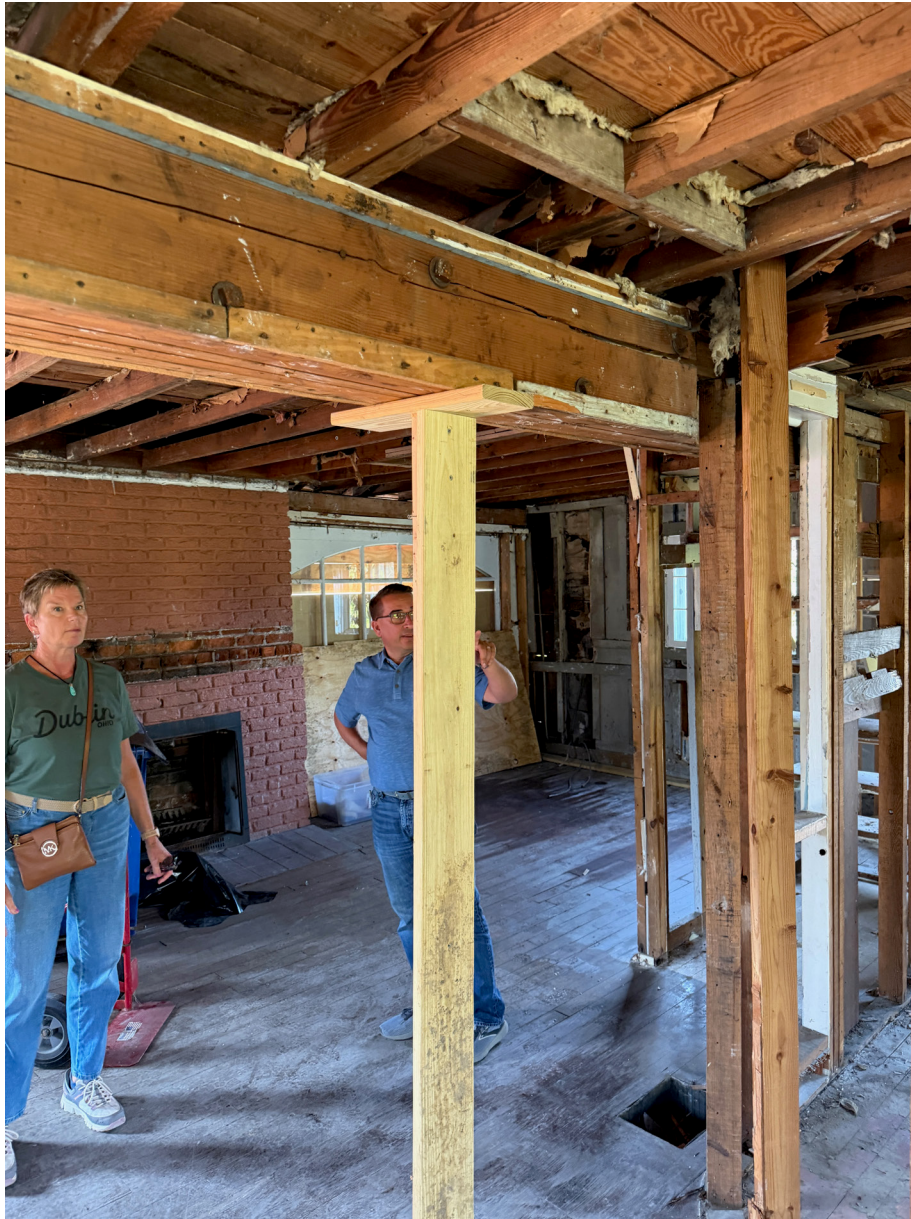
The giant wood beam supporting ceiling joists are not supported by anything but nailed into the wood stud.

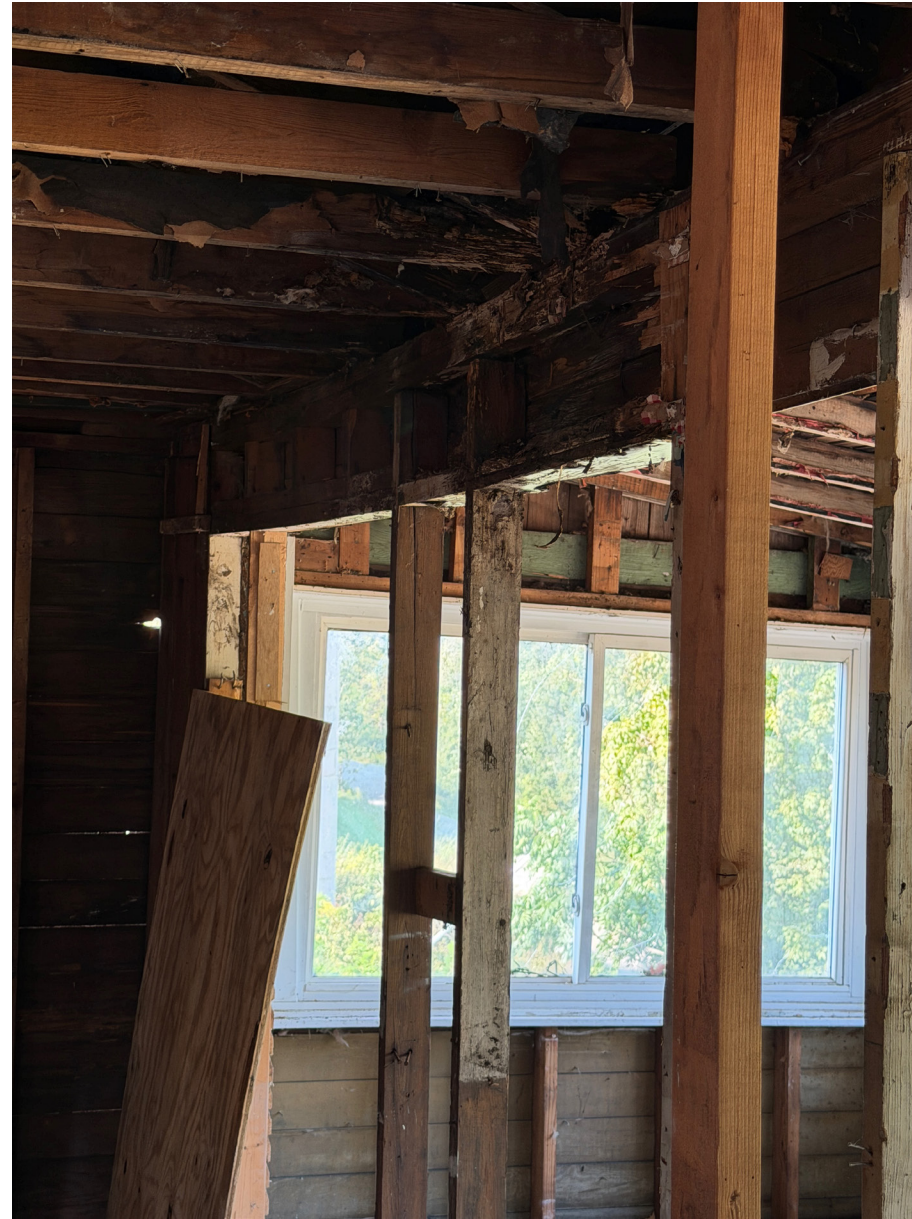
Header wall and ceiling joists are seriously rotted and sagging.

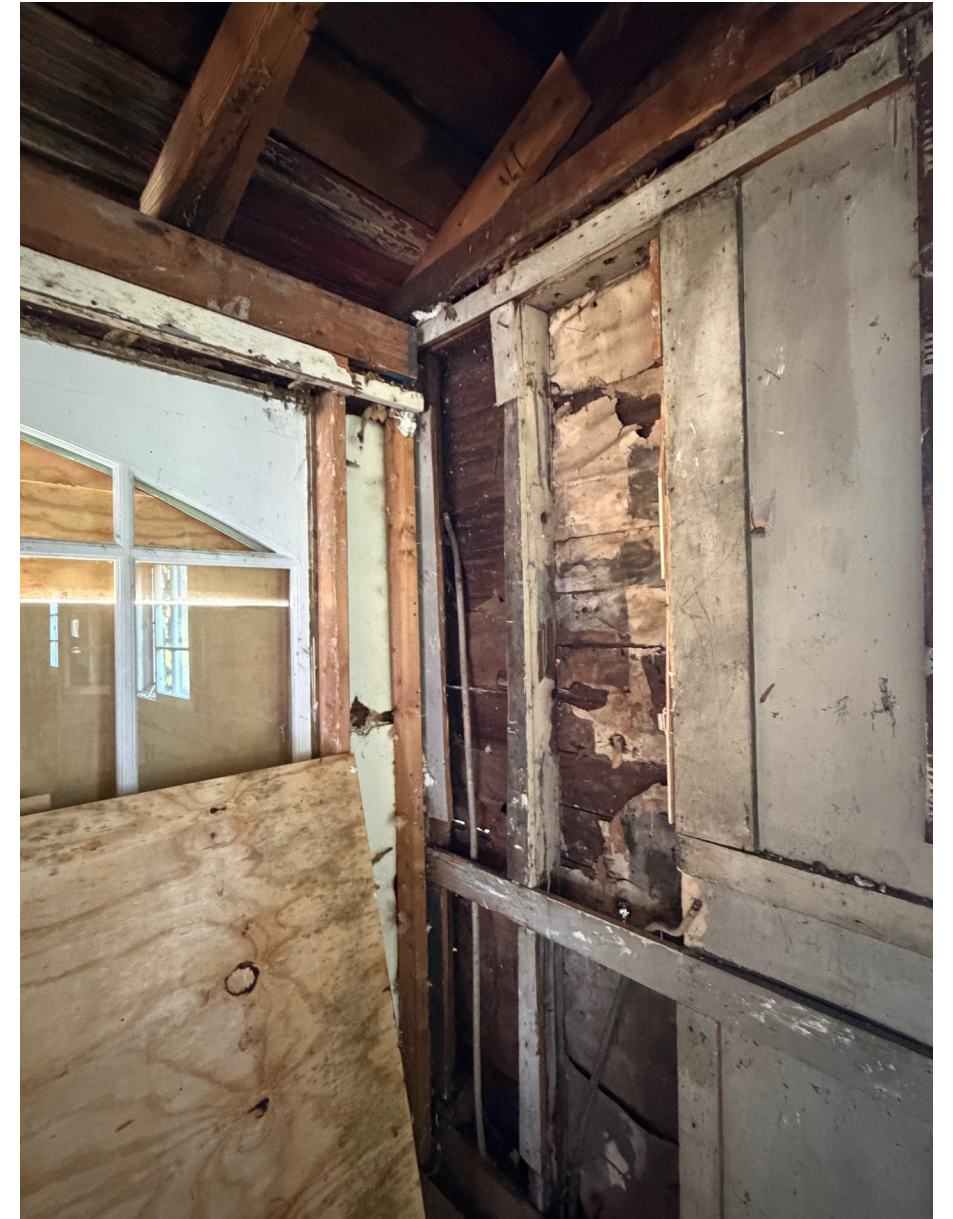
Framing inside some walls are cobbled together and would required complete replacemenn.

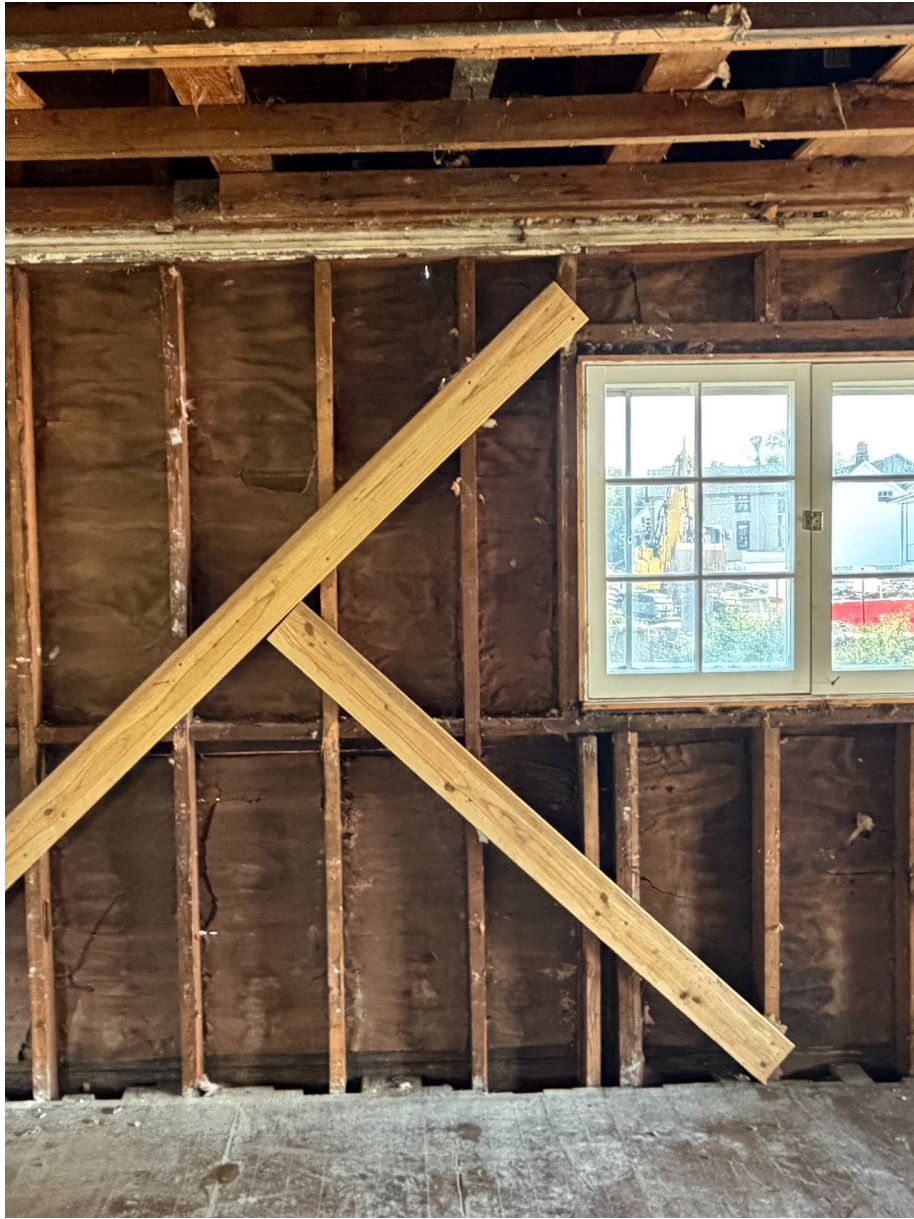
Lack of sheathing behind siding would not meet structural requirement for new use.

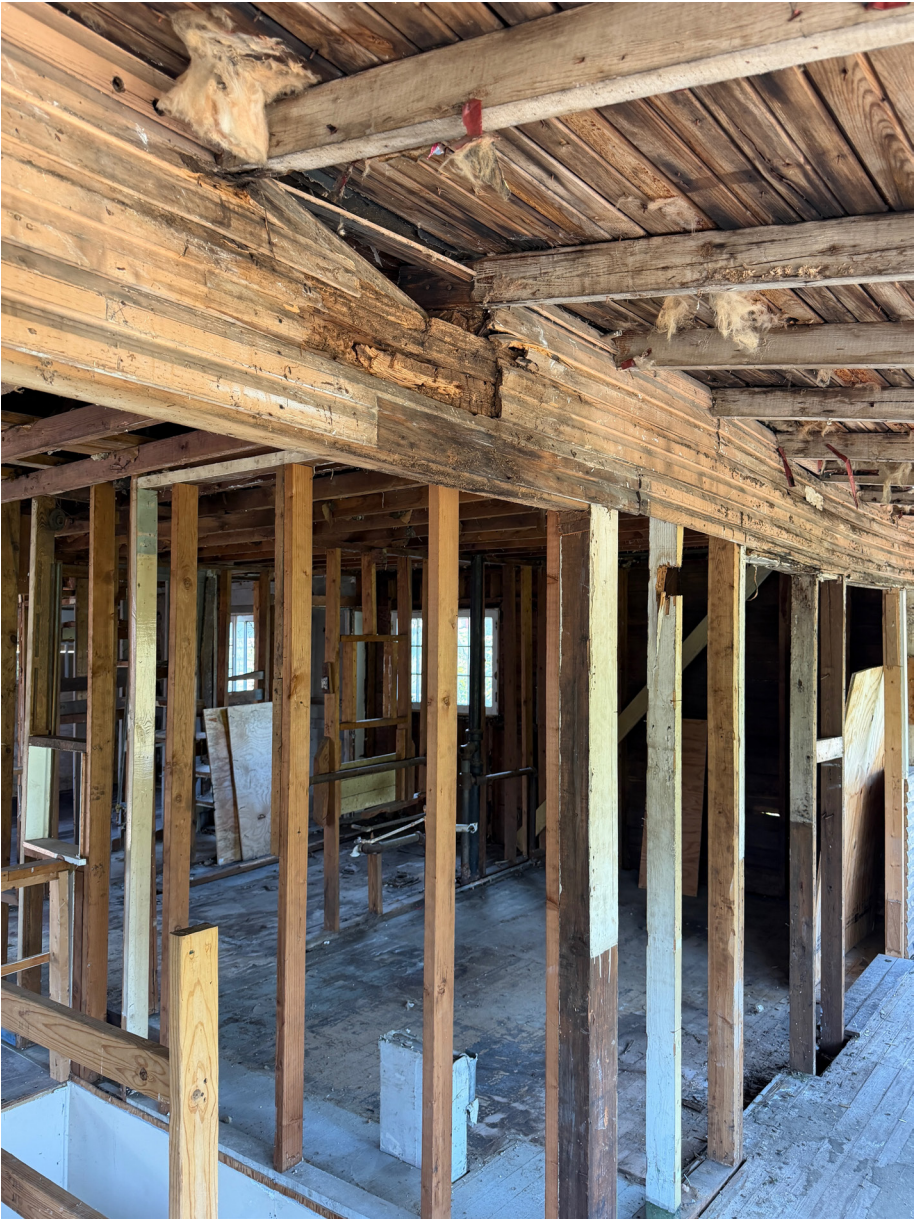
Header wall/ beam and rafters are severely rotten and sagged.
