**COHATCH RIVERVIEW VILLAGE**  
**RED CABIN DEMOLITION**  
**08.26.2026**  
© Tim Lai ArchitecT

**Project Narrative for Demolition:**

Re: 62 N. Riverview Street (COhatch Riverview) Existing Building Condition Assessment  
Schaefer # 23-1574

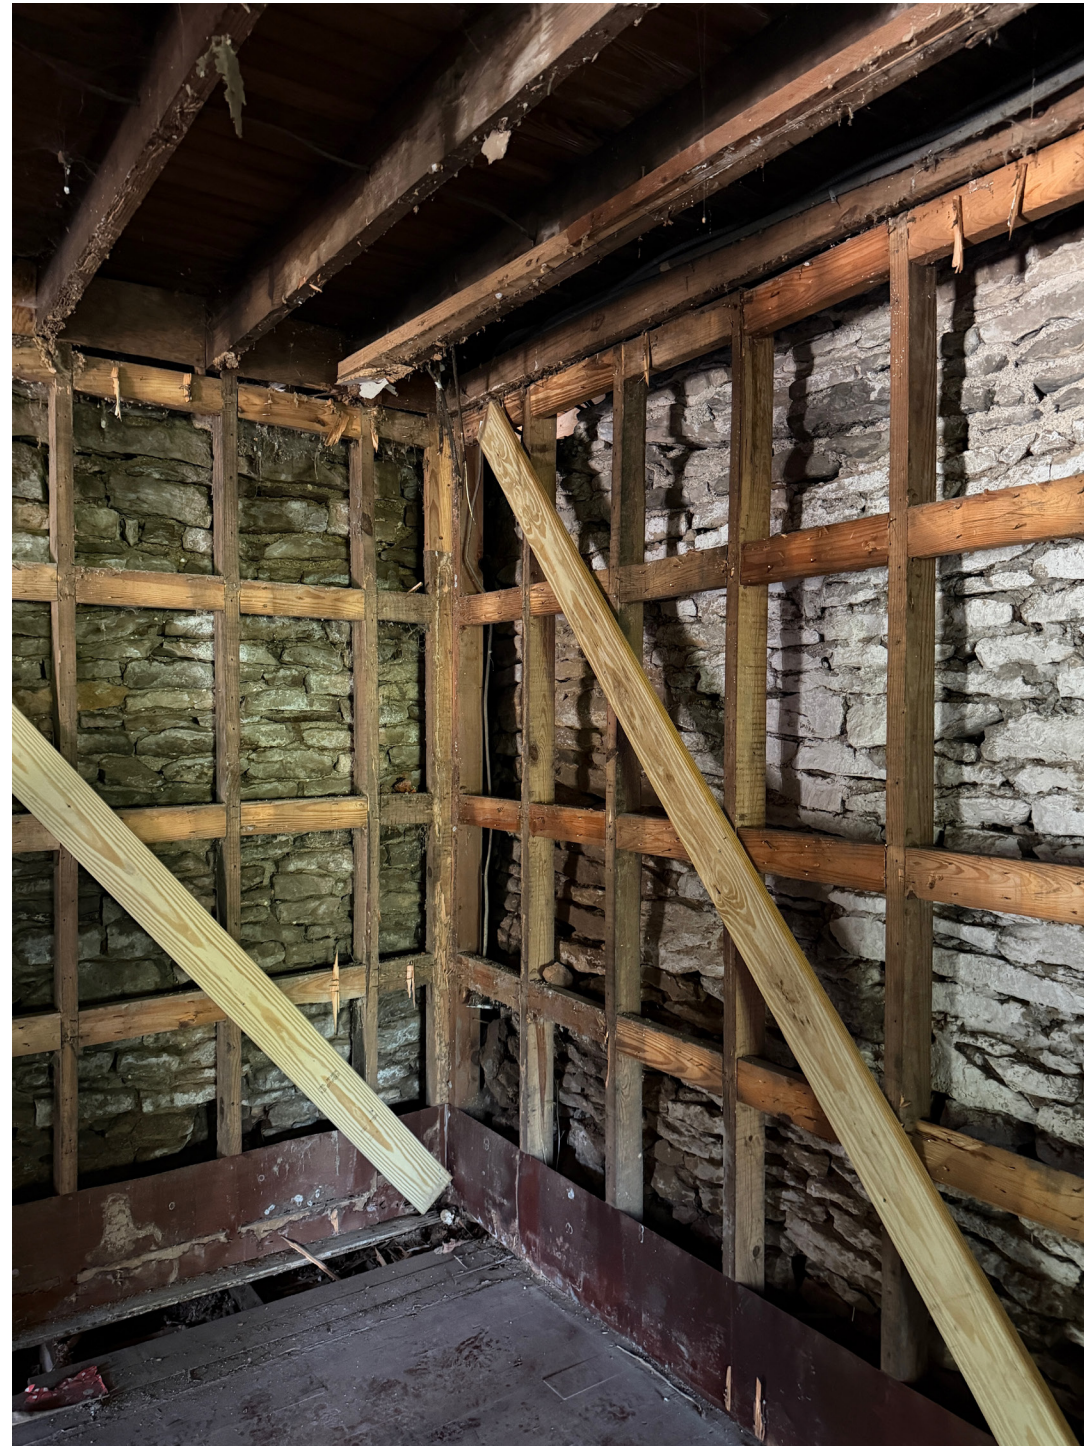
Extensive rotting at the bottom of wall framing against stack stone foundation wall, with groundwater coming in through the gap.

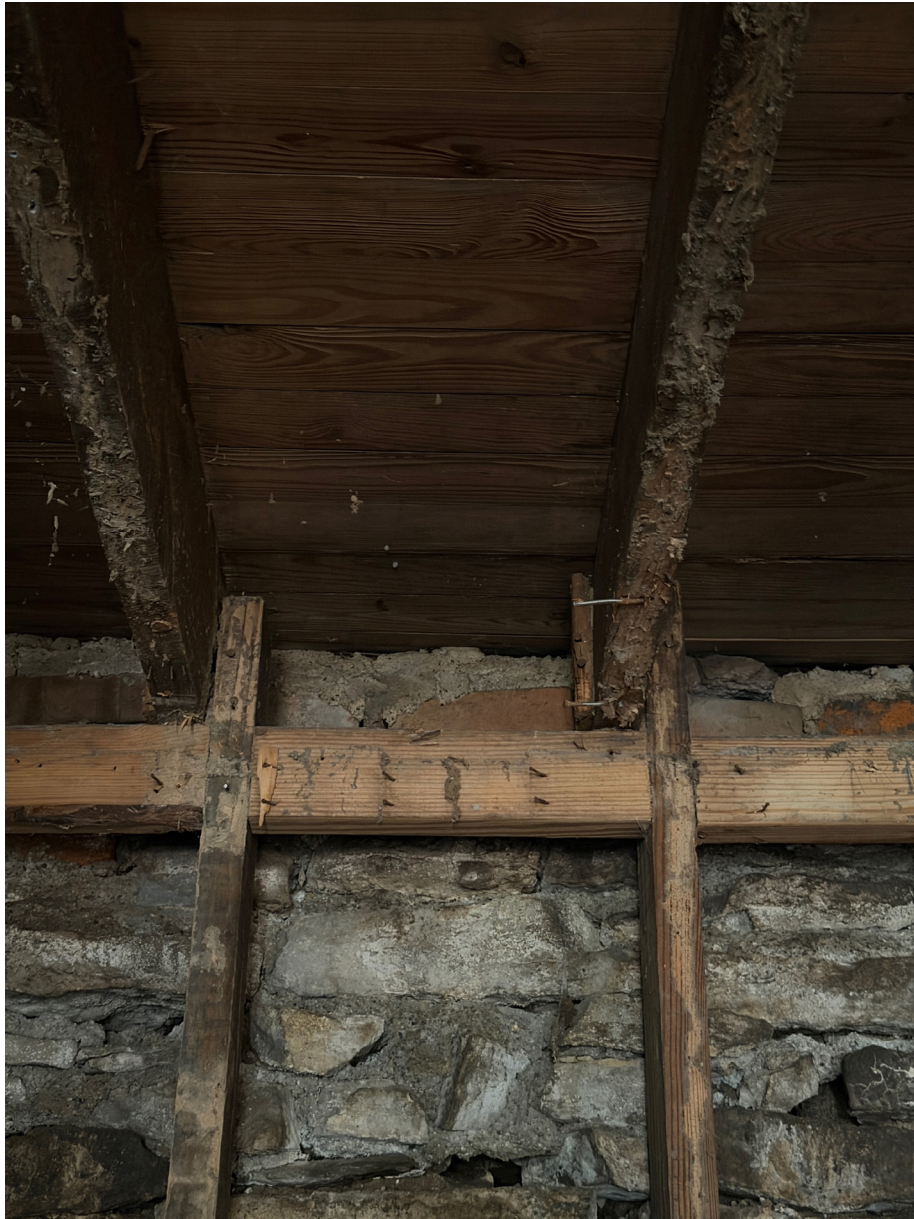
Wall framing is hung from the floor joist above, while the bottom all rotten away and nothing to bear on.

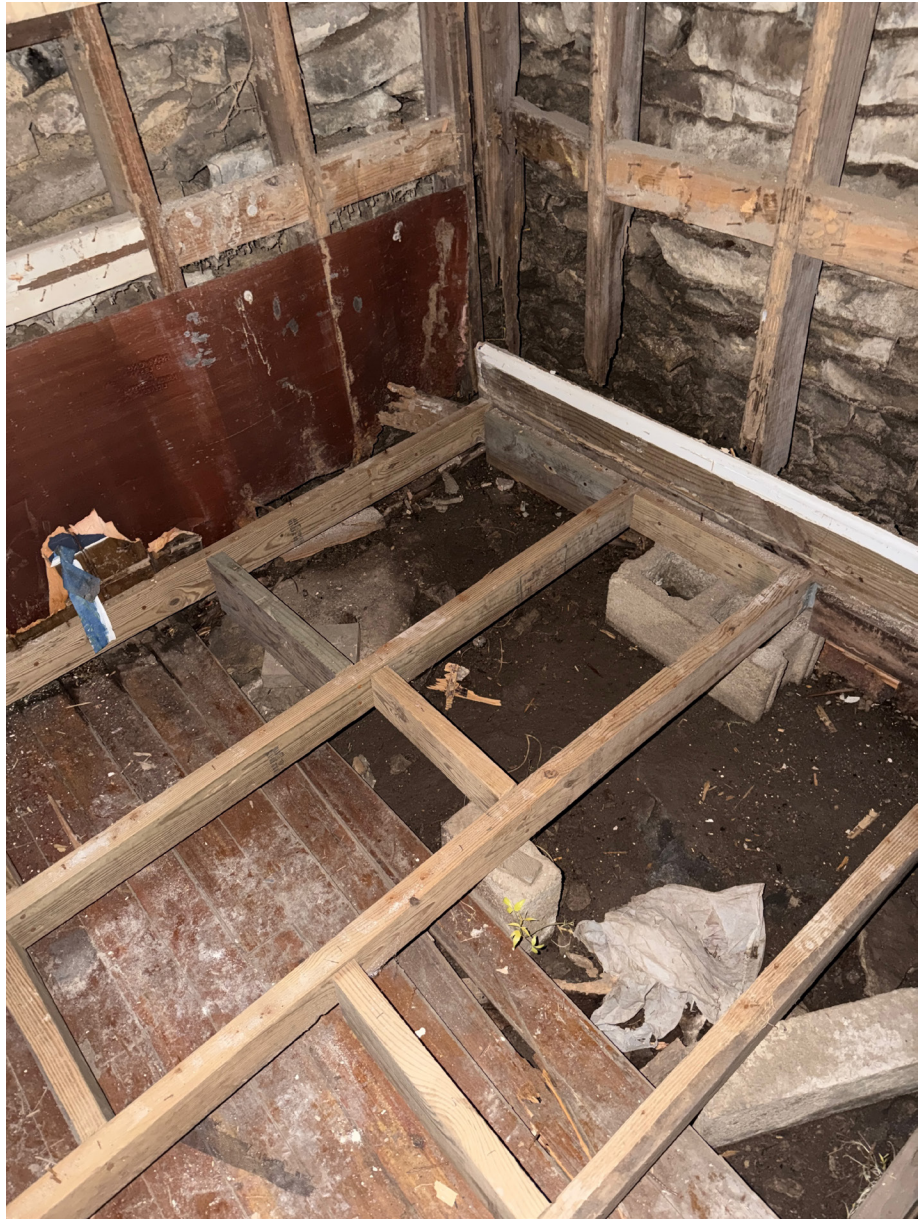
Floor joists are without proper support. Crawl space below shows deposit of soil and shattered rock.
