MEMO

Re: Application #16-05, 30 & 32 S. High St.

30 South High Street Supporting Photos:

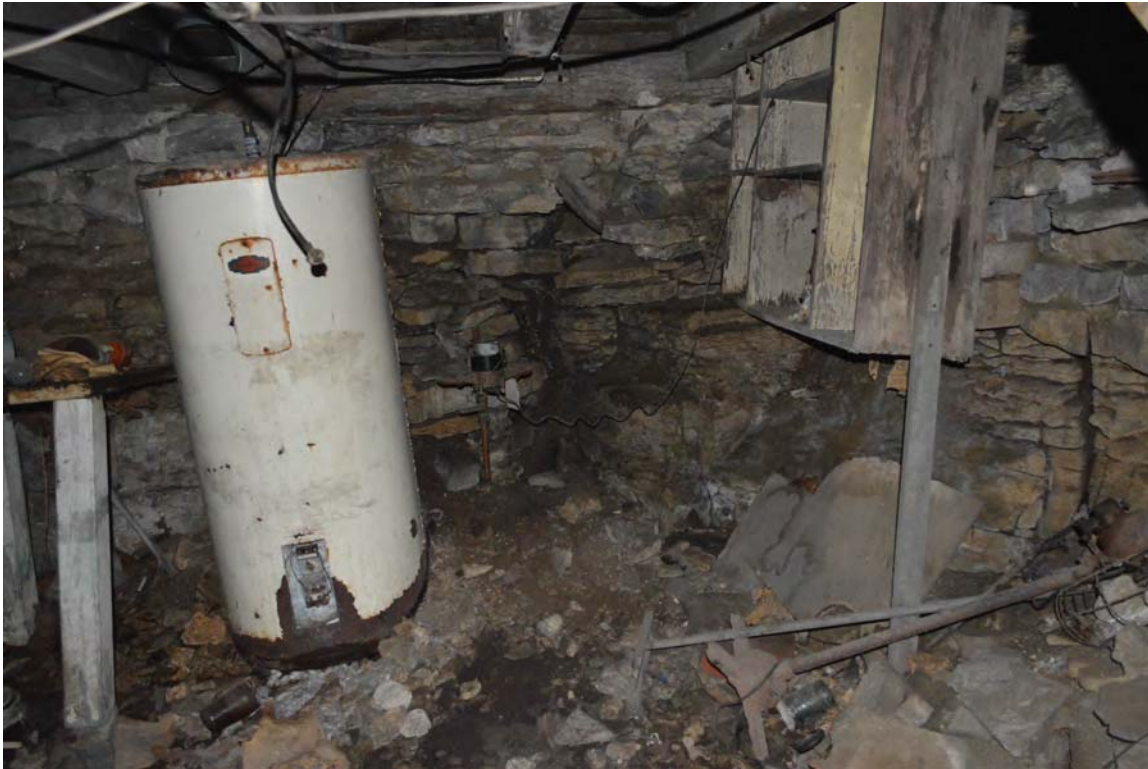
Photo 1- Foundation wall has fallen away at the base

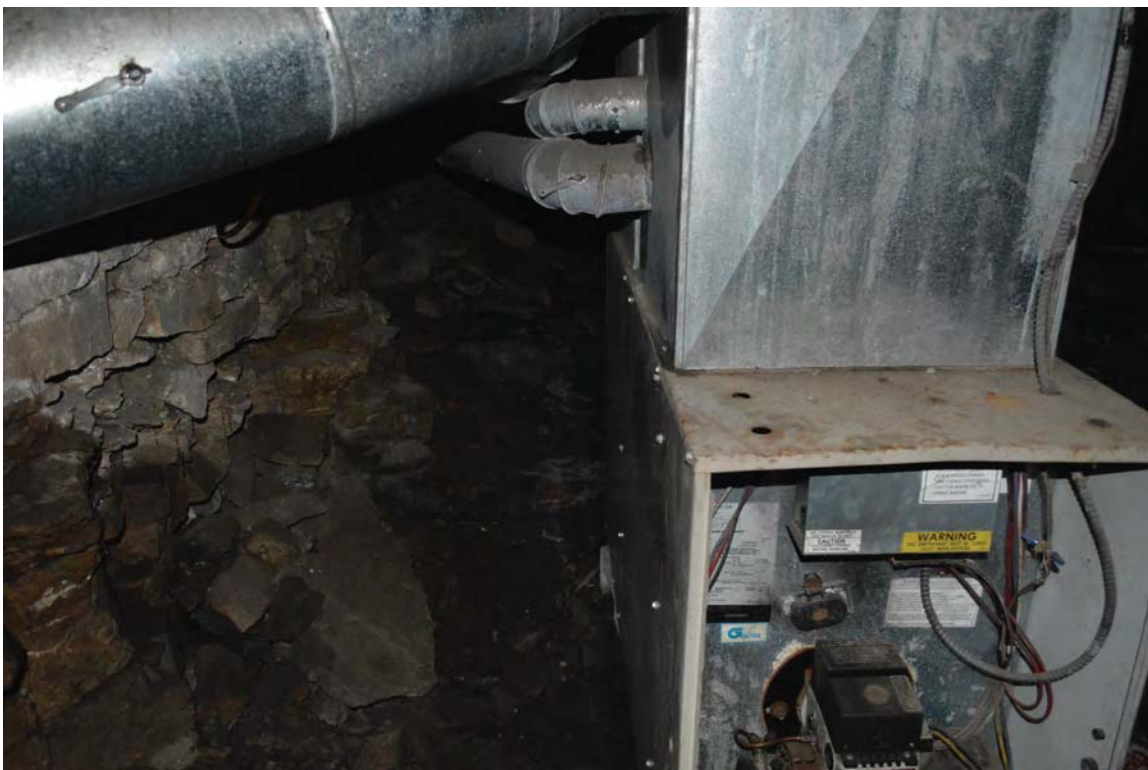
Photo 2- Additional foundation stones falling away

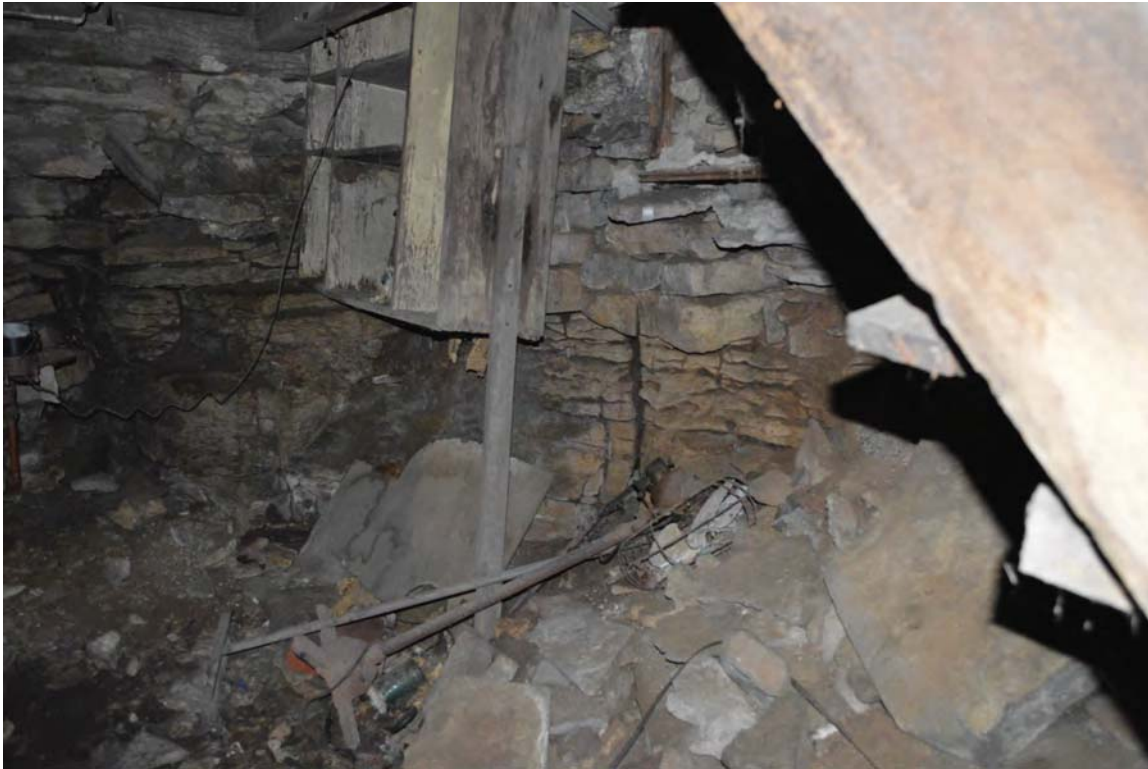
Photo 3- Additional photo of foundation damage

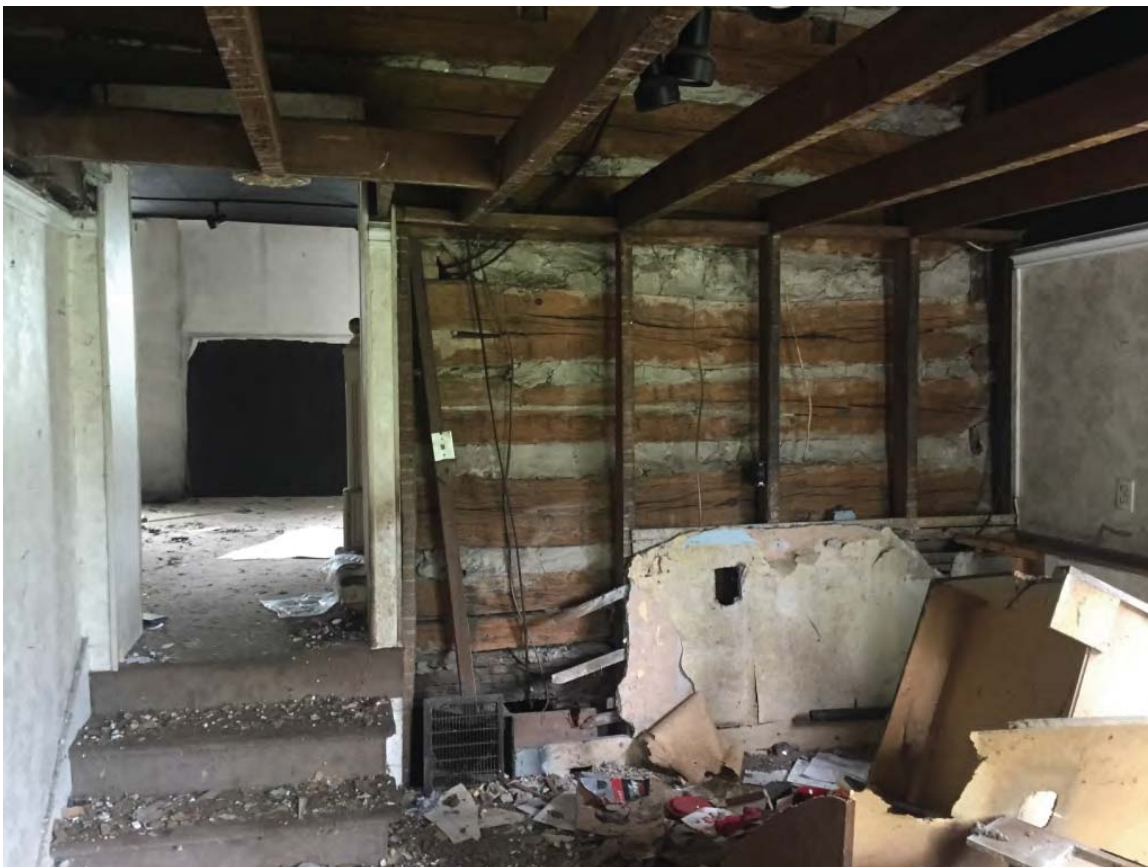
developed in other ways. Could it be used as a small dining or gathering room attached to a larger structure? How low are the ceilings? Notching in the logs indicate that the ceilings may have been higher at one time and later lowered to inhabit the upper story (Photo 4). Before the applicant can state that there is no economic use for the property, thorough analyses of potential options need to be explored. Just because the property is not suitable to their proposed development plan does not mean that it has no potential. And although Bass Studio Architects states that the property has no street presence since the main entry is to the side of the structure, the proposed patio will create a worse situation with a void along the street in the winter months. As such, this criterion is not met.

Photo 4- Exposed cabin logs, will require rethinking.

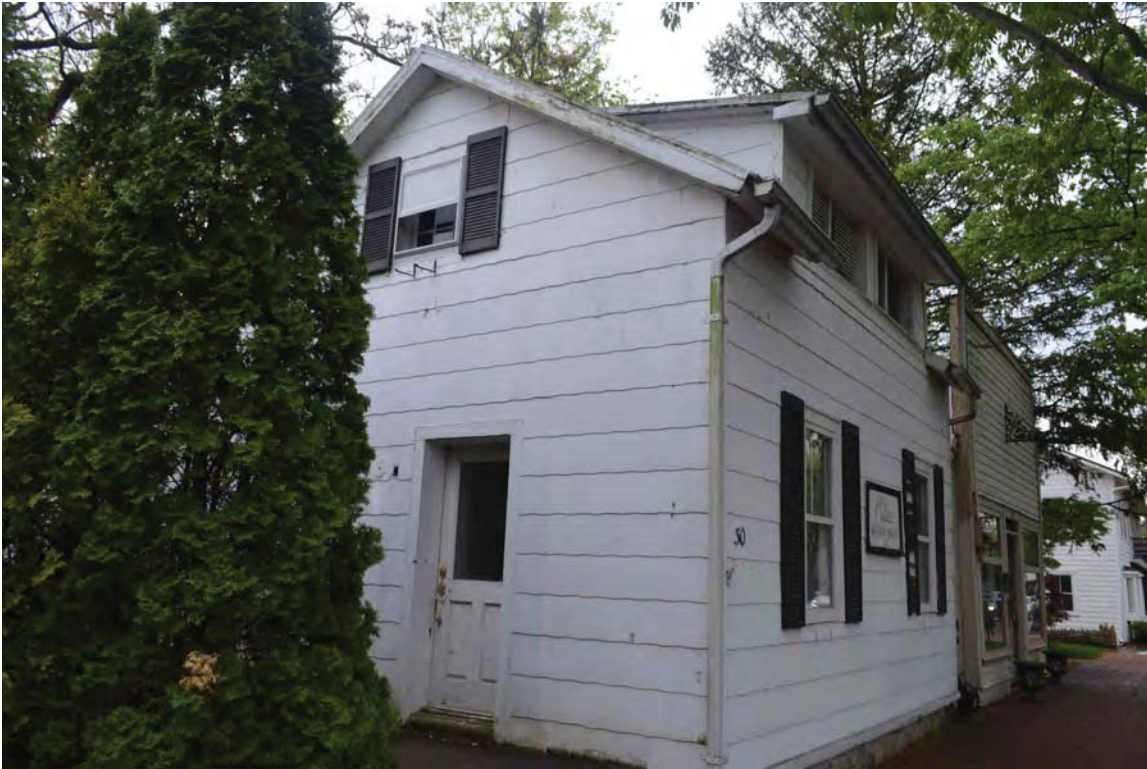
Photo 5- The cabin has little activation of the street edge, only two small windows. The entry is removed from the street on the North of the building.

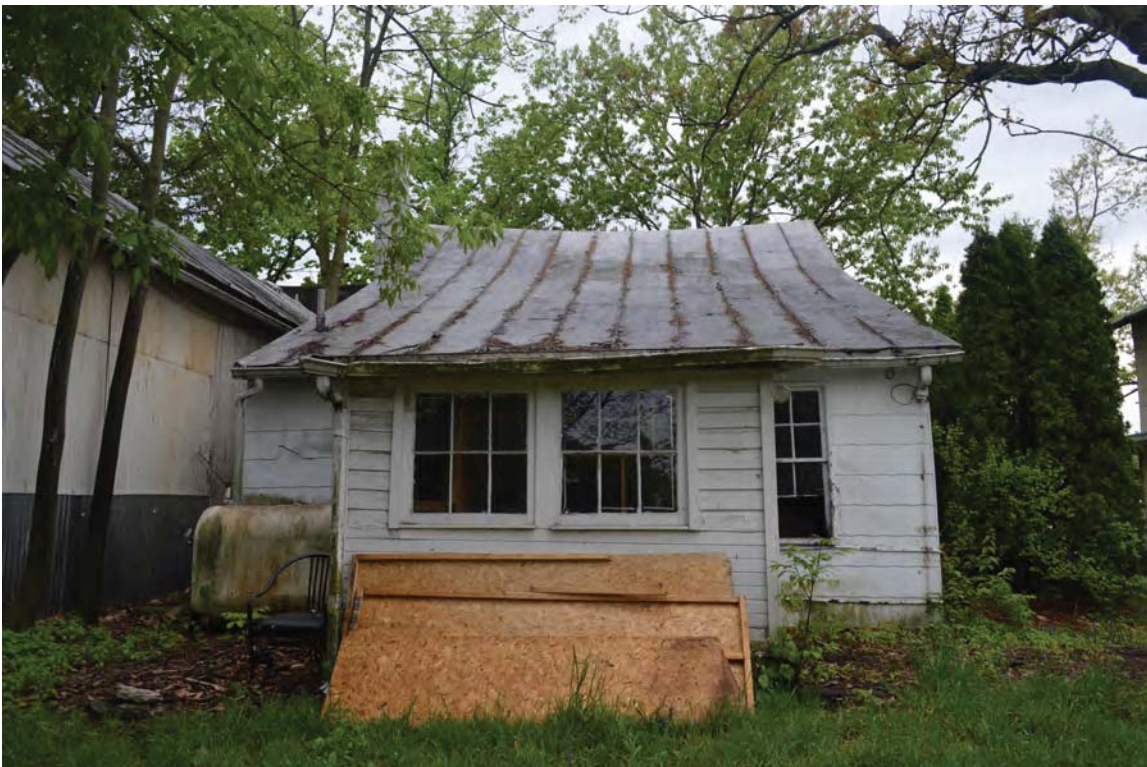
Photo 6- Rear of the 32 S High Building, note the later addition that hides the central cabin.

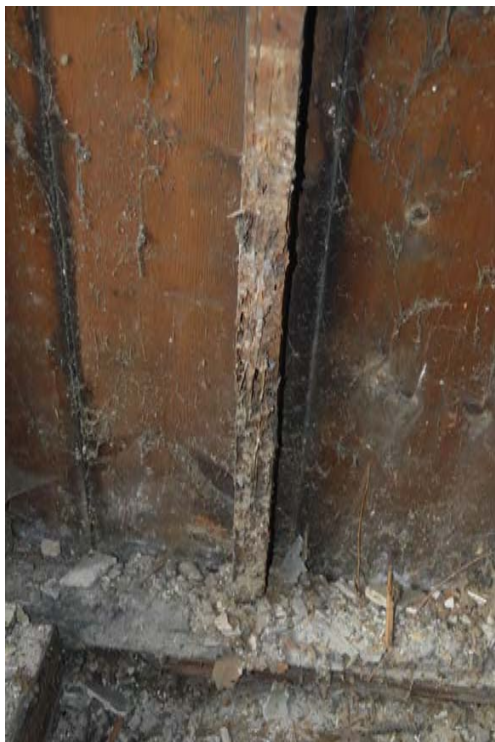
Photo 2- Insect damage on some structural studs, there appears to be no active insects at this time.

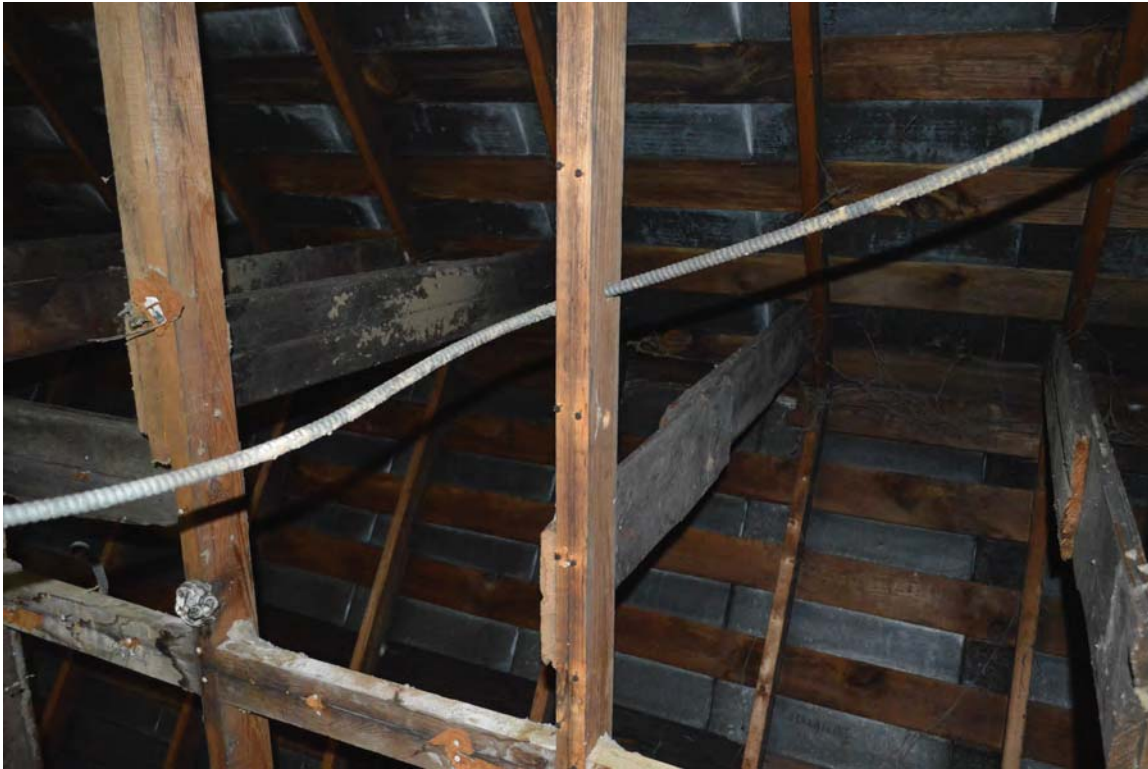
Photo 3- Existing roof framing will require some reframing and alterations to meet or exceed modern building code.

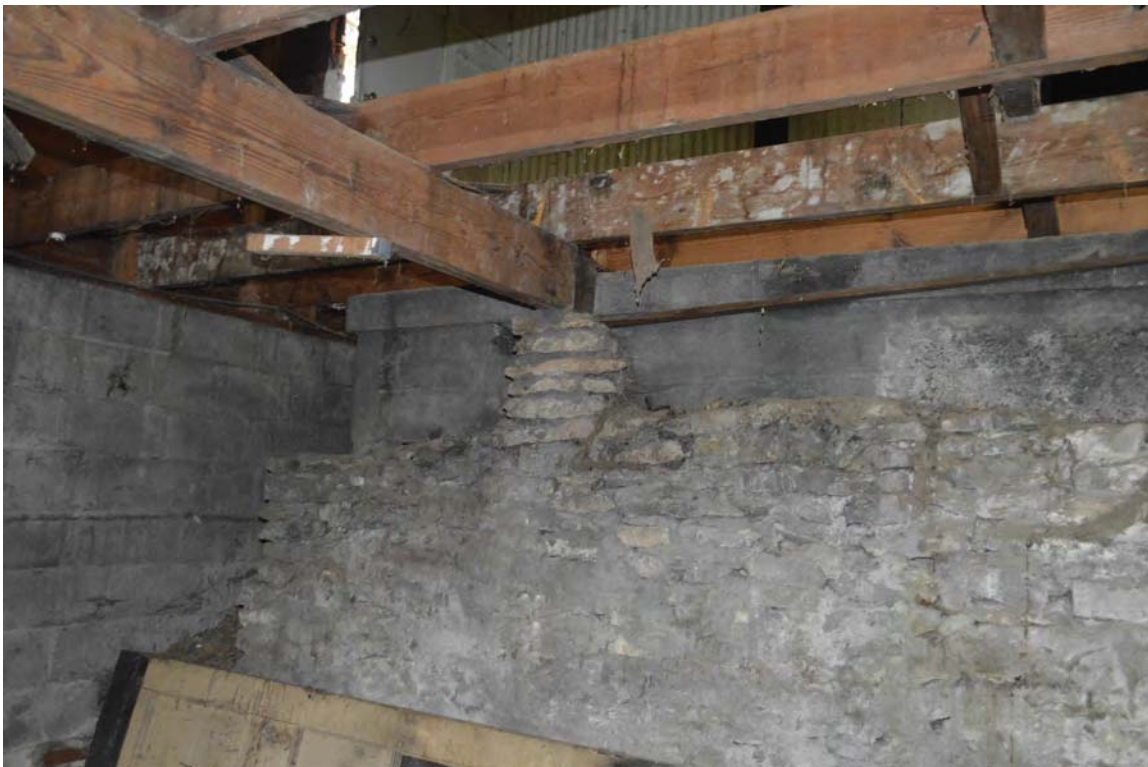
Photo 4- Basement foundation will require some repairs

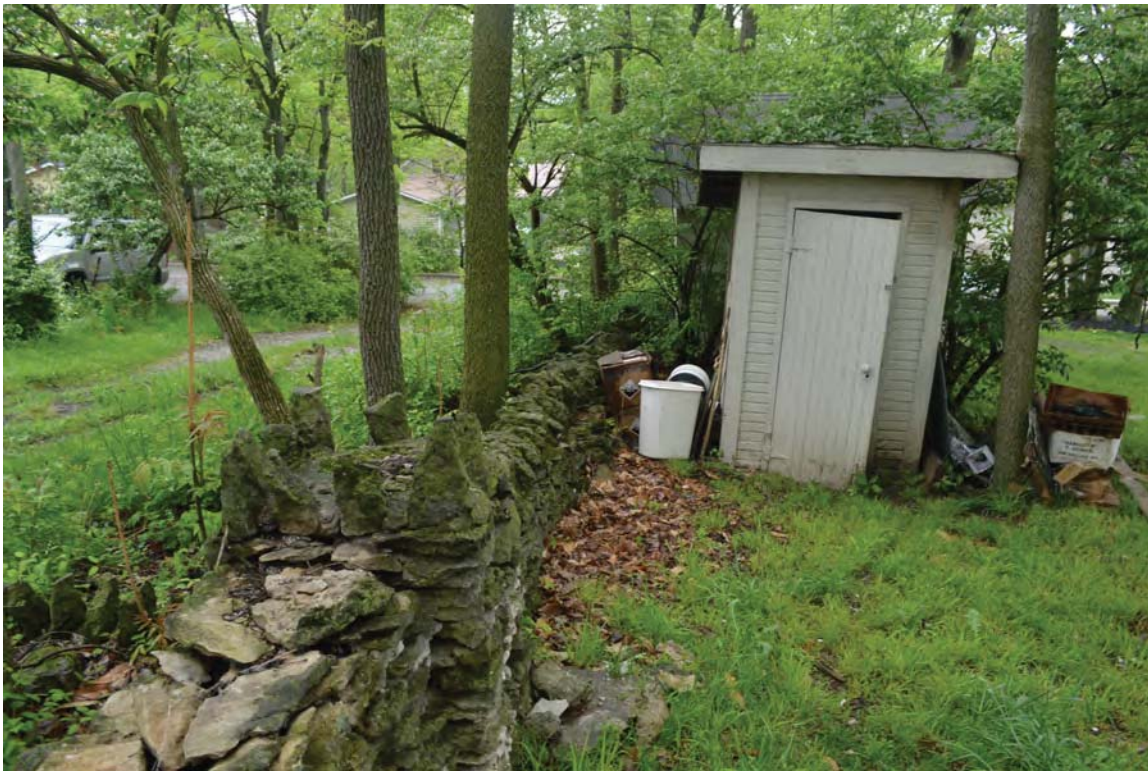
Photo 1- Historic stone wall with associated mature tree line to remain in place.
Small outhouse building to be removed.
