**PROJECT NAME: DESIGN SERVICES FOR THE NEW CITY HALL COUNCIL CHAMBERS ADDITION
5555 Perimeter Drive
City of Dublin, Ohio**

At the request of the City of Dublin, Osborn Engineering Company (OEC) in conjunction with our architectural sub-consultant (m+a architects) conducted a facility condition assessment at the existing building and parking lot located at 5555 Perimeter Drive, Dublin, Ohio formerly owned by Delta Energy. The assessment included Architectural (provided by m+a architects), Civil/Site, Mechanical, Electrical, and Plumbing systems. The objectives within this assignment include performing a survey of the existing building and its systems and providing recommendations for the facility including a summary rough order-of-magnitude costs for equipment replacement and repair within the next 20 years for major systems.

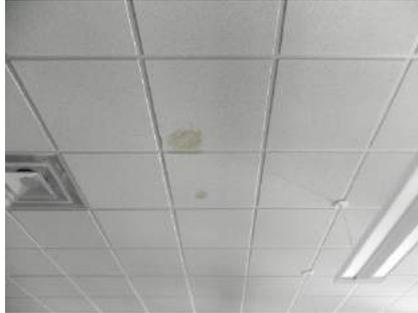
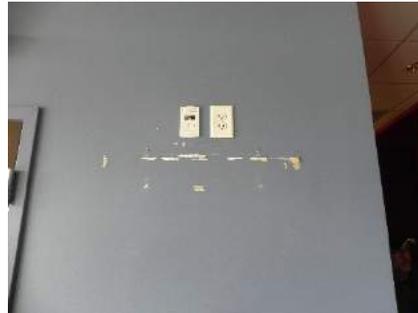
- The Eastern second floor open office area has two – 2 x 2 acoustic ceiling tiles that are stained from old roof top air handling unit leaks and need replaced.

- Painted gypsum wall board repair will be needed to eliminate holes placed to install wall hangings and picture frames.

- Architectural
 - Interior Elements
 - The Eastern second floor open office area has two – 2 x 2 acoustic ceiling tiles that are stained from old roof top air handling unit leaks and need replaced.

- Painted gypsum wall board repair will be needed to eliminate holes placed to install wall hangings and picture frames.
 - Exterior Building Envelope
 - The column base cast stone mortar/grout joints are loose and or falling out and need raked and mortar installed.

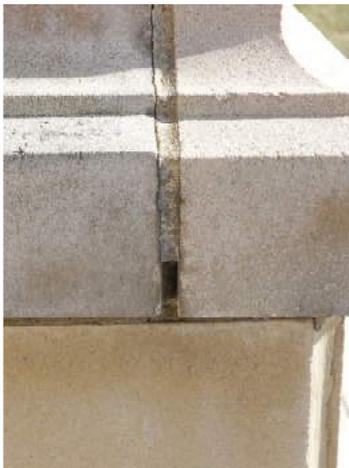
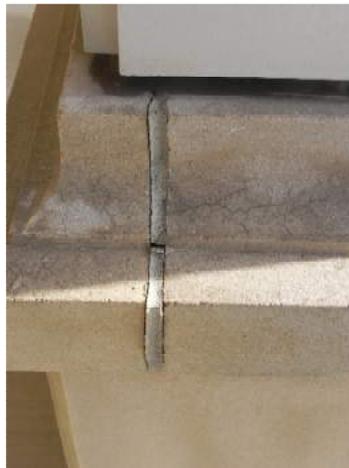
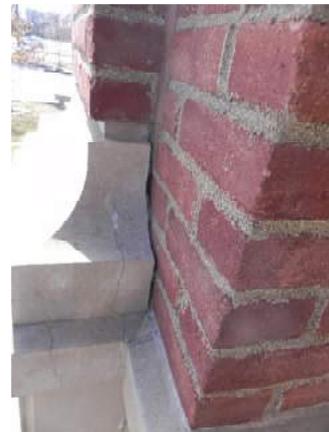
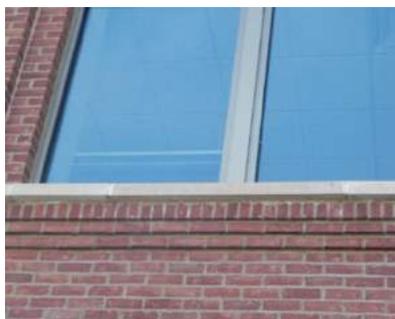
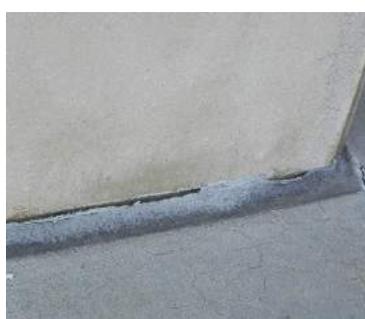
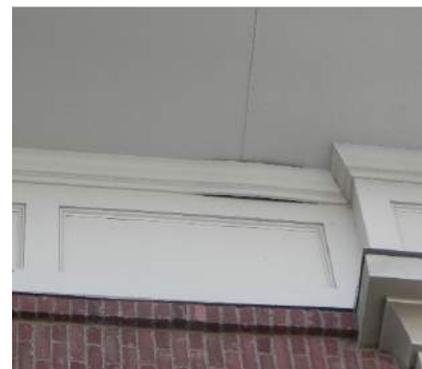
- The column base cast stone mortar/grout joints are loose and or falling out and need raked and new mortar installed.
- The sealant joints between the limestone column bases and the adjacent paving is loose and separating which allows water to enter. These joints need the existing sealant removed and new backer rods and sealant installed. The same type of work should be performed at the limestone window sill joints.
- A small length of the wood trim is bowed and a joint is open. This area should have sealant installed

- A Small length of the wood trim is bowed and a joint is open. This area should have sealant installed
 - The sealant joints between the limestone column bases and the adjacent paving is loose and separating which allows water to enter. These joints need the existing sealant removed and new backer rods and sealant installed. The same type of work should be performed at the limestone window sill joints.

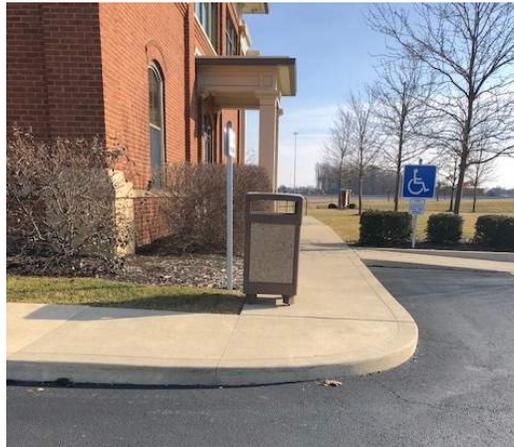
- Relocate trash bin for ADA accessibility to front entrance.

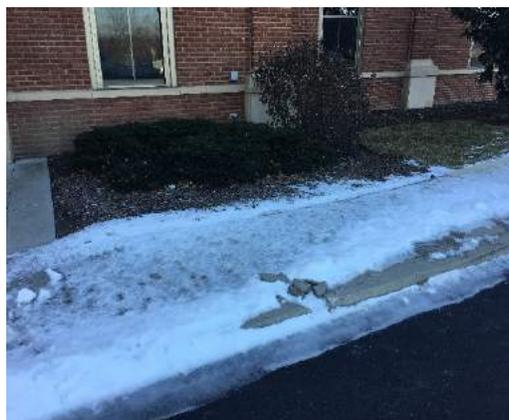
- Small concrete curb area near the building entrance (west side) needs to be repaired.

- Civil/Site
 - In the immediate term (0-5 years), there is minimal civil/site improvements anticipated outside of the light pole base and curb/sidewalk repair.

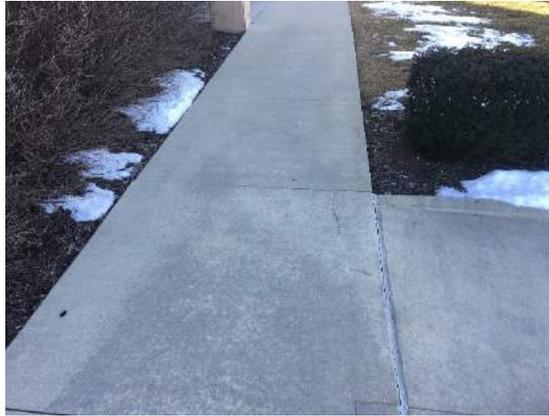
- Minor cracking in the sidewalk near the building entrance (east side).

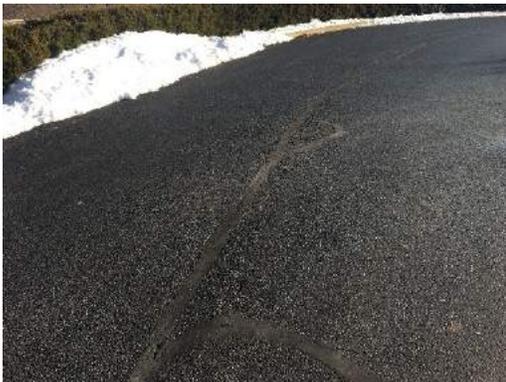
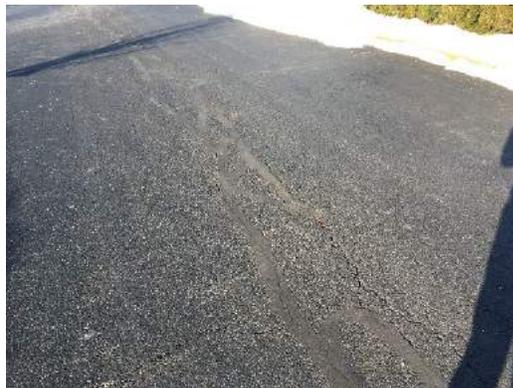
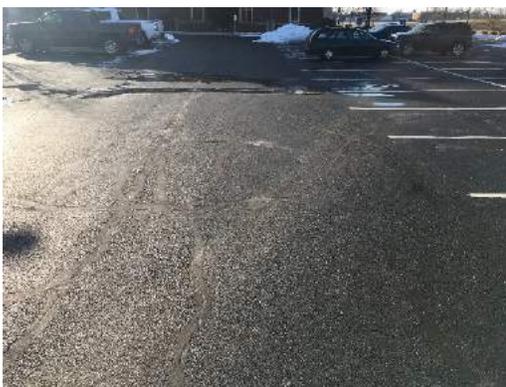
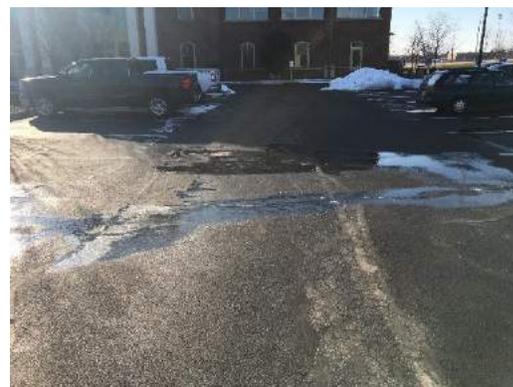
- Pavement appears to have been previously repaired with crack sealing. Additional surface cracking has occurred after the repair.

- Civil/Site
 - In the long-term (10-20 years), it should be budgeted to mill, overlay and restripe the parking lot with the noted surface cracking. There were no other findings that would lead to assumption of other major site/civil repairs.

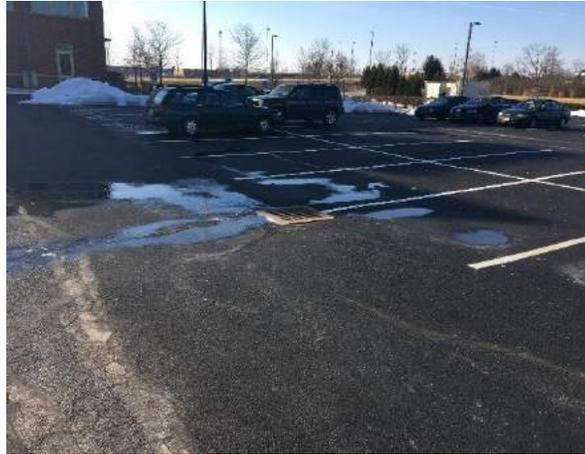
- Pavement is starting to settle around catch basin near the visitor parking area.

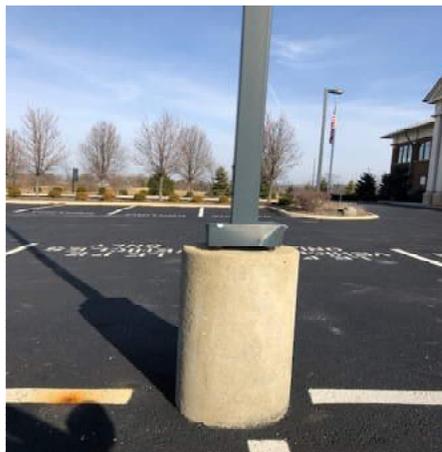
- Light Pole base at LEFE parking designated area needs repaired.

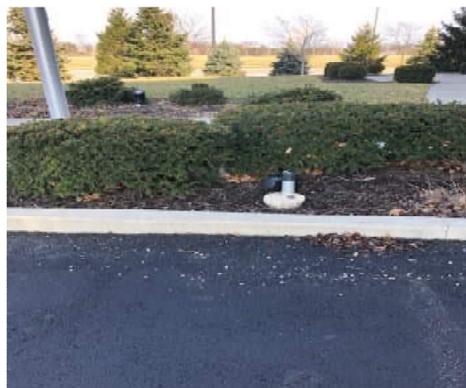
- Accent light for flag pole needs repaired.

- **Electrical Systems**
 - In the immediate term (0-5 years), the fire alarm system should be expanded upon or replaced in order to provide complete building notification to be in compliance with the OBC. It is also expected to need to replace the batteries on the UPS systems serving the IT room. The lighting control panel should also be considered for relocation to provide adequate working access for programming purposes. The flagpole flood light that has been damaged should also be replaced.

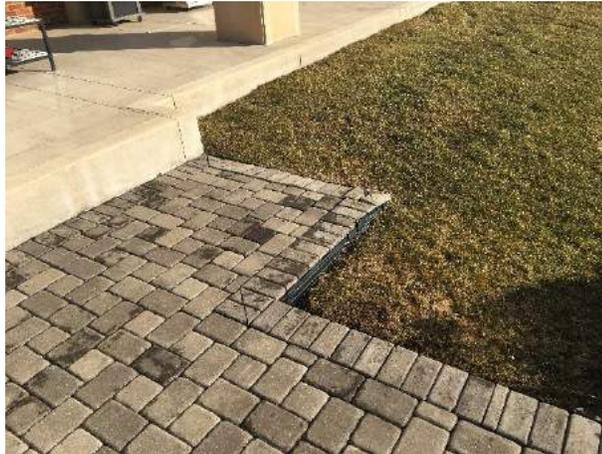
- Overall in good condition. ADA access route to the lower patio near the south pond is not provided. Minor settlement near the lower level patio edge.

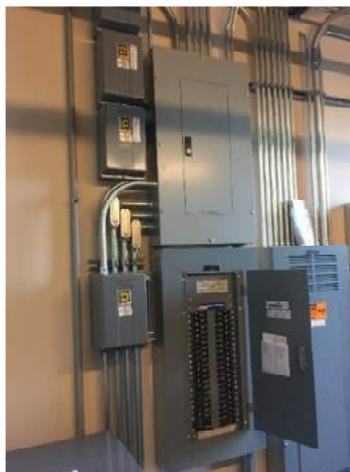
- Within the main electrical room, the lighting control panel that controls the lighting contactors is mounted overtop of an electrical panel. Per NEC Article 404.8 all switches and circuit breakers must be installed below 6'-7" to be considered accessible. Although this does not contain switches or circuit breakers, it does still require access for programming the control system. It would be recommended to relocate the control panel to an adjacent wall to insure that the panel is accessible.
