EXPRESS REPORT

Report ID: 13209 / Underwood

SUMMARY OF INSPECTOR COMMENTS

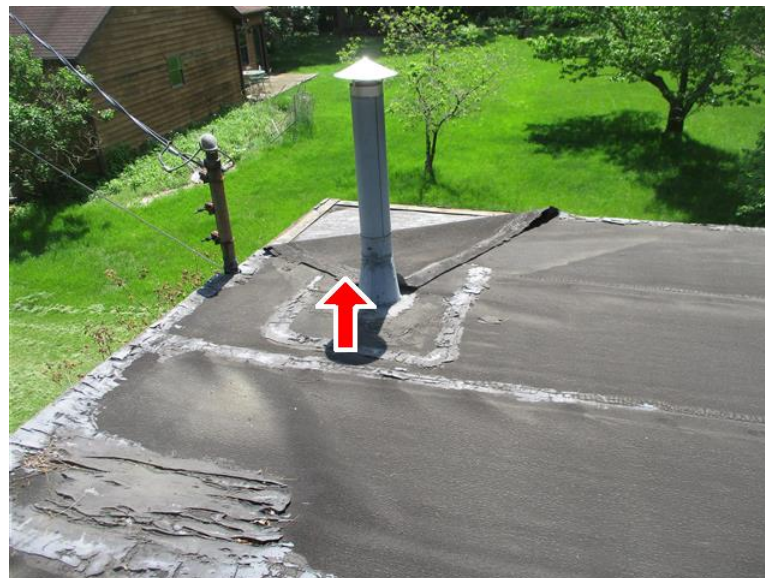
1.0 Item 1(Picture)

The roof is need of repair/replacement. Roof damage is present and roof leaks are evident in the garage. Recommend repairs by a qualified roofing contractor.

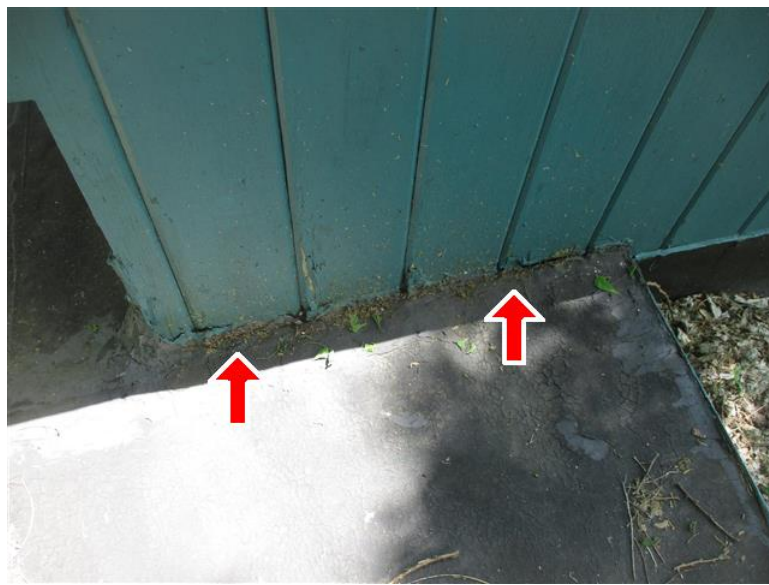
1.1 Item 1(Picture)

Poor flashing detail is noted at the roof; repairs are needed.

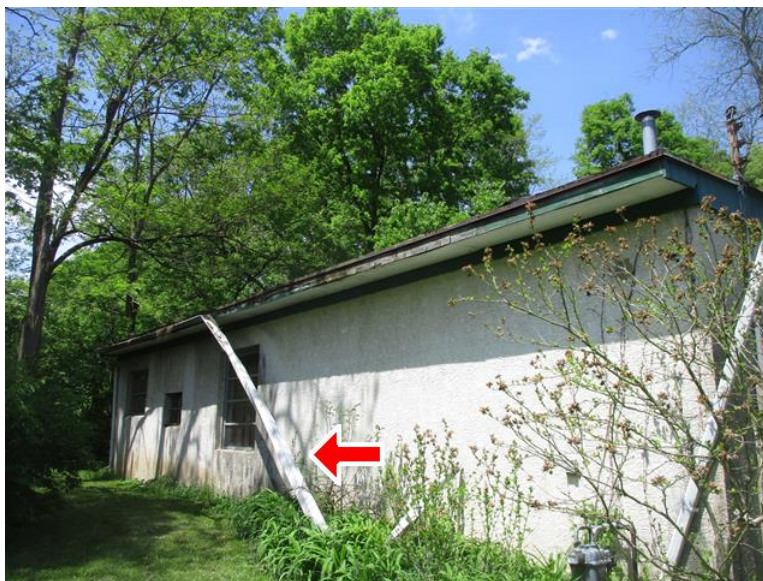
1.4 Item 1(Picture)

Damaged gutter at rear of home and loose gutter at garage; repairs are needed.

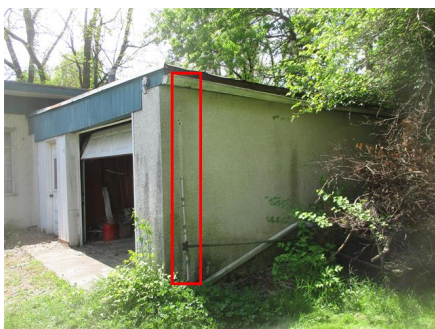
1.5 Item 1(Picture)

Missing downspouts at several areas; add where needed.

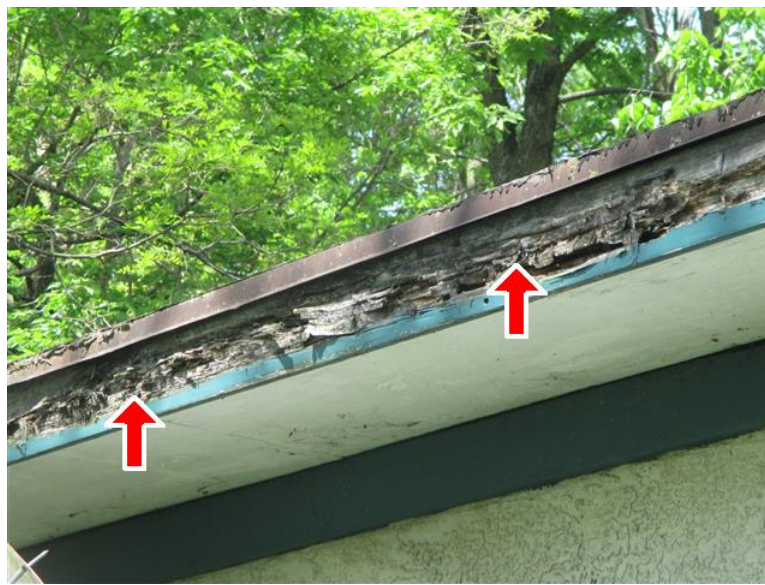
1.6 Item 1(Picture)

Moisture rot noted on the wood soffit and fascia at rear of home; repairs are needed.

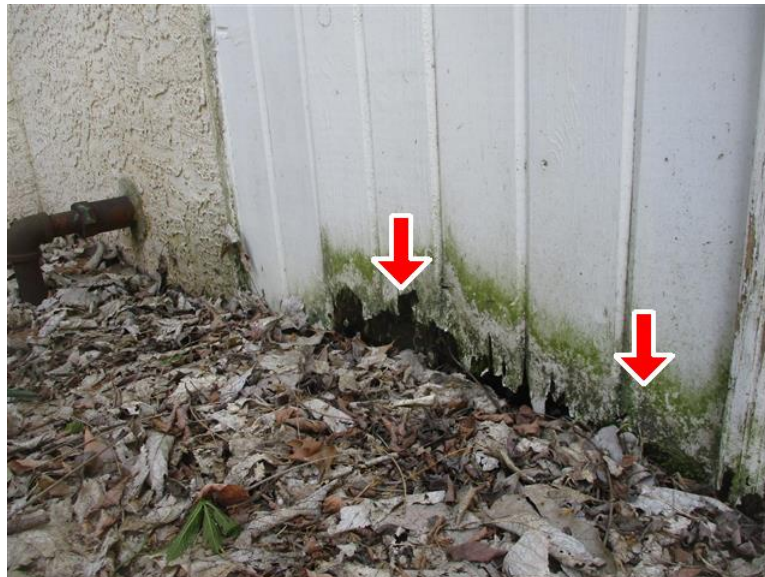
2.0 (1) Item 1(Picture)

2.0 (1) Wood rot present on the wood siding to the left of the garage; recommend repairs.

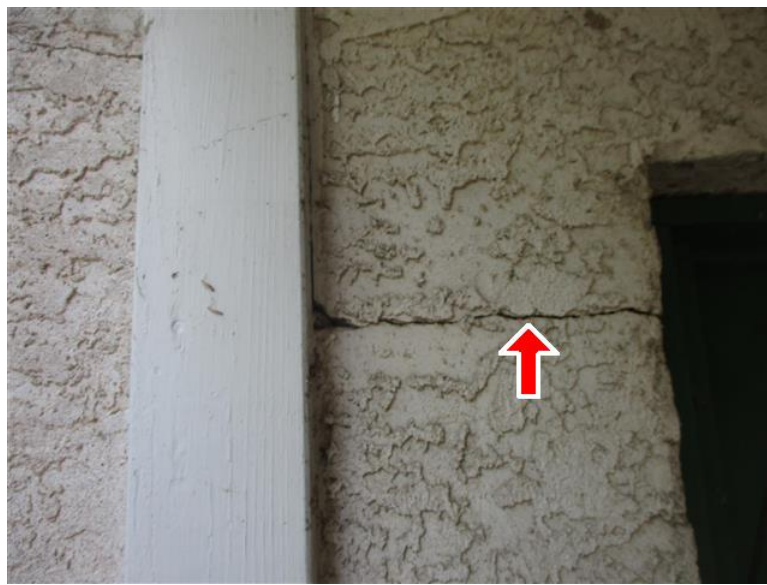
2.0 (2) Item 1(Picture)

2.0 (2) Cracking noted on the stucco siding at several areas. Small cracking is common with stucco. Recommend sealing all cracks to help prevent moisture intrusion.

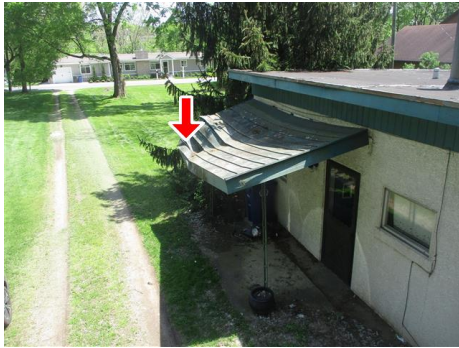
2.3 Item 1(Picture)

Damage present on the front porch roof; repairs are needed.

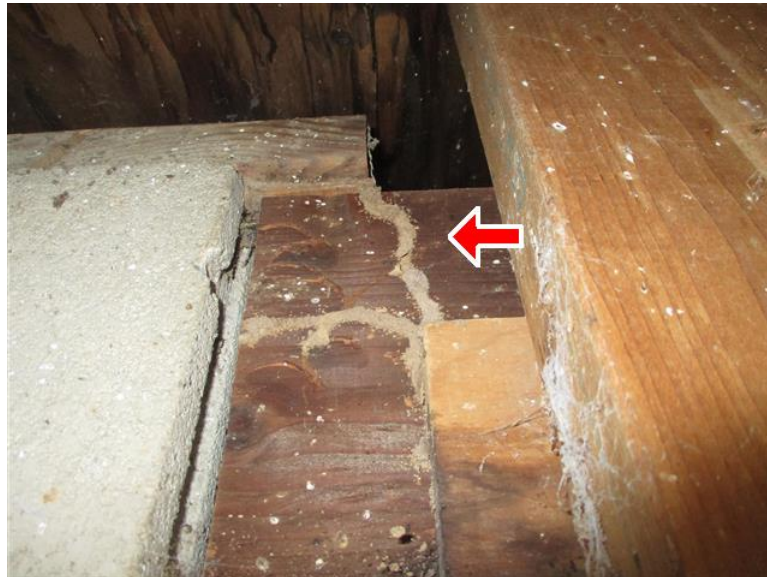
4.0 Item 1(Picture)

Evidence of wood destroying insects is present in the garage. Termite tubes and live activity is noted. Recommend further evaluation by a qualified exterminating company.

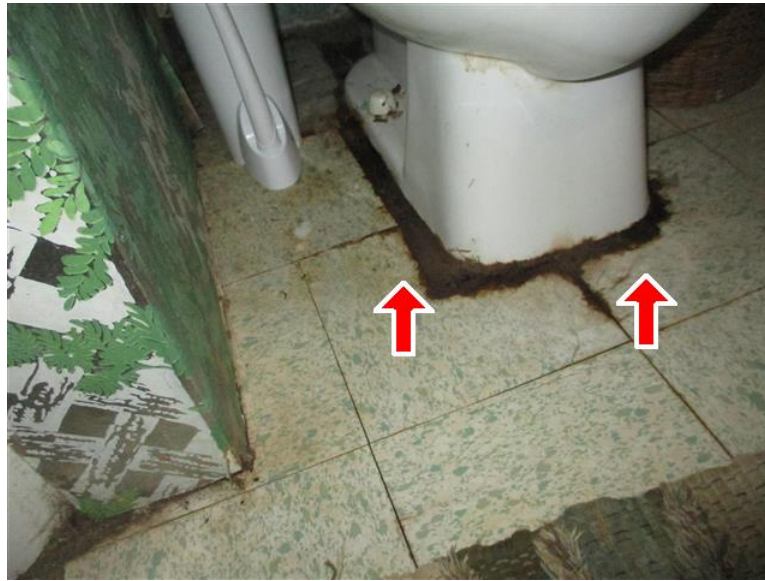
5.1 Item 1(Picture)

A moisture meter was used around the base of the toilet and the meter indicated a possible leak around the seal. Floor, flooring, and/or other damage may be uncovered when the toilet is lifted for repair. Have checked and corrected as required.

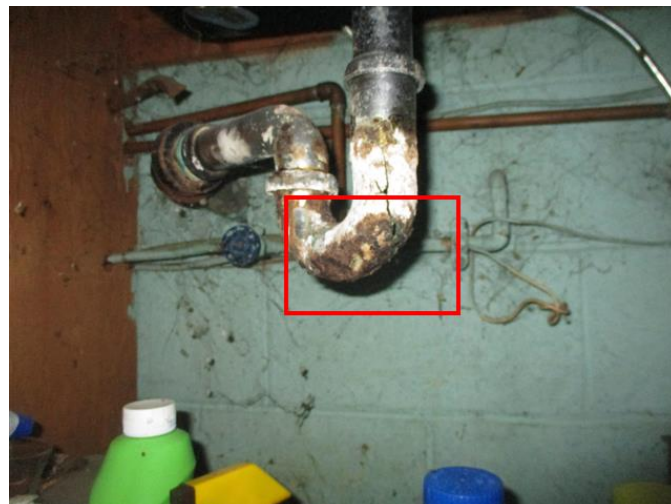
6.0 Item 1(Picture)

Damage is noted on the plumbing drain under the kitchen sink; repairs are needed.

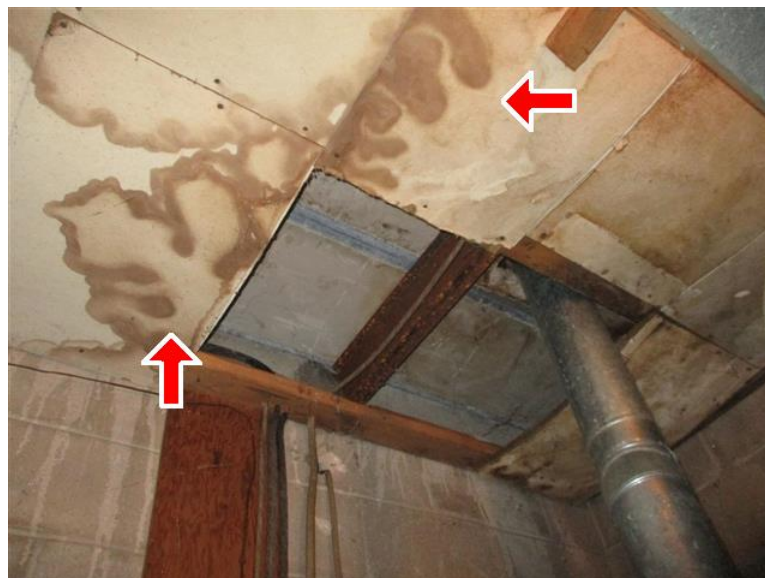
7.0 Item 1(Picture)

Moisture stains are noted on the ceilings in several rooms. Roof leaks are probable. Repair as needed after the roof is repaired.

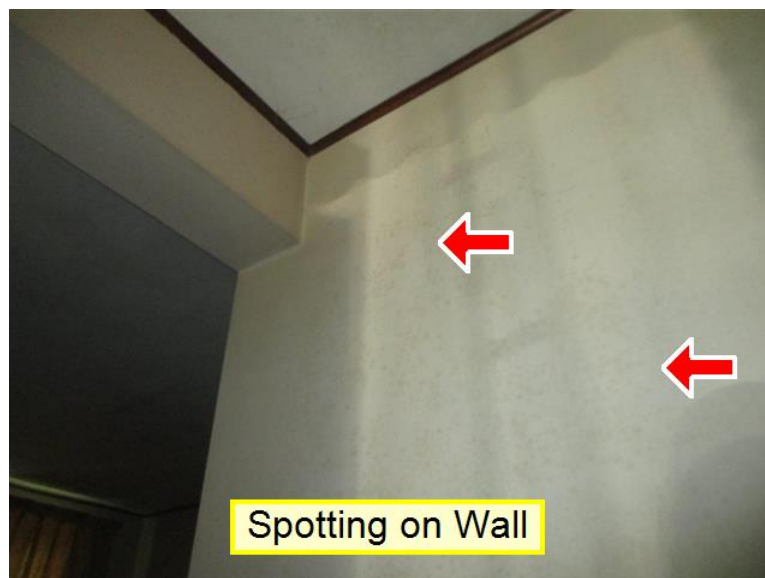
7.1 Item 1(Picture)

Suspect mold growth is present on the walls in the living room. No testing was conducted the day of the inspection to determine the type of growth. Recommend further evaluation by a qualified company for proper cleaning.

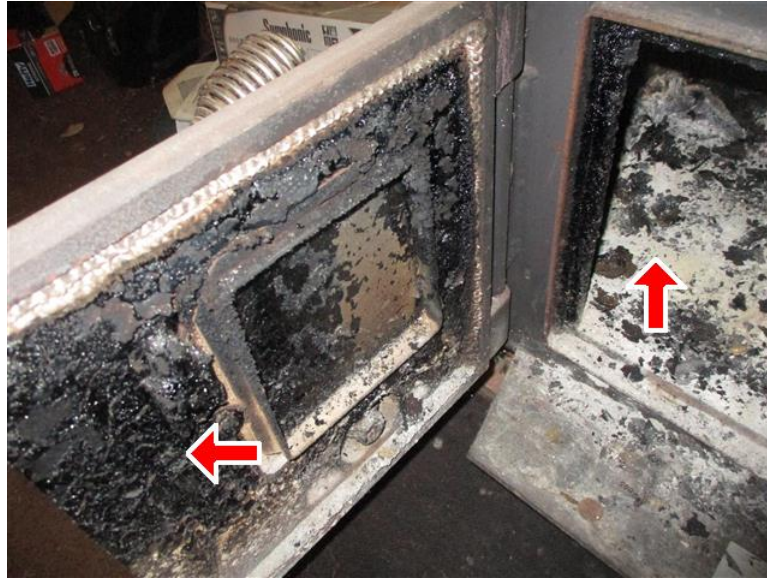
7.4 Item 1(Picture)

Wood burning stove present in the living room. The seller stated the unit has not been operated in several years. Creosote buildup is present inside the stove and flue. Unit needs cleaned by a qualified chimney sweep.

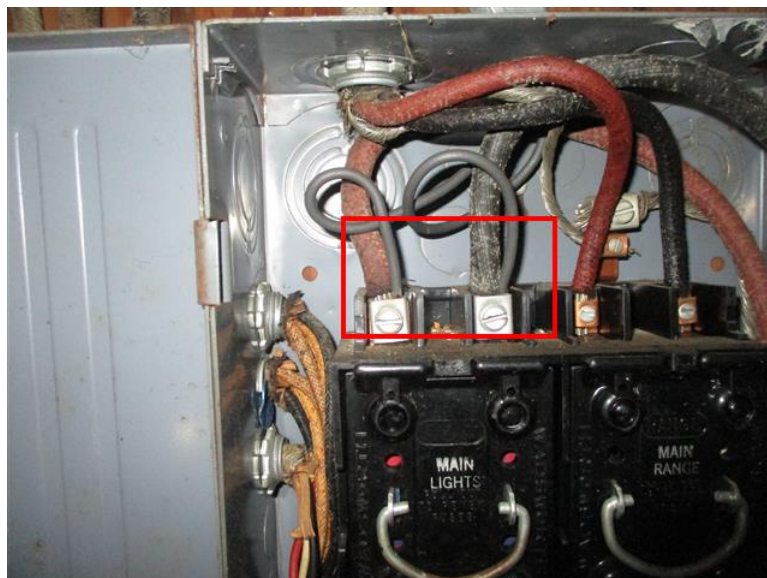
8.2 Item 1(Picture)

Doubled-up circuits noted. This is not acceptable unless approved for the specific connected devices. Advise redistribution where warranted. Have an electrician determine need.

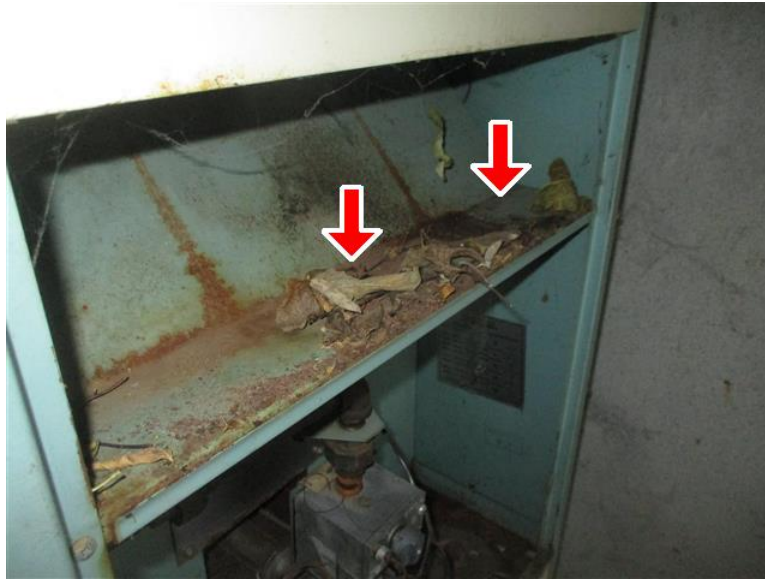
9.1.A Item 1(Picture)

Rust and/or debris noted in the burner compartment indicates deterioration of combustion chamber or heat exchanger; anticipate repair/replacement needs. Further evaluation by a qualified HVAC contractor is needed.

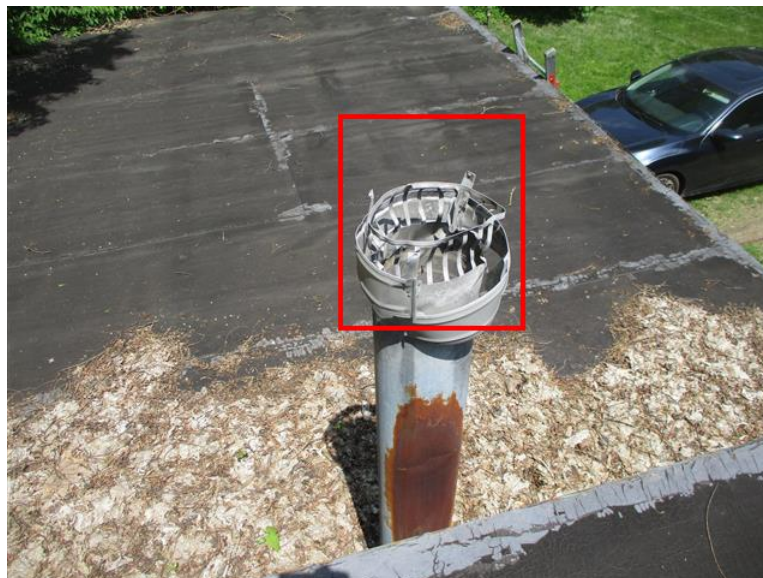
Missing cap present at the furnace vent. Debris is noted inside the furnace. Repairs are needed.

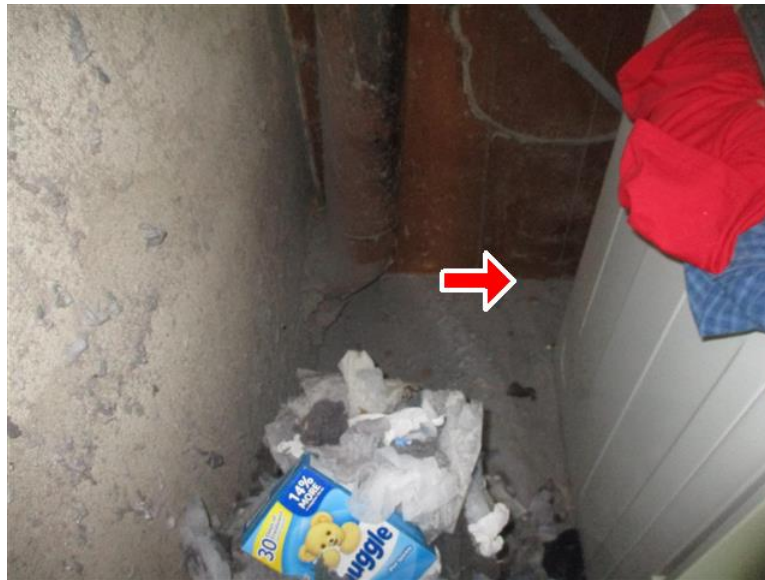
10.3 Item 1(Picture)

The dryer vent terminates in the laundry room. It is recommended that the vent terminate to the exterior.
