185 S Riverview St
Dublin OH 43017

5/7/2019

AM Inspections, LLC. dba HouseMaster Home Inspections

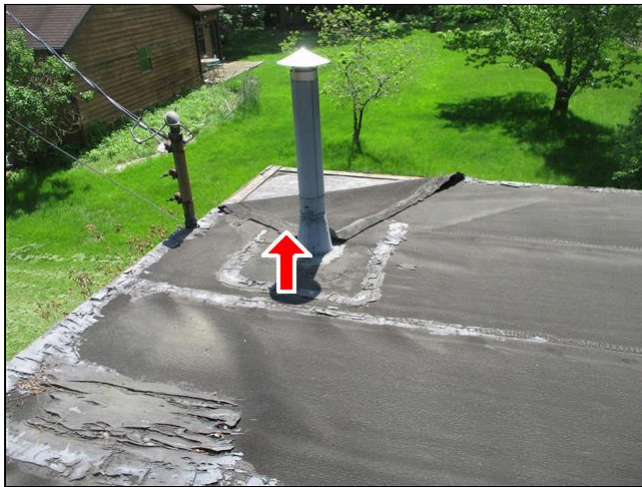
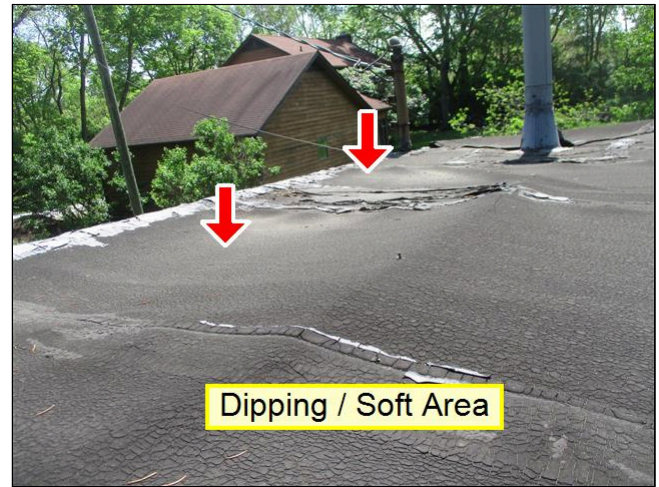
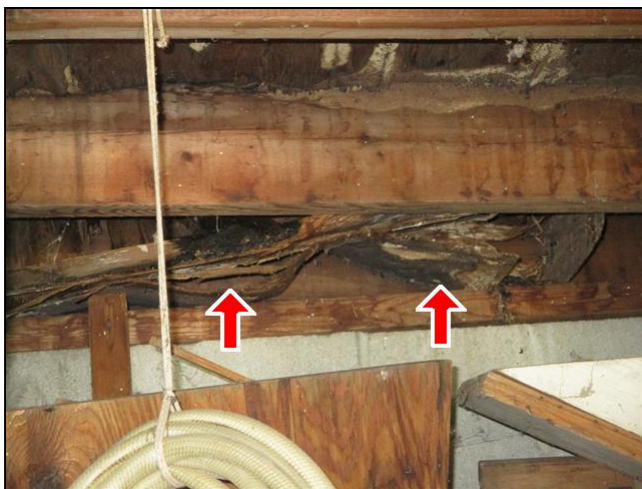
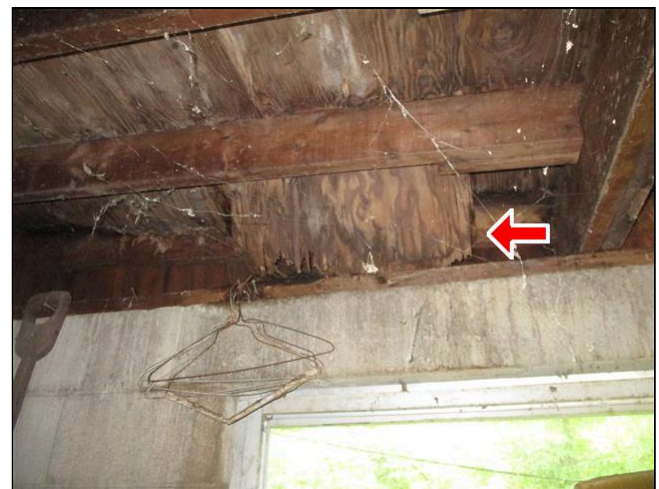
The roof is need of repair/replacement. Roof damage is present and roof leaks are evident in the garage. Recommend repairs by a qualified roofing contractor.

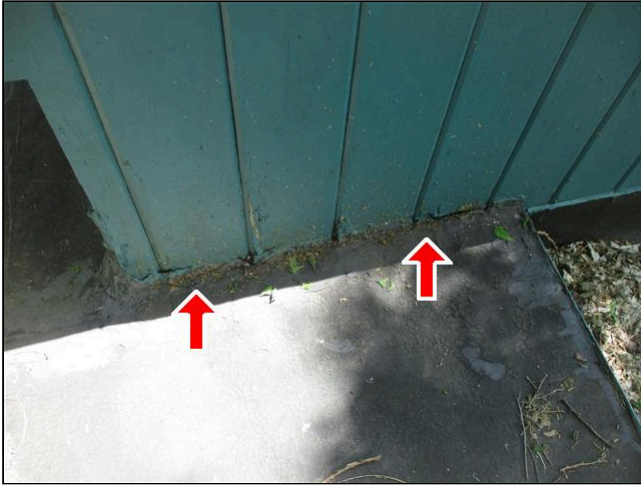
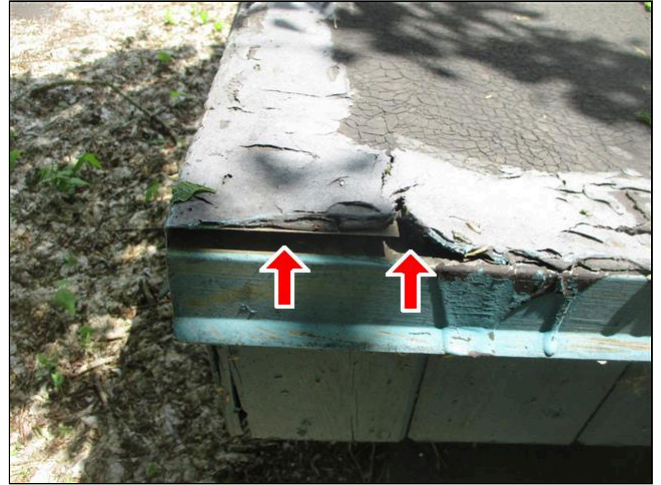
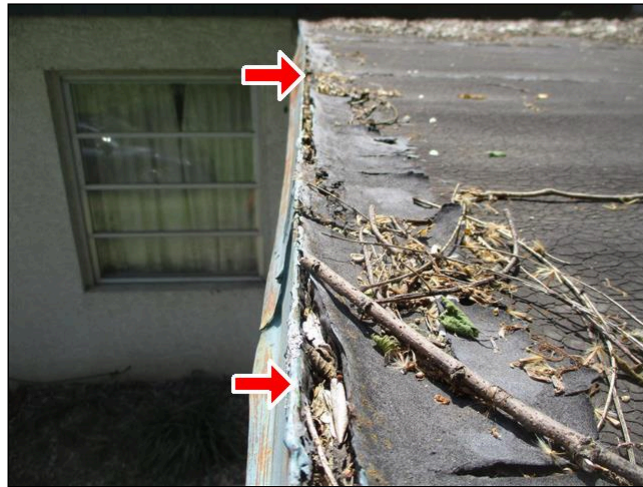
Poor flashing detail is noted at the roof; repairs are needed.

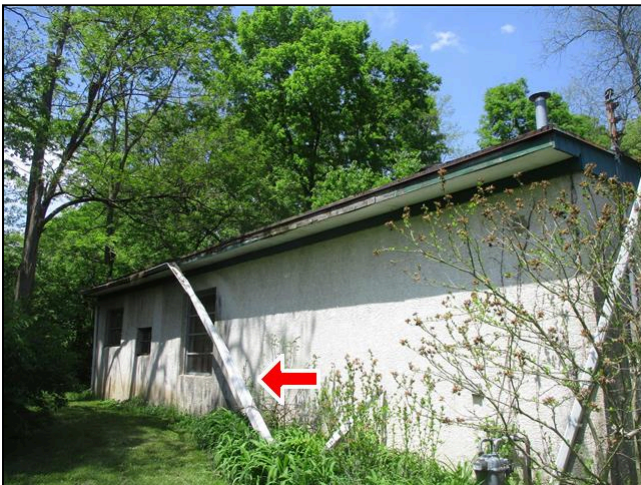
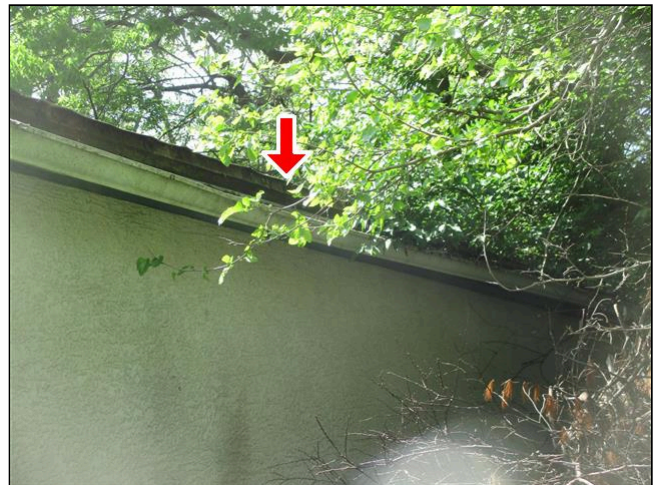
Damaged gutter at rear of home and loose gutter at garage; repairs are needed.

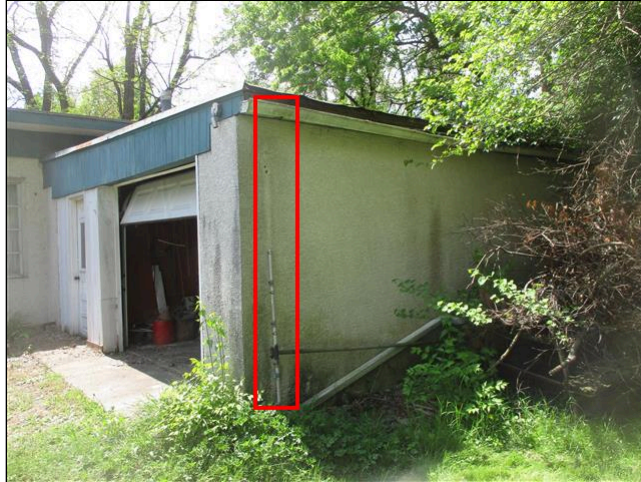
1.5 Item 1(Picture)

Missing downspouts at several areas; add where needed.

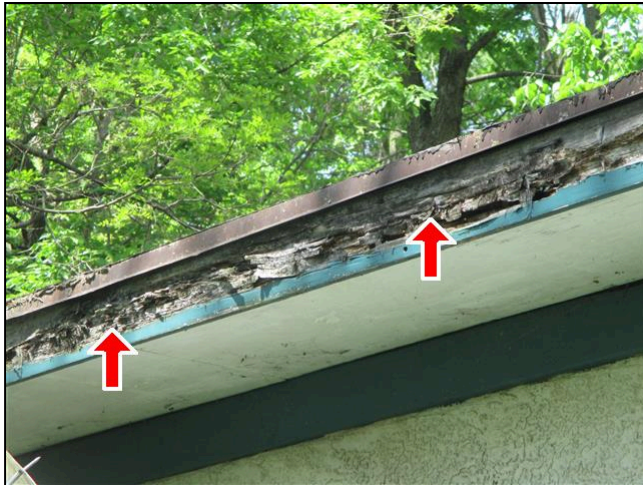
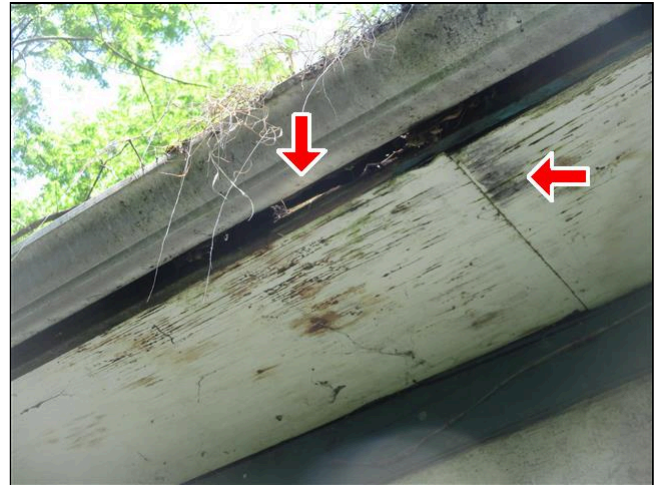
Moisture rot noted on the wood soffit and fascia at rear of home; repairs are needed.

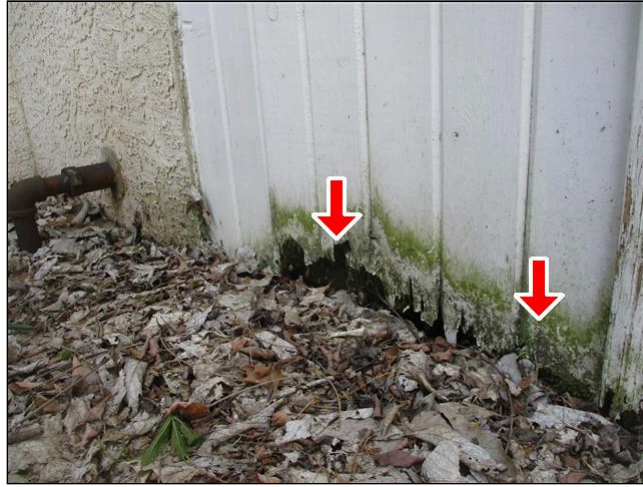
2.0 (1) Item 1(Picture)

2.0 (1) Wood rot present on the wood siding to the left of the garage; recommend repairs.

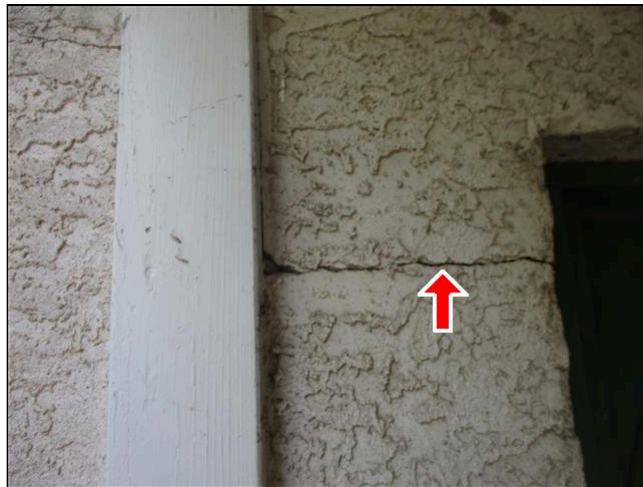
2.0 (2) Item 1(Picture)

2.0 (2) Cracking noted on the stucco siding at several areas. Small cracking is common with stucco. Recommend sealing all cracks to help prevent moisture intrusion.

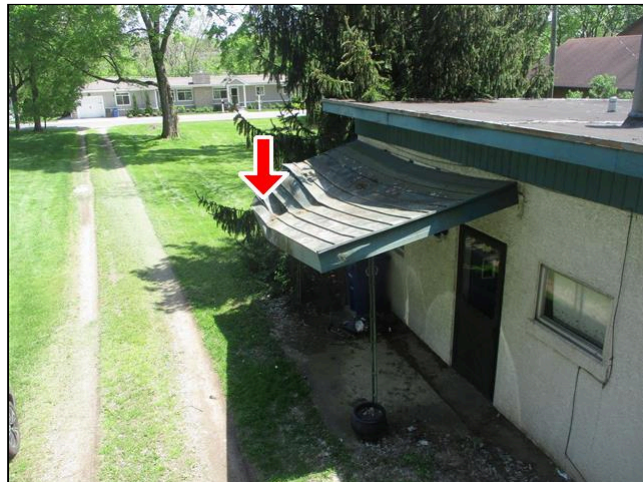
2.3 Item 1(Picture)

Damage present on the front porch roof; repairs are needed.

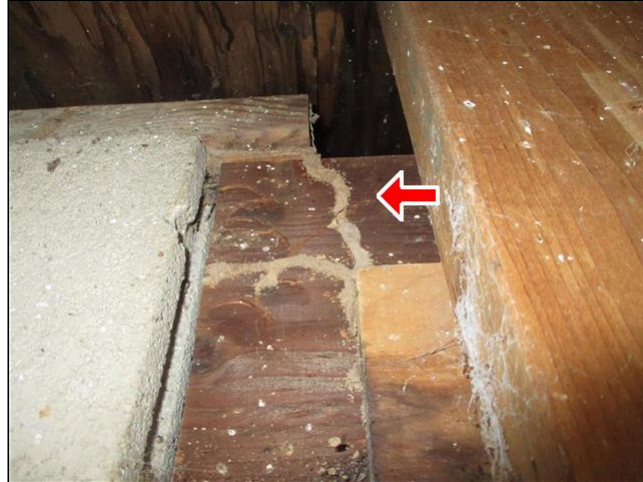
4.0 Item 1(Picture)

Evidence of wood destroying insects is present in the garage. Termite tubes and live activity is noted. Recommend further evaluation by a qualified exterminating company.

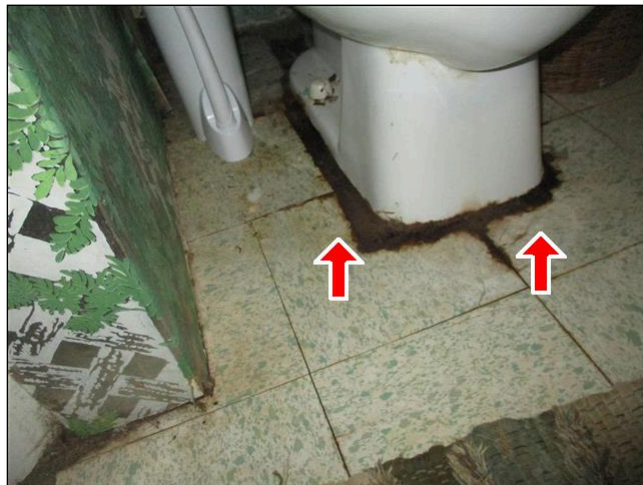
5.1 Item 1(Picture)

A moisture meter was used around the base of the toilet and the meter indicated a possible leak around the seal. Floor, flooring, and/or other damage may be uncovered when the toilet is lifted for repair. Have checked and corrected as required.

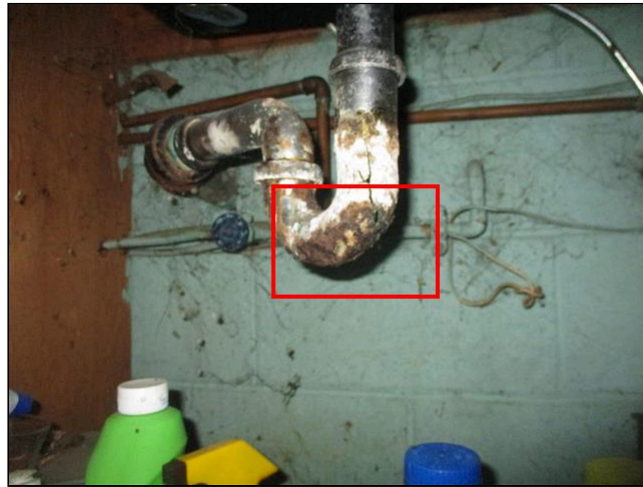
6.0 Item 1(Picture)

Damage is noted on the plumbing drain under the kitchen sink; repairs are needed.

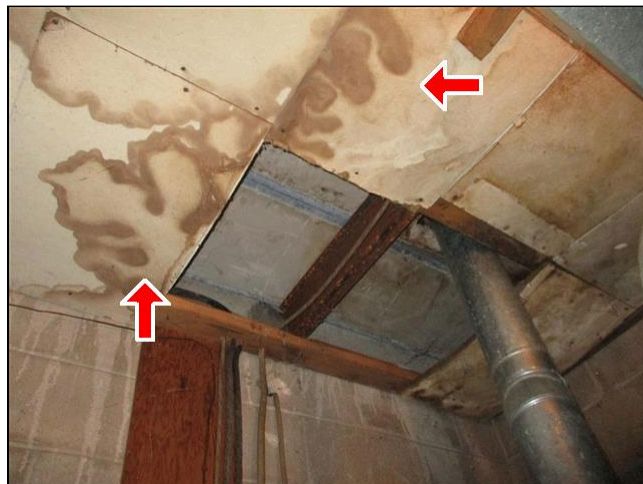
7.0 Item 1(Picture)

Moisture stains are noted on the ceilings in several rooms. Roof leaks are probable. Repair as needed after the roof is repaired.

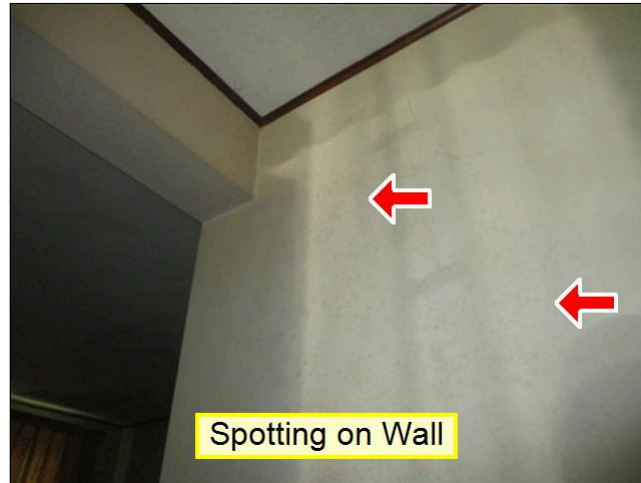
7.1 Item 1(Picture)

Suspect mold growth is present on the walls in the living room. No testing was conducted the day of the inspection to determine the type of growth. Recommend further evaluation by a qualified company for proper cleaning.

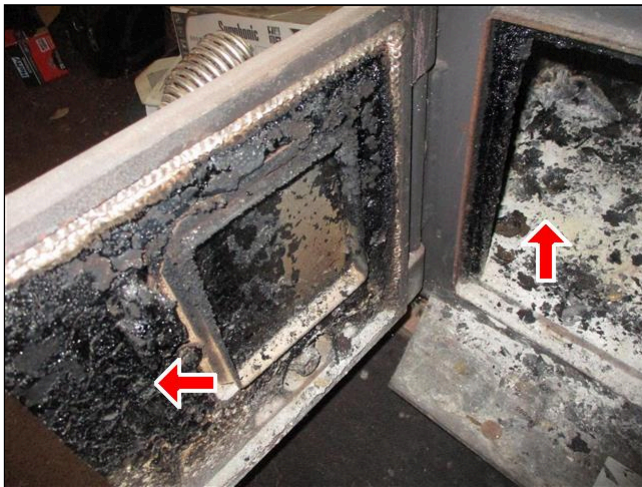
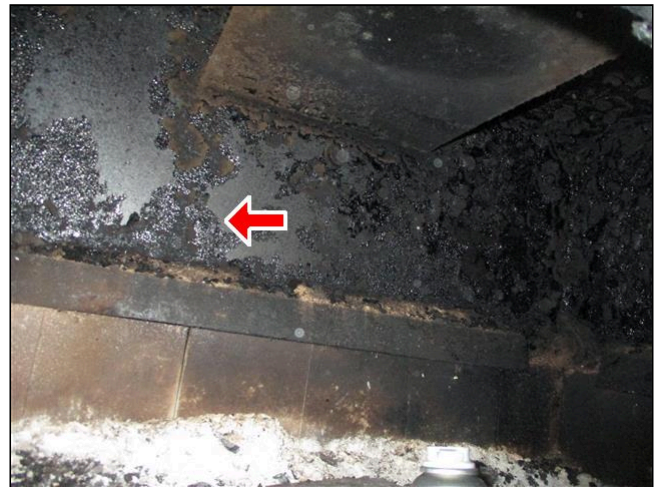
Wood burning stove present in the living room. The seller stated the unit has not been operated in several years. Creosote buildup is present inside the stove and flue. Unit needs cleaned by a qualified chimney sweep.

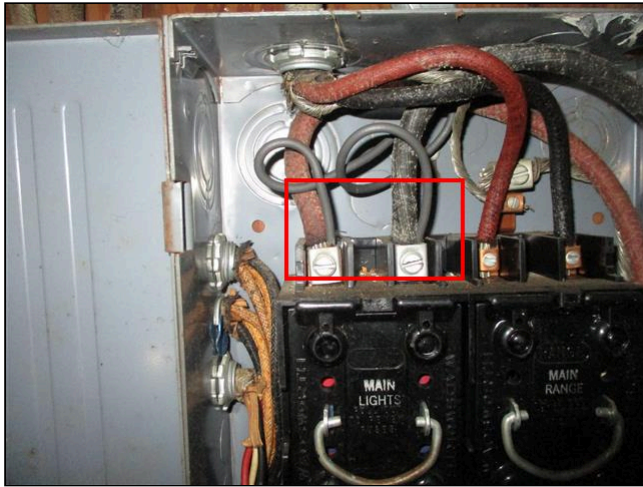
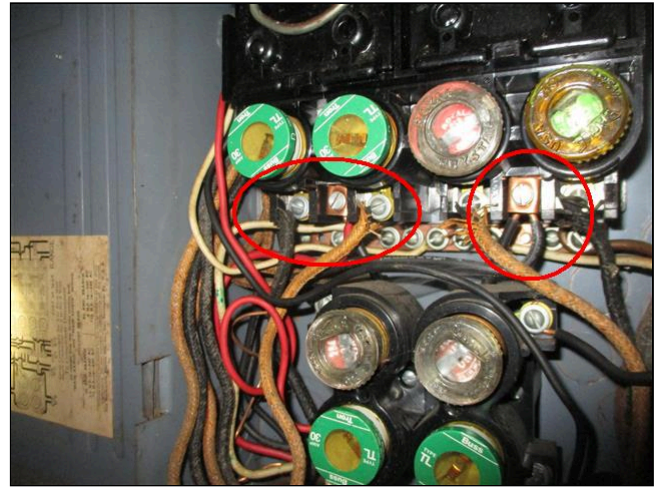
Doubled-up circuits noted. This is not acceptable unless approved for the specific connected devices. Advise redistribution where warranted. Have an electrician determine need.

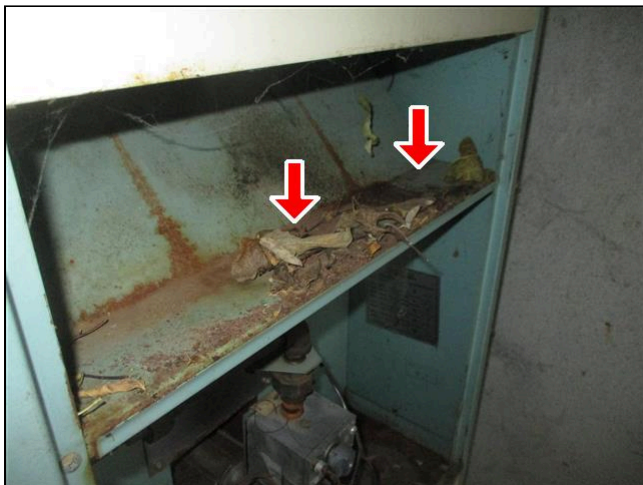
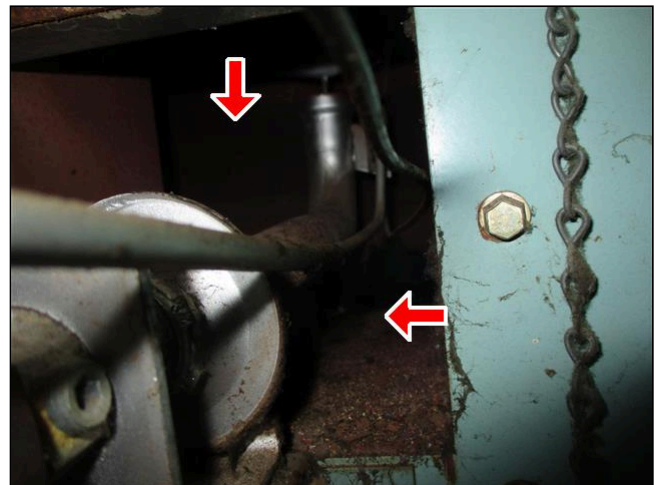
Rust and/or debris noted in the burner compartment indicates deterioration of combustion chamber or heat exchanger; anticipate repair/replacement needs. Further evaluation by a qualified HVAC contractor is needed.

I recommend the furnace be checked/serviced by a qualified HVAC contractor due to the age and condition of the unit.

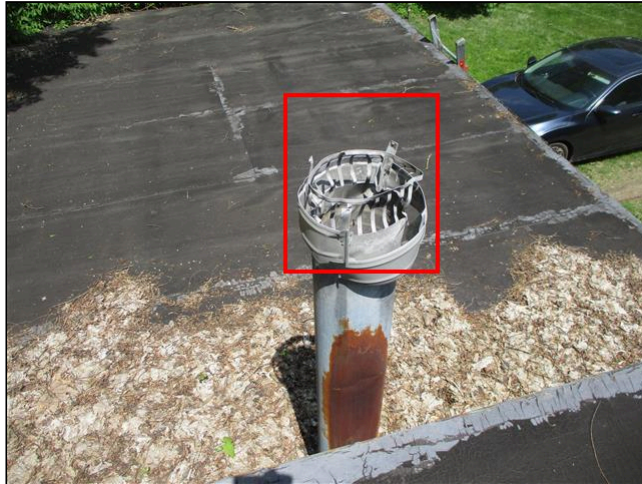
9.4.A Item 1(Picture)

Missing cap present at the furnace vent. Debris is noted inside the furnace. Repairs are needed.

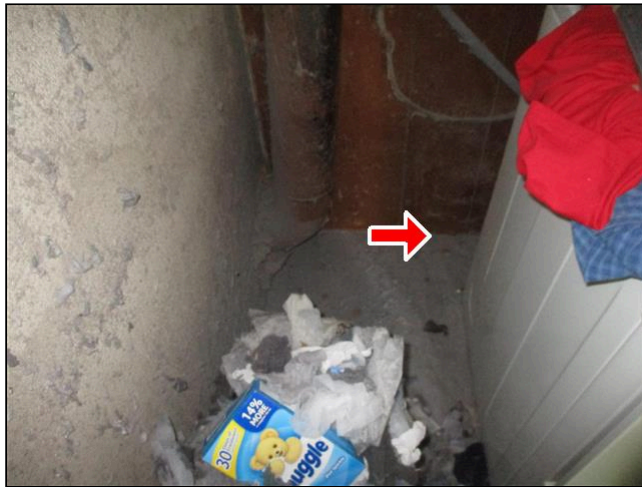
10.3 Item 1(Picture)

The dryer vent terminates in the laundry room. It is recommended that the vent terminate to the exterior.
