Memo

To: Members of Community Development Committee
From: Dana L. McDaniel, City Manager
Initiated By: Robert Taylor, PE, Director of Asset Management & Support Services
Jennifer Rauch, AICP, Director of Planning
J.M. Rayburn, Planner I
Date: March 18, 2021
Re: Maintenance of Historically Significant Stone Walls

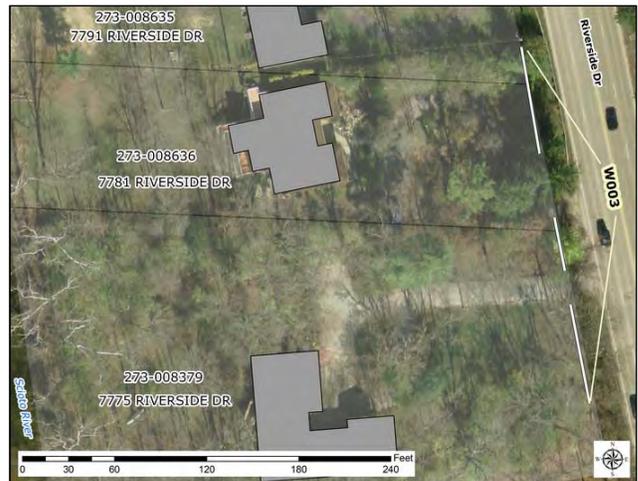
Condition: Fair, Ruinous, Overgrown

Integrity Notes: Wall has fair integrity. The location, design, and materials appear to be original but the wall is in deteriorated condition.

Overview of wall, looking south

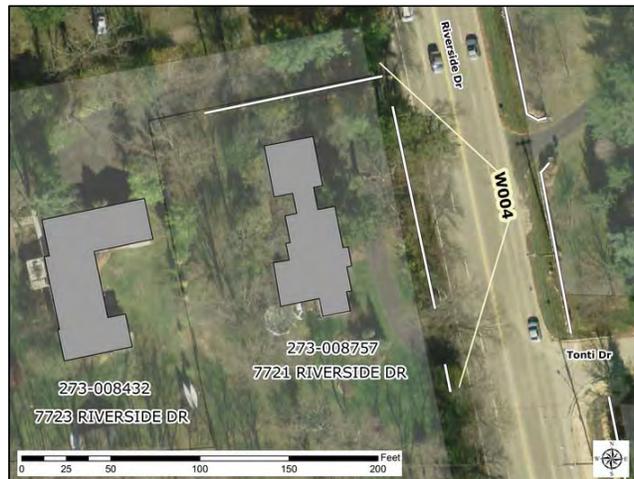
Wall Identifier W004

Condition: Good, Repaired

Overview of wall, looking south

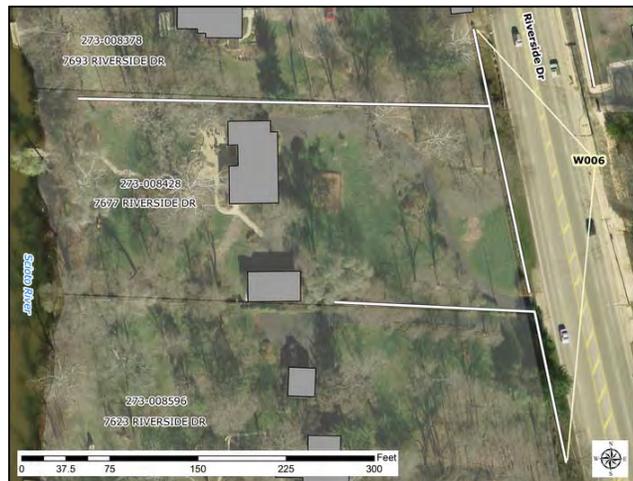
Wall Identifier W006

Condition: Good, Fair, Overgrown

Overview of wall, looking northwest

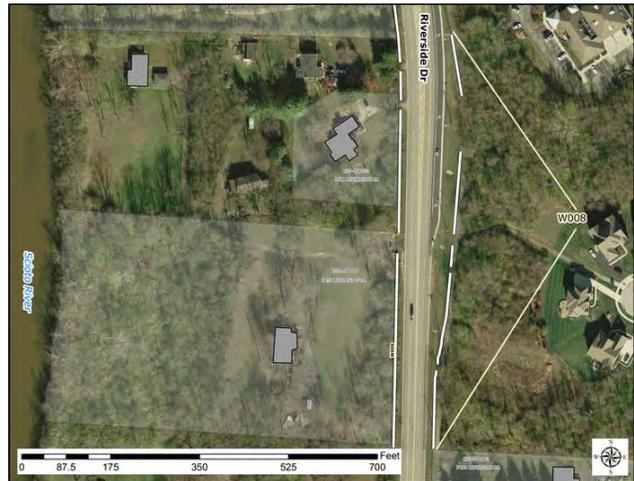
Wall Identifier W008

Condition: Good

Overview of wall, looking south

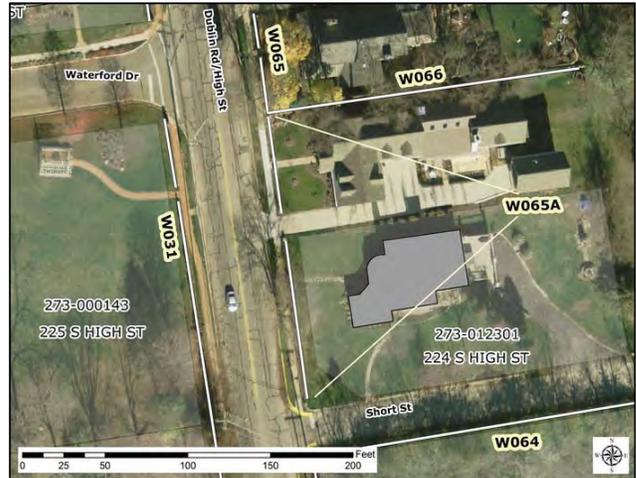
Overview of wall (new section in foreground, old section at far upper right of photo), looking south-southeast

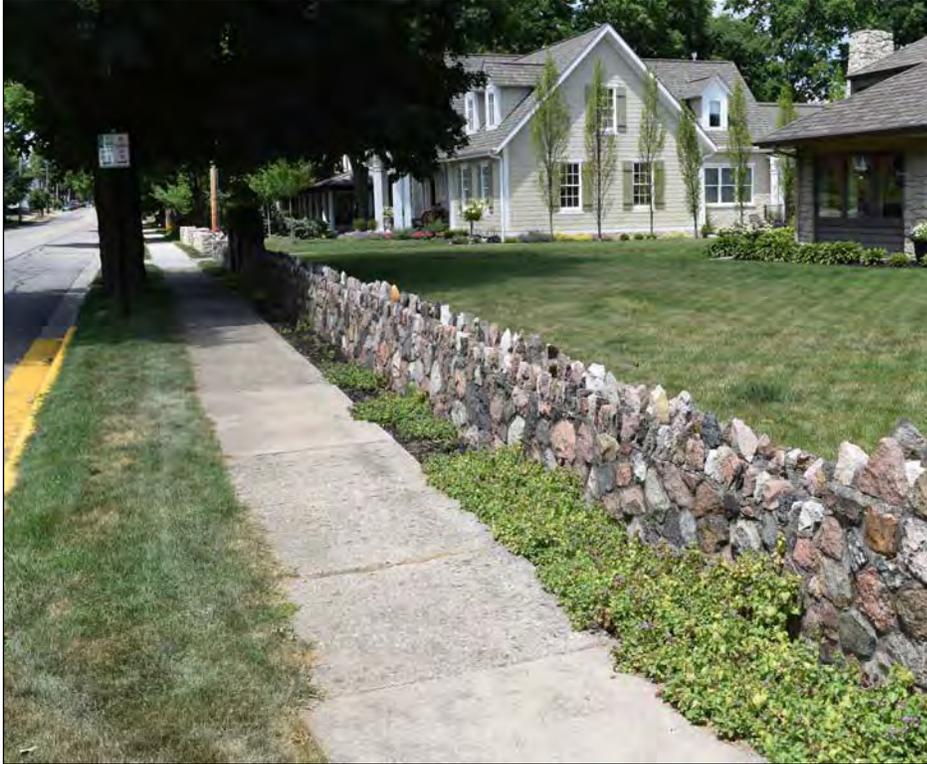
Figure 94. Example of an atypical stone wall (W065A) in front of 824 S. High Street, looking northeast

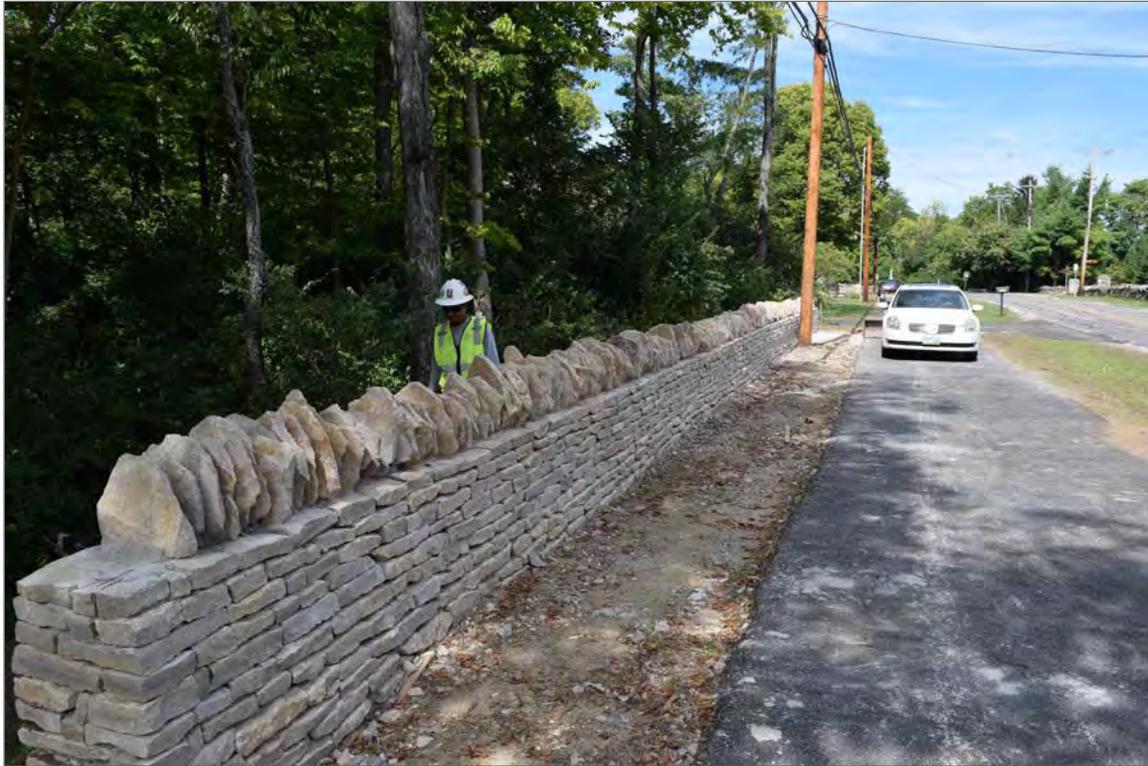
Figure 96. Wall in process of being rebuilt as part of trail project (W034 along west side of Dublin Road south of downtown, looking north). Note top course set in mortar.
