MEMO

Re: 7298 Post Road / 7298 Hyland Croy Road

The City of Dublin Planning Department contacted Preservation Designs LTD in April 2021 to conduct an independent analysis of the historic integrity of the farmstead complex to the supplement the 2016 HCA. A potential green-field development will impact the site, and the following report addresses the historic context, National-Register eligibility, and historic integrity of the farmstead site. These comments are based on the reviewers' understanding of the National Register Criteria for Evaluation as well as their professional experience and judgement regarding historic architecture and preservation projects. However, these comments do not (and cannot) identify every issue that may be of concern to the City of Dublin and the Planning Department. As always, the final determination of these issues lies with the City of Dublin.

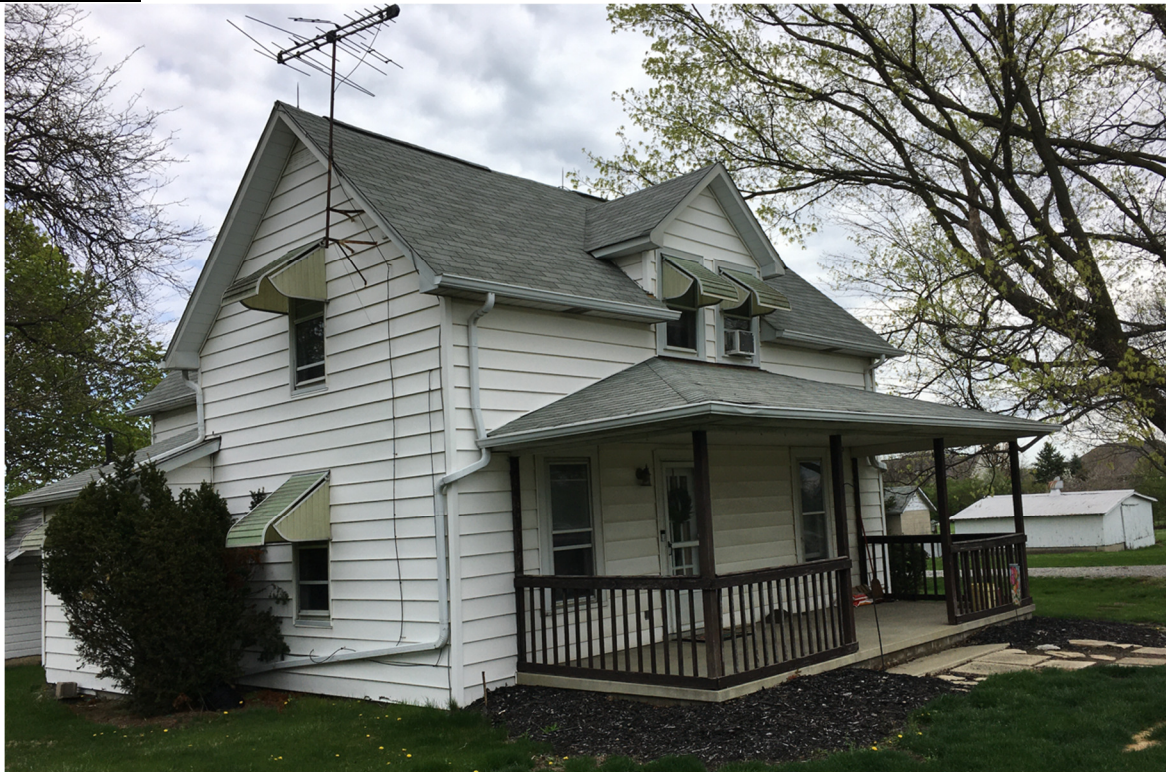
1. Farmhouse at 7298 Post Road, looking northeast.

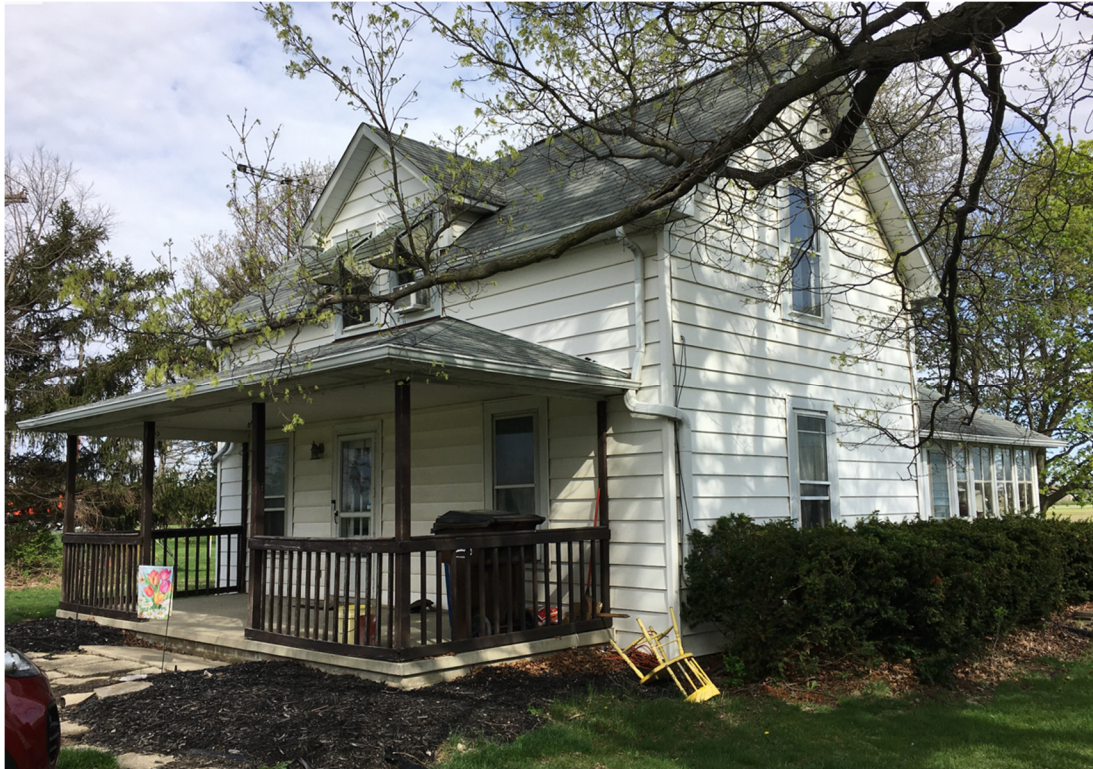
2. Farmhouse at 7298 Post Road, looking northwest.

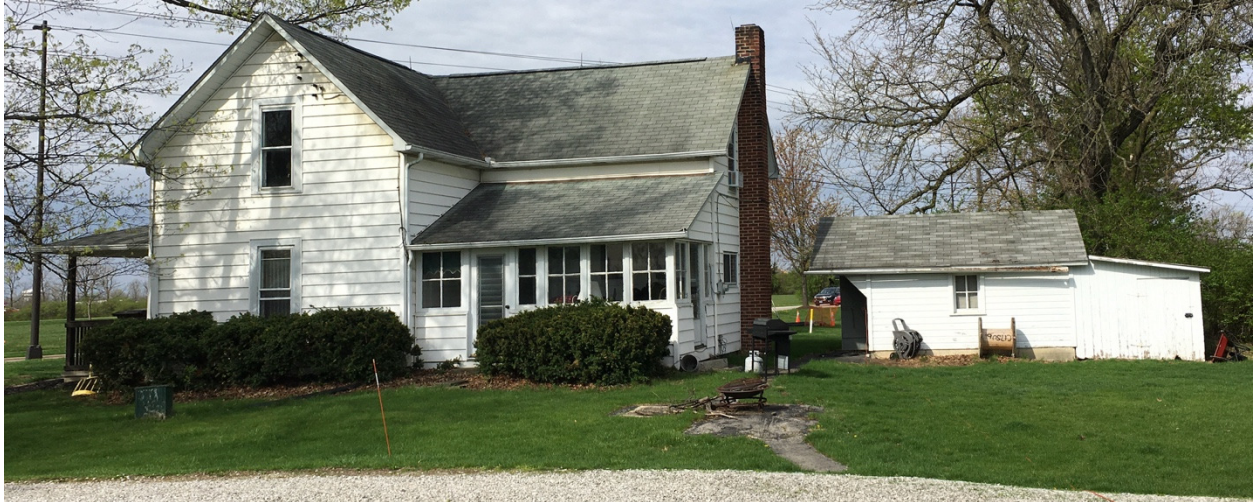
3. Farmhouse and cellar with a lean-to at the rear, looking west by southwest. Note the enclosed rear porch.

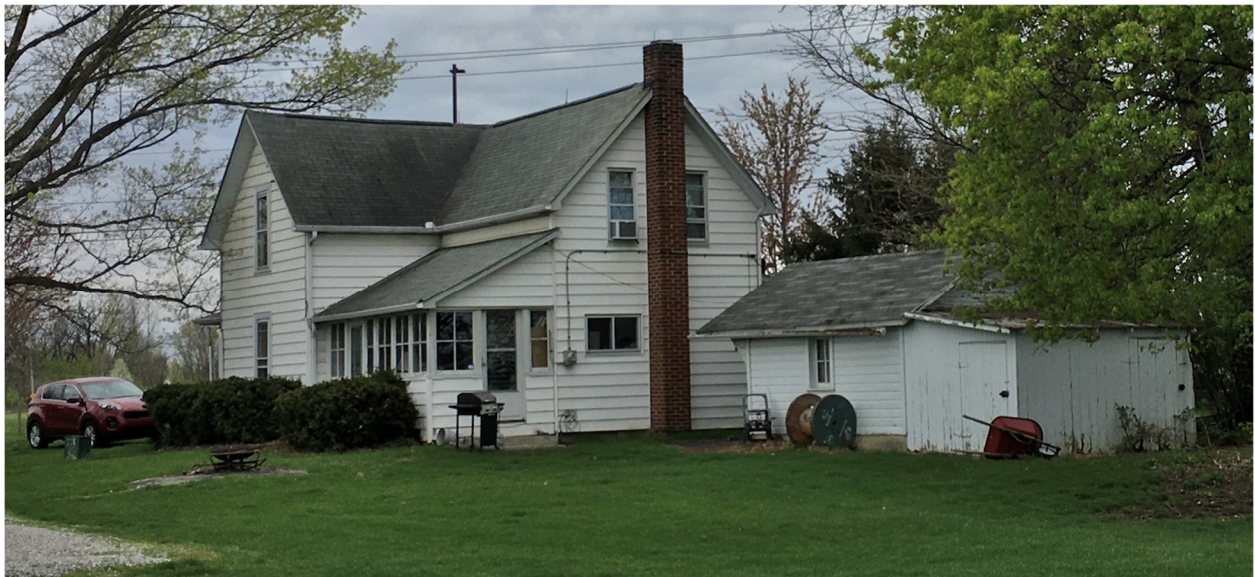
4. Similar to the above, looking south by southwest.

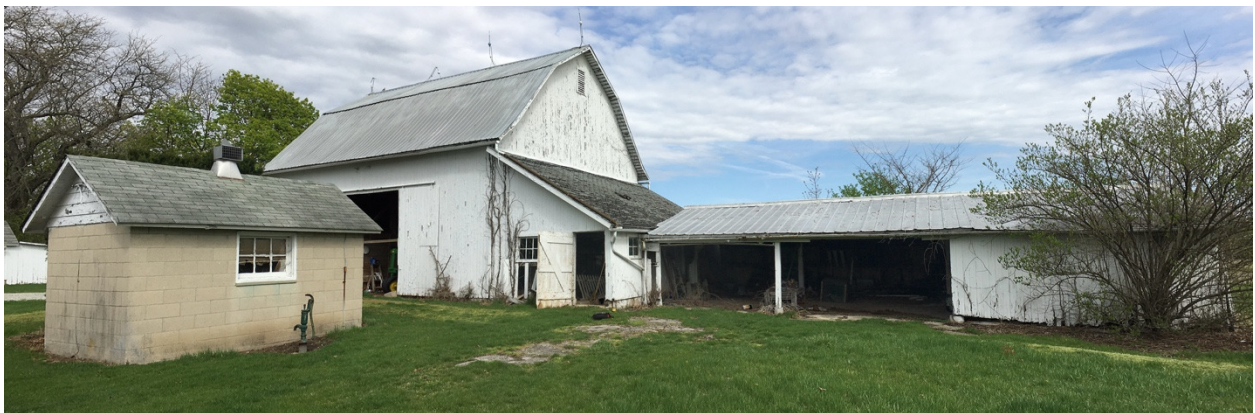
5. From left to right, the milk house, barn, milking parlor, and cow shed. Note the hand pump in front of the milk house.

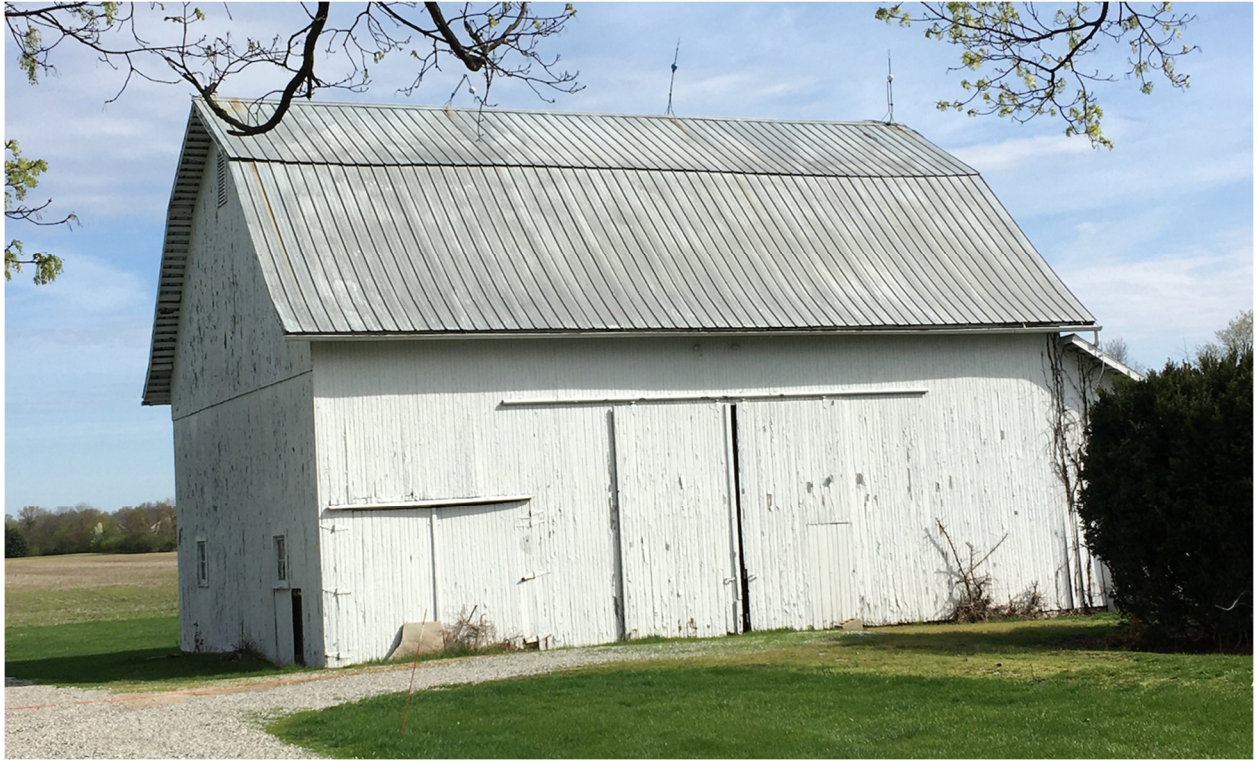
6. View of barn, looking north by northeast.

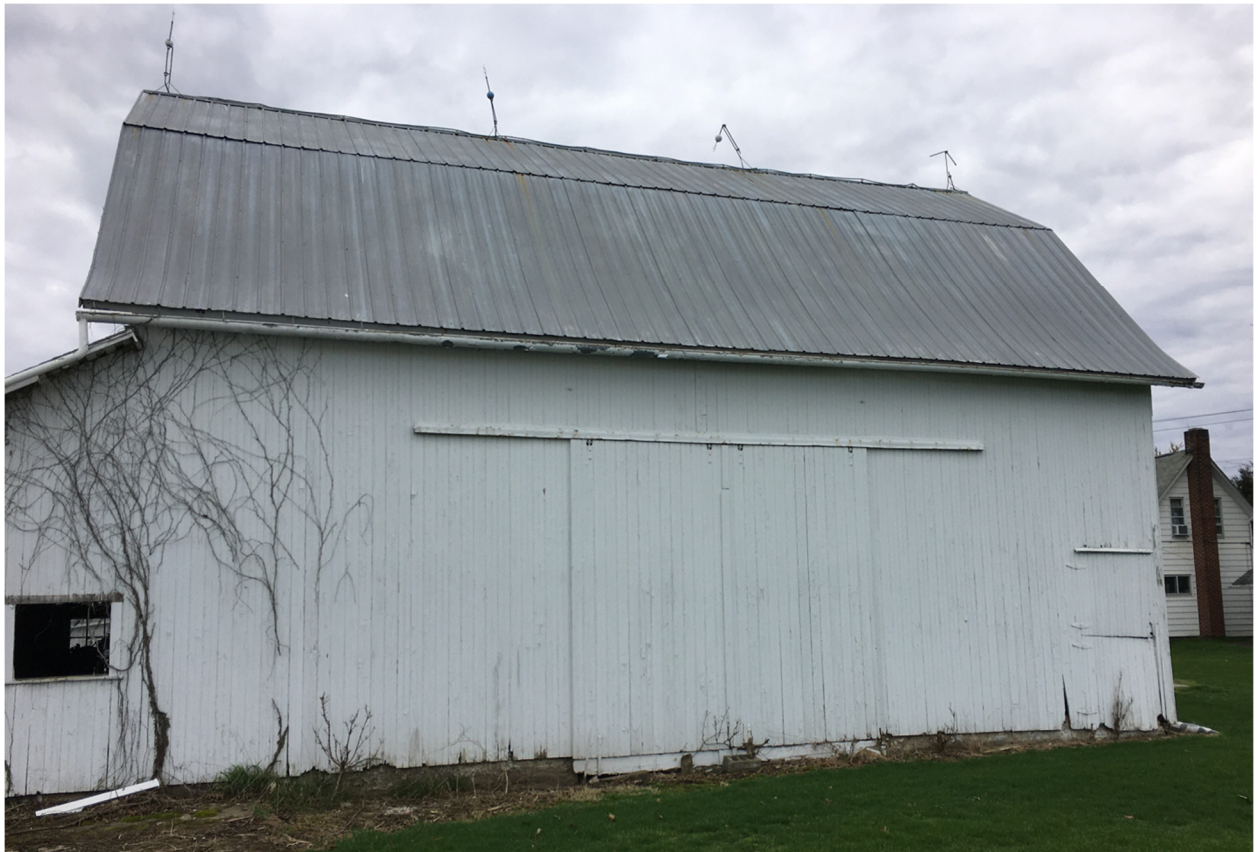
7. View of barn's north elevation.

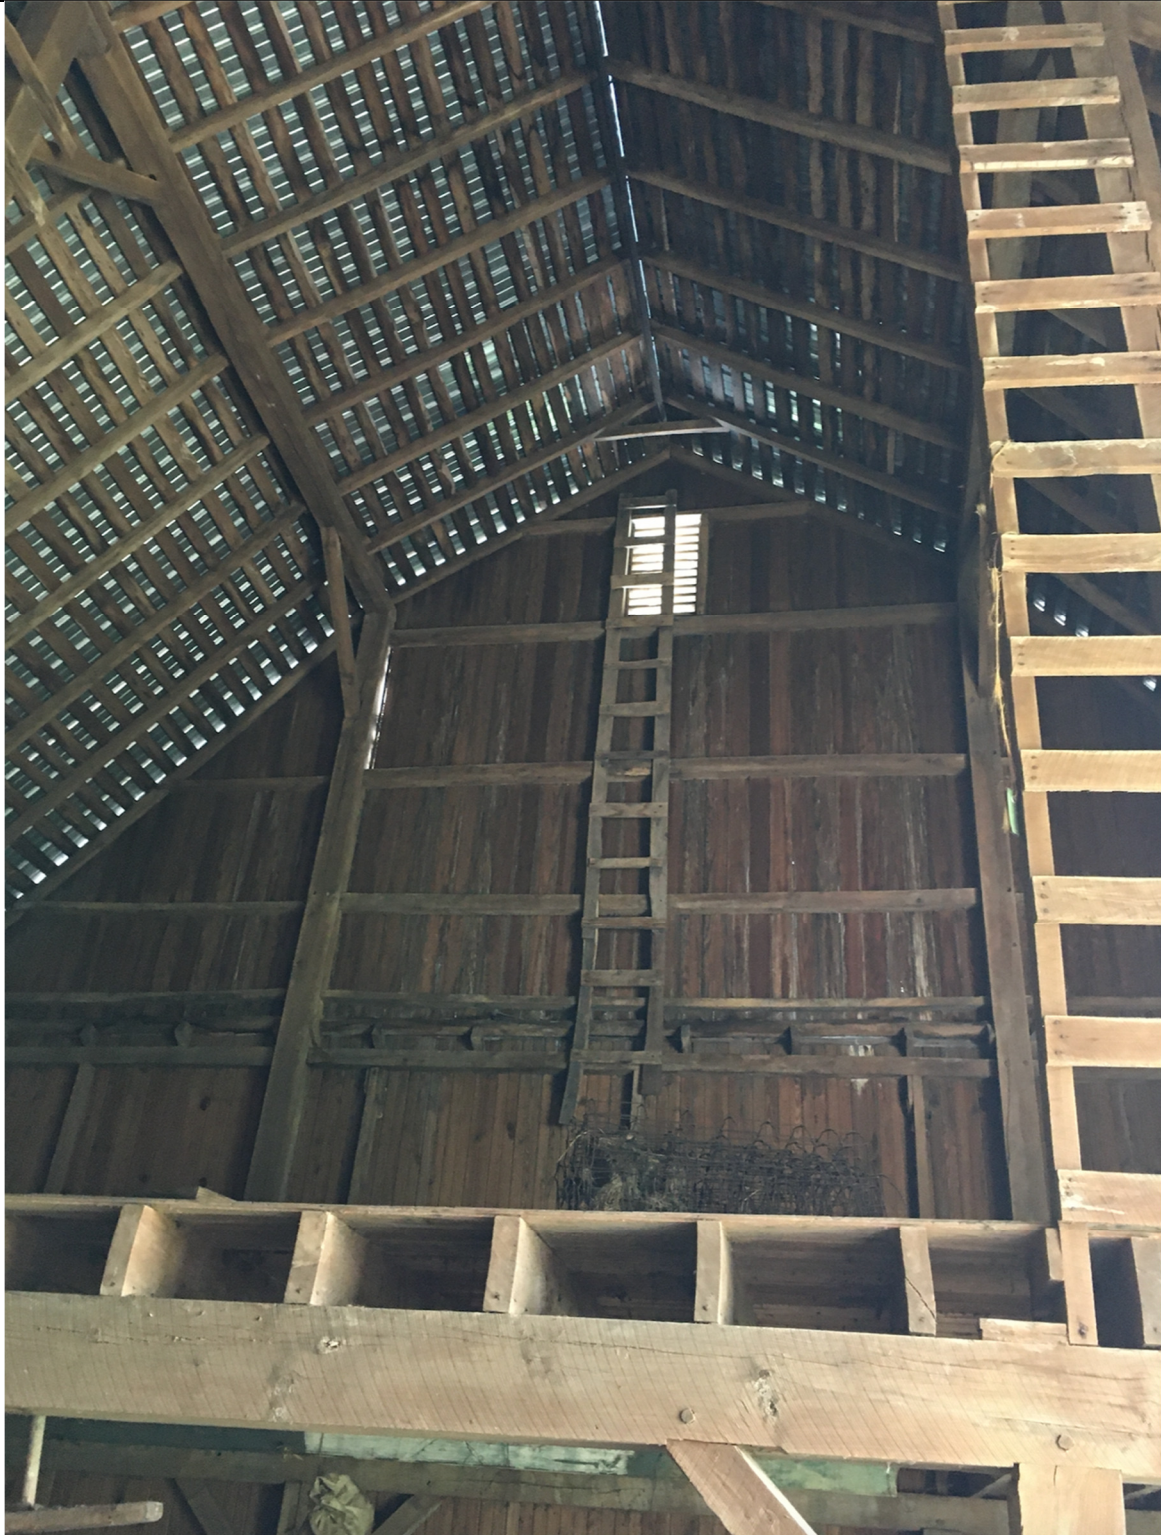
8. Interior view of barn, looking up into the loft. Note the circular marks on the heavy timbers from the saw mill as well as the mortise-and-tenon joints.

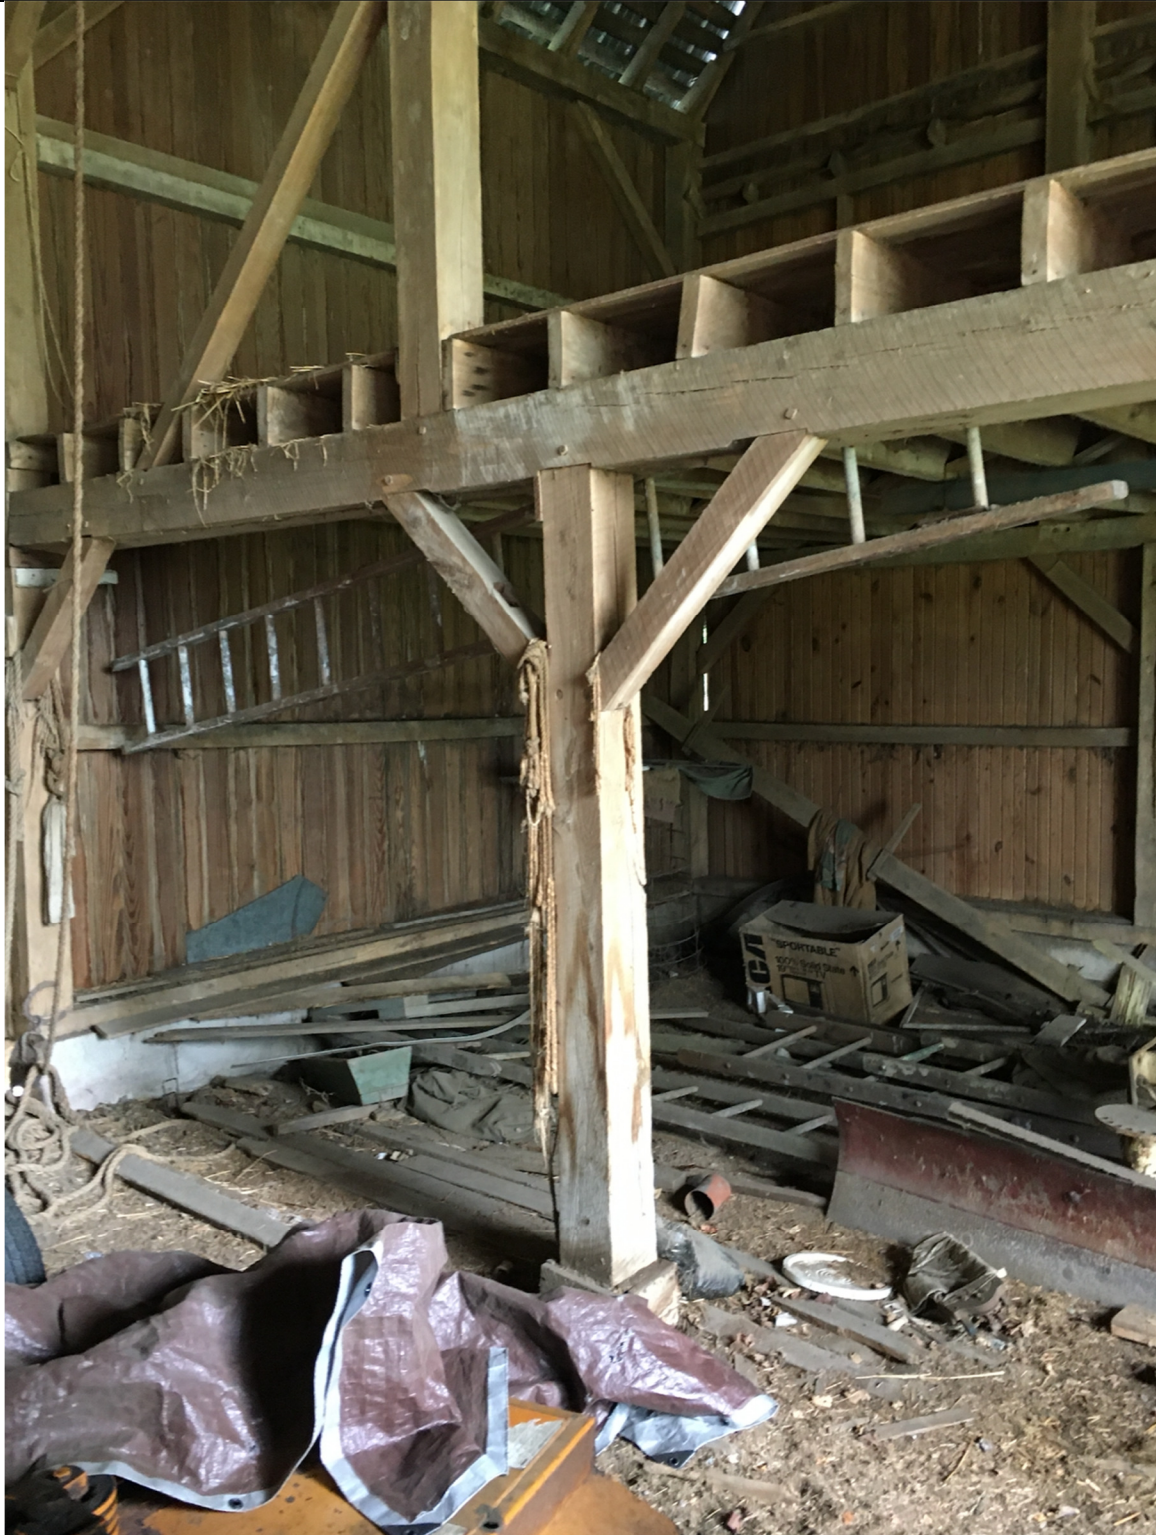
9. Interior view of barn, showing traditional wood joinery of mortise and tenon secured with wooden pegs. Note the circular marks on the heavy timbers from the saw mill.

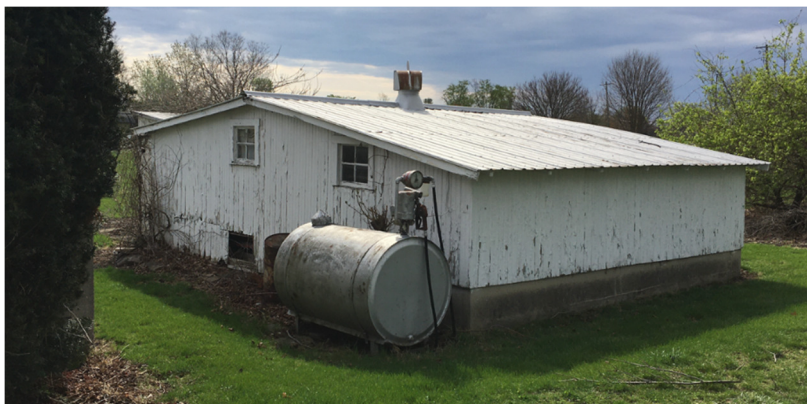
10. Looking southeast at the steer shed. Note the gasoline storage tank for farm equipment.

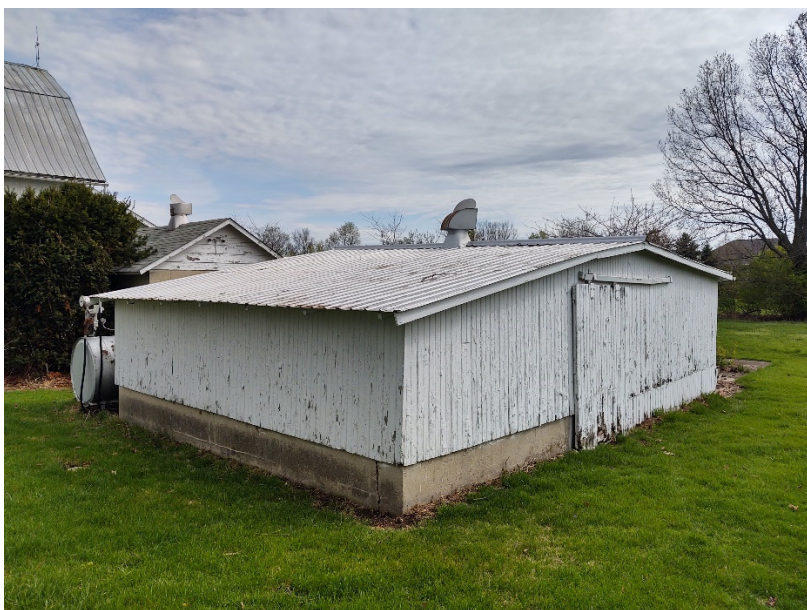
11. Looking northeast at the steer shed with the barn and milk house behind.

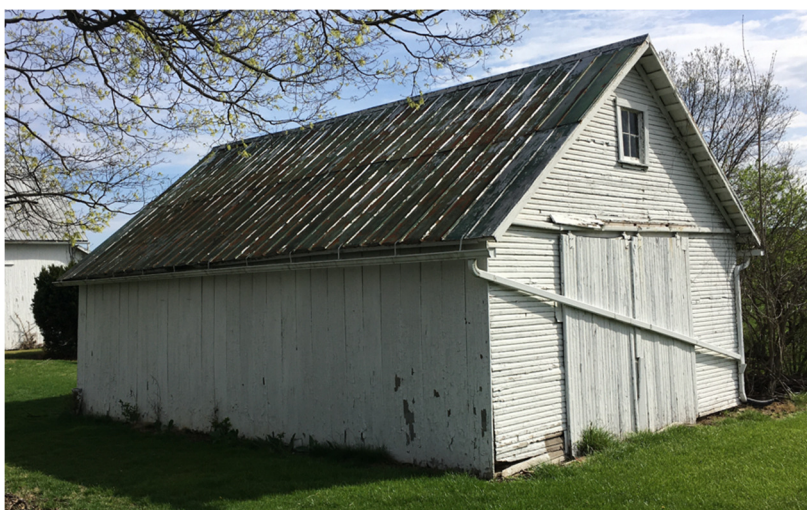
12. Looking north by northeast at the granary.
