110-112 S Riverview Photos

April 13, 2021

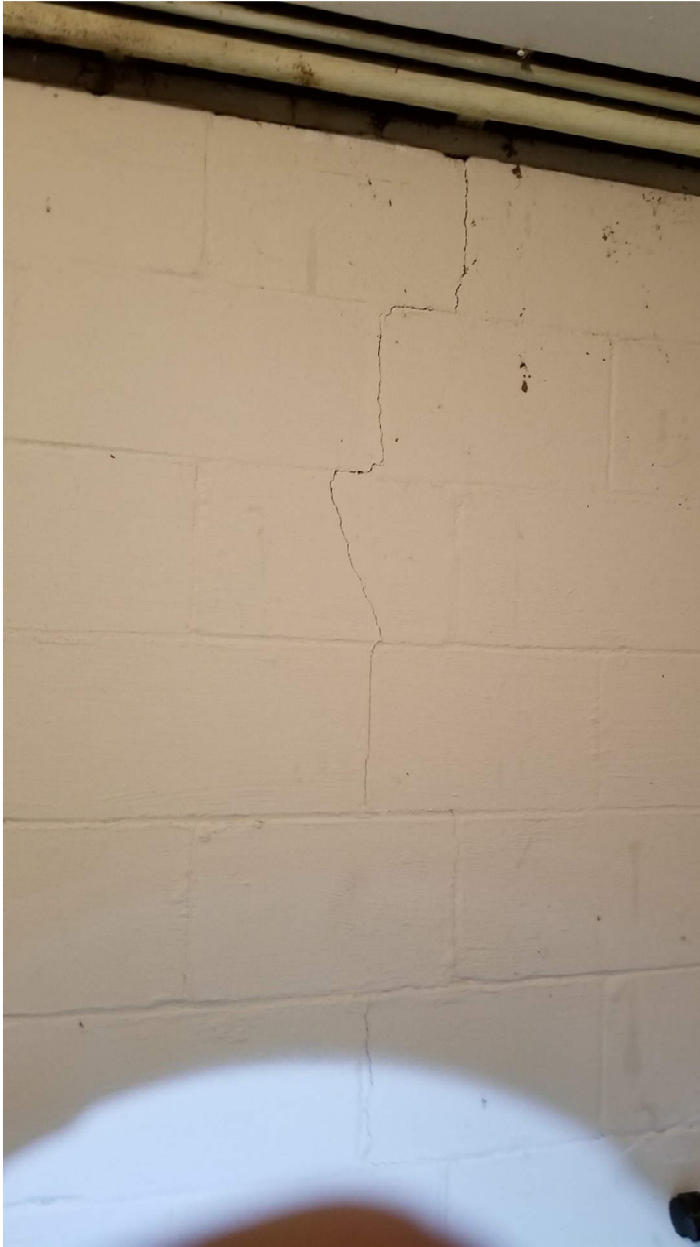
Figure 1

Interior foundation crack at front of house

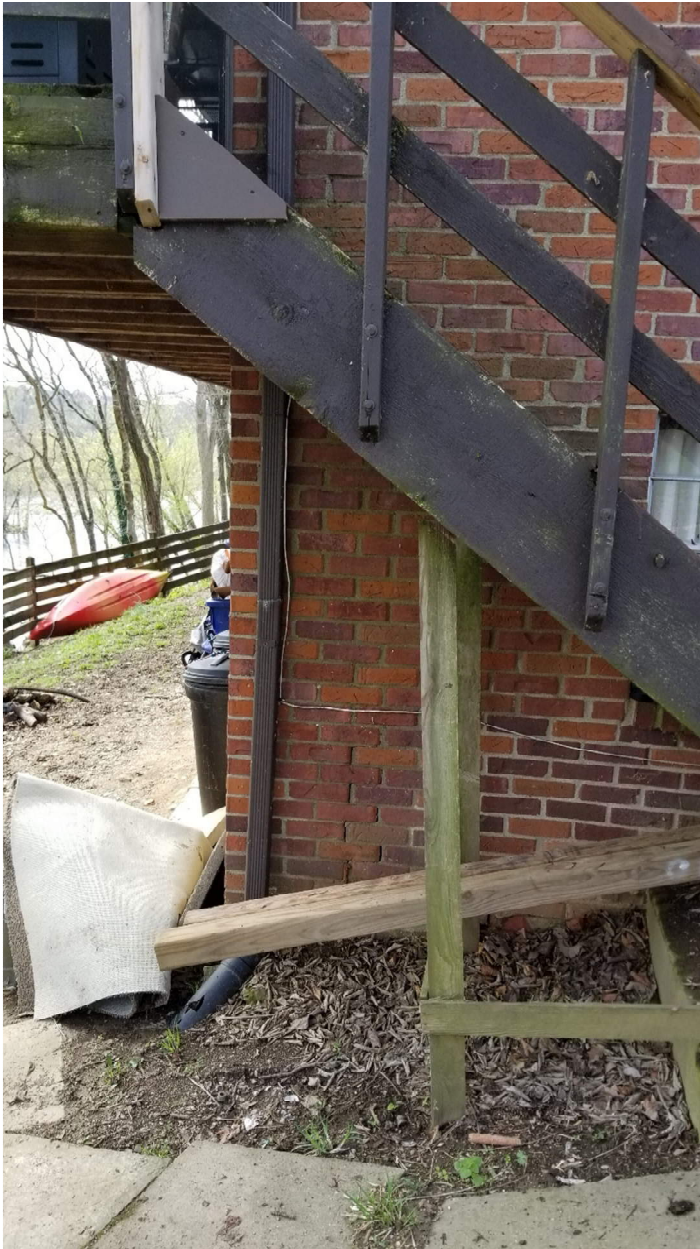
Figure 2

Crack at north wall at rear of house. Deteriorated and unsafe decking and railing.

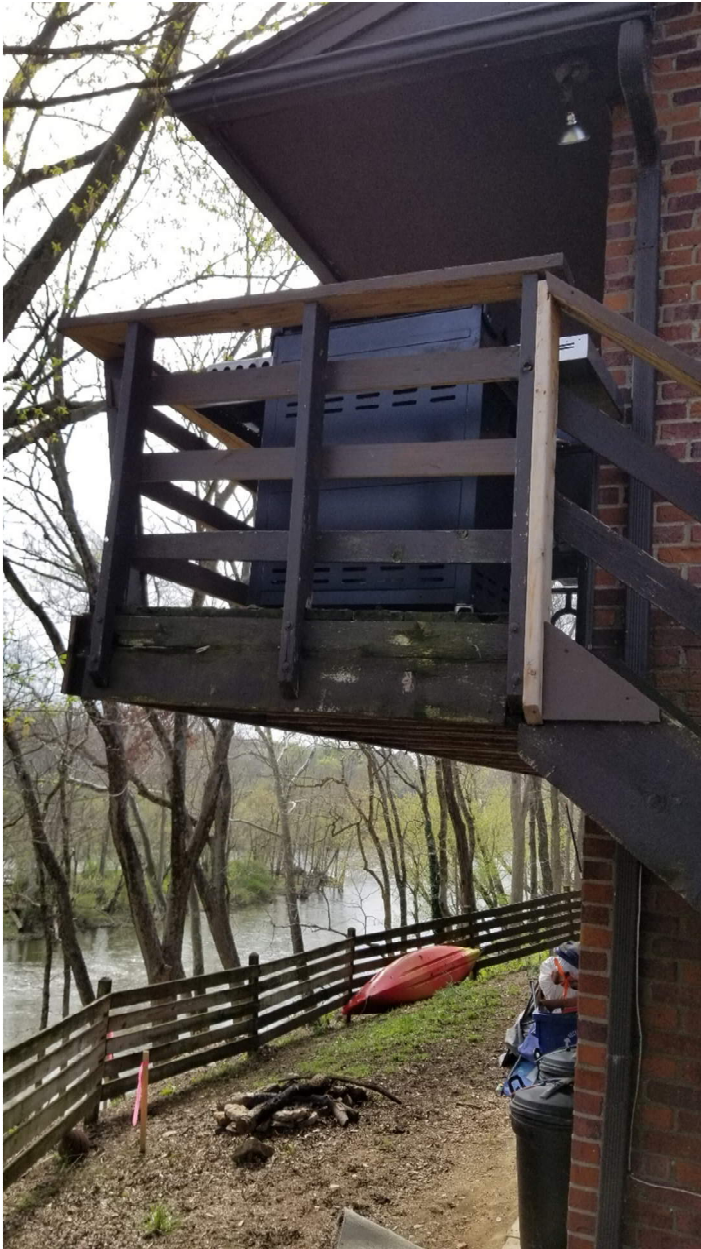
Figure 3

Deteriorated and unsafe decking and railing.

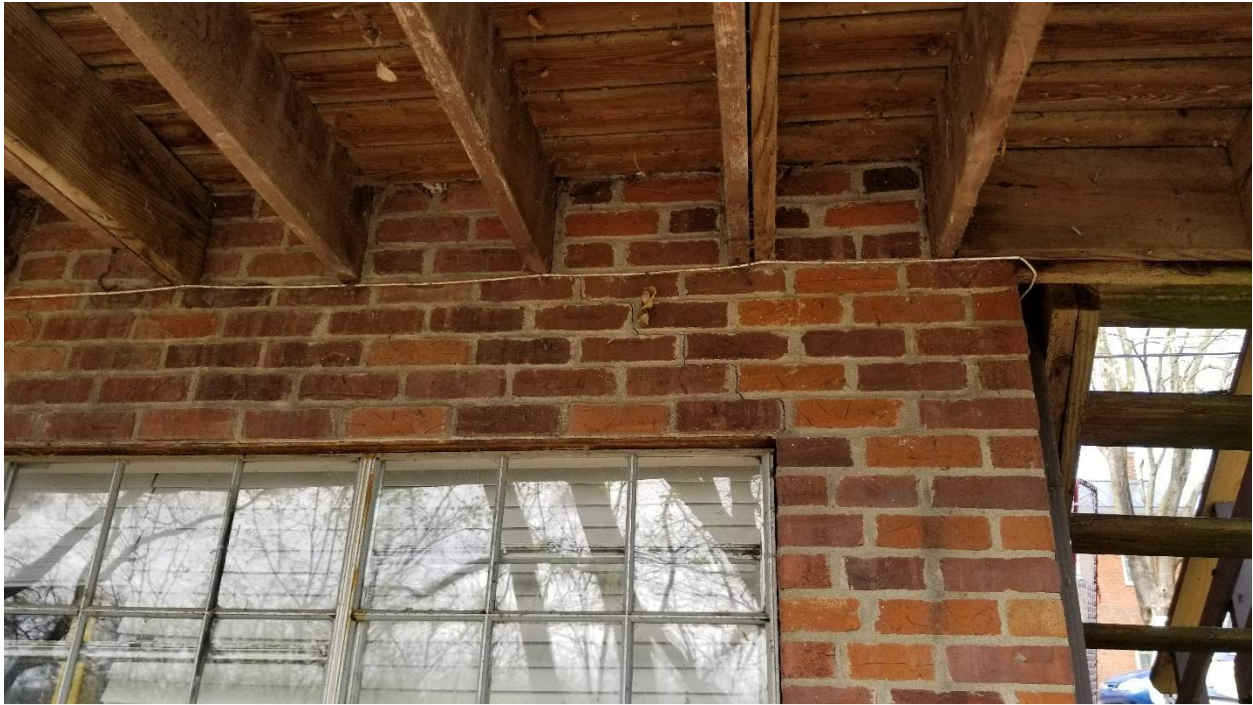
Figure 4

Decking penetrating brick veneer. Crack in masonry and sagging lintel.

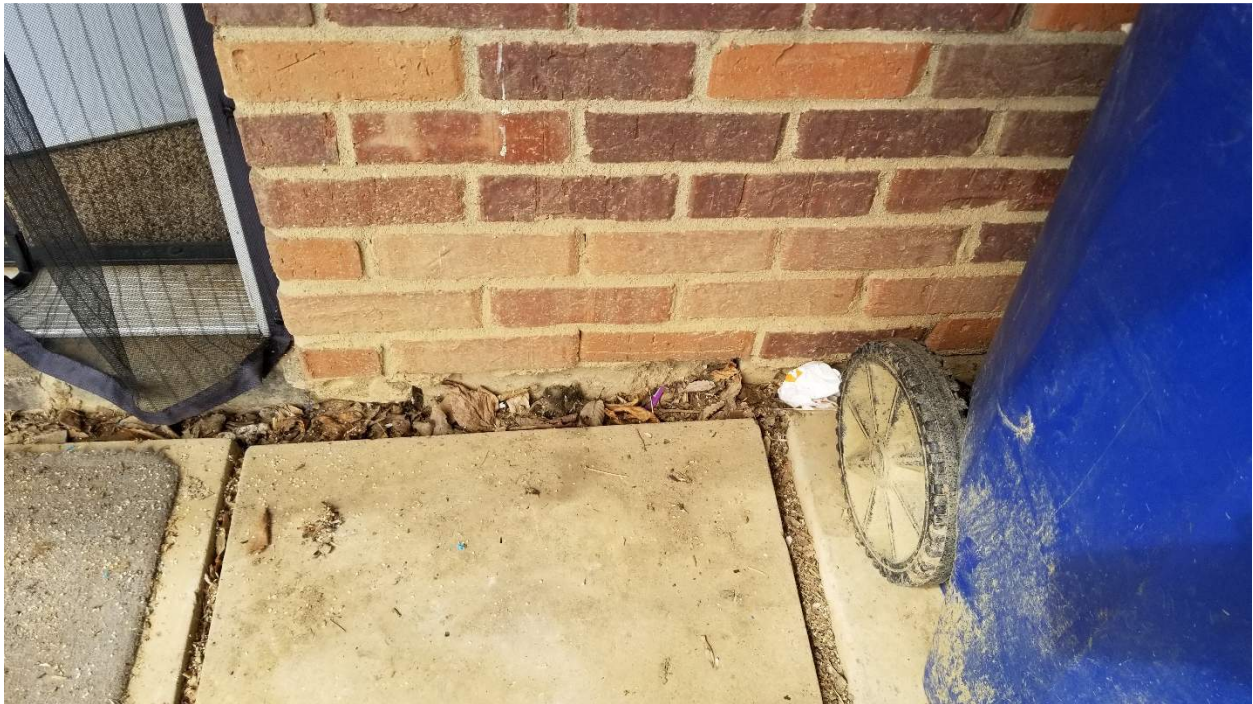
Figure 5

Deterioration of CMU foundation below brick.

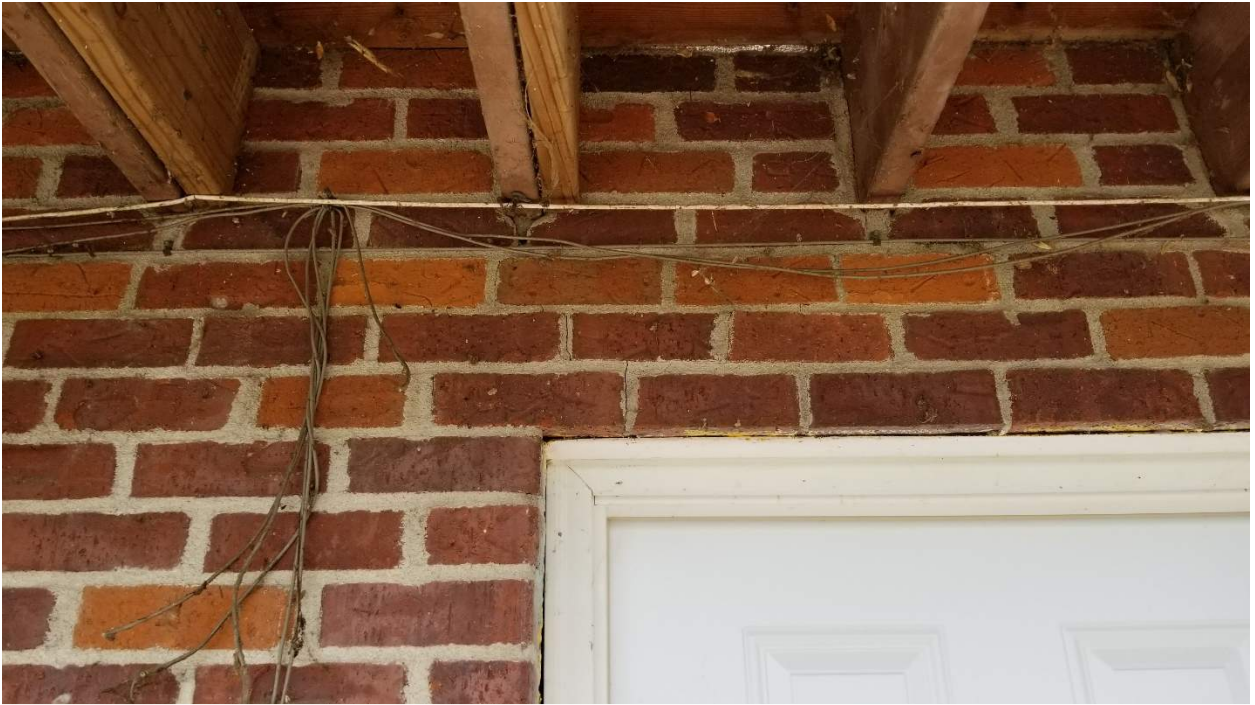
Figure 6

Decking penetrating brick veneer. Crack in masonry at lintel.

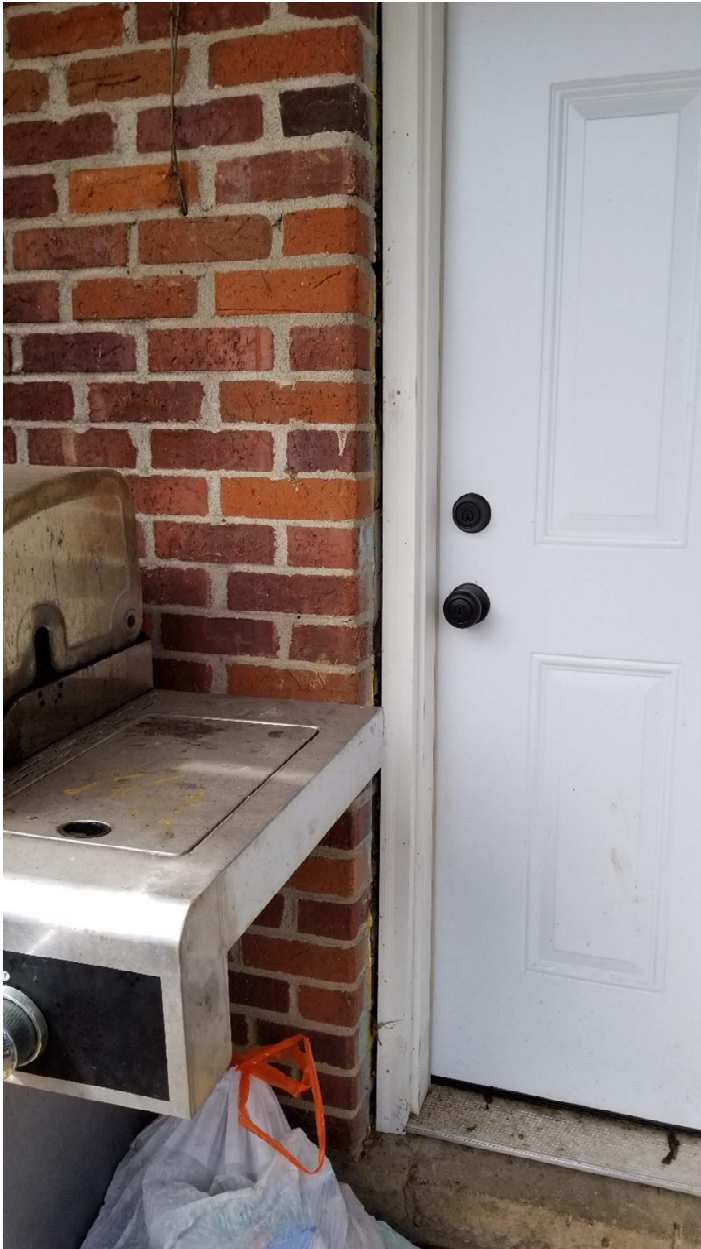
Figure 7

Gap between door and brick.

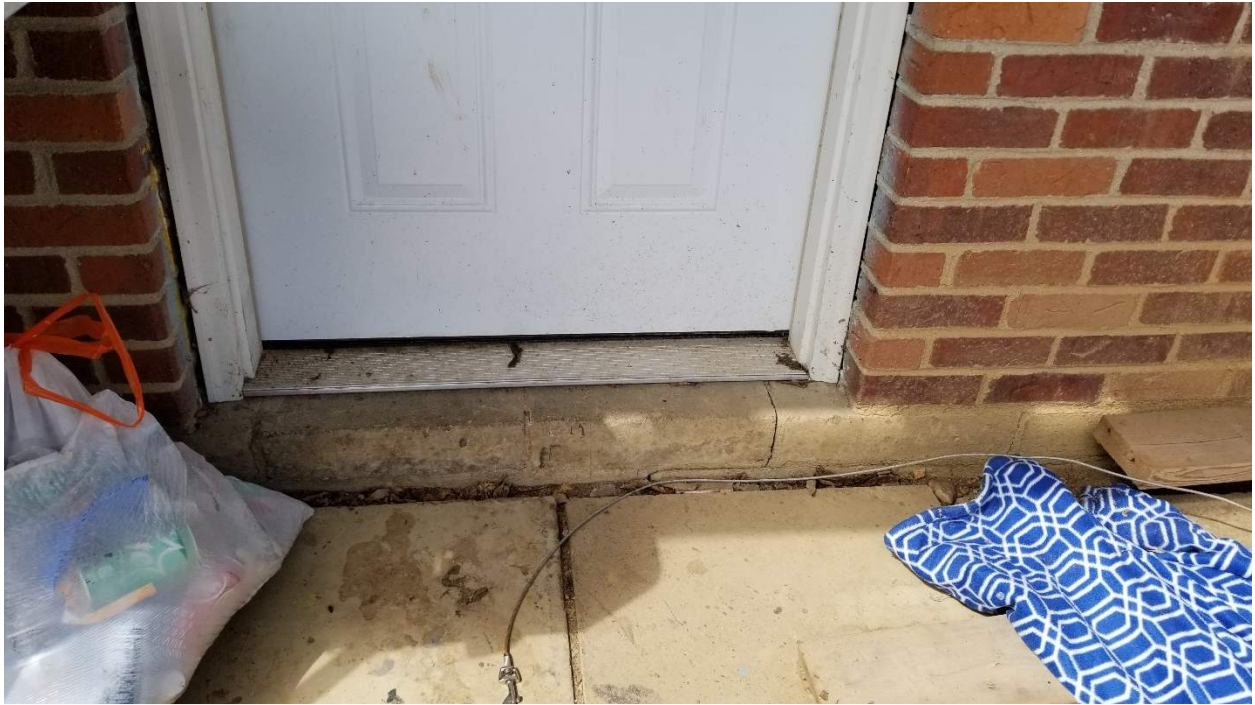
Figure 8

Crack in foundation.

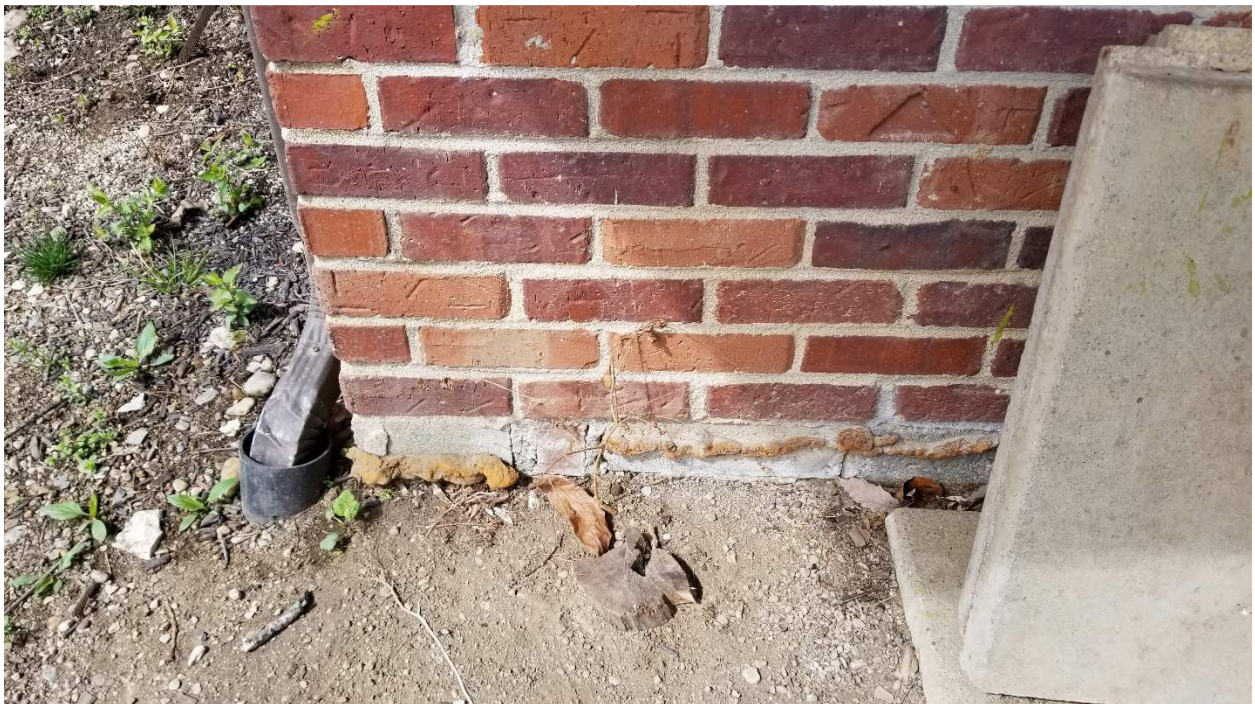
Figure 9

Crack in foundation and deterioration of CMU

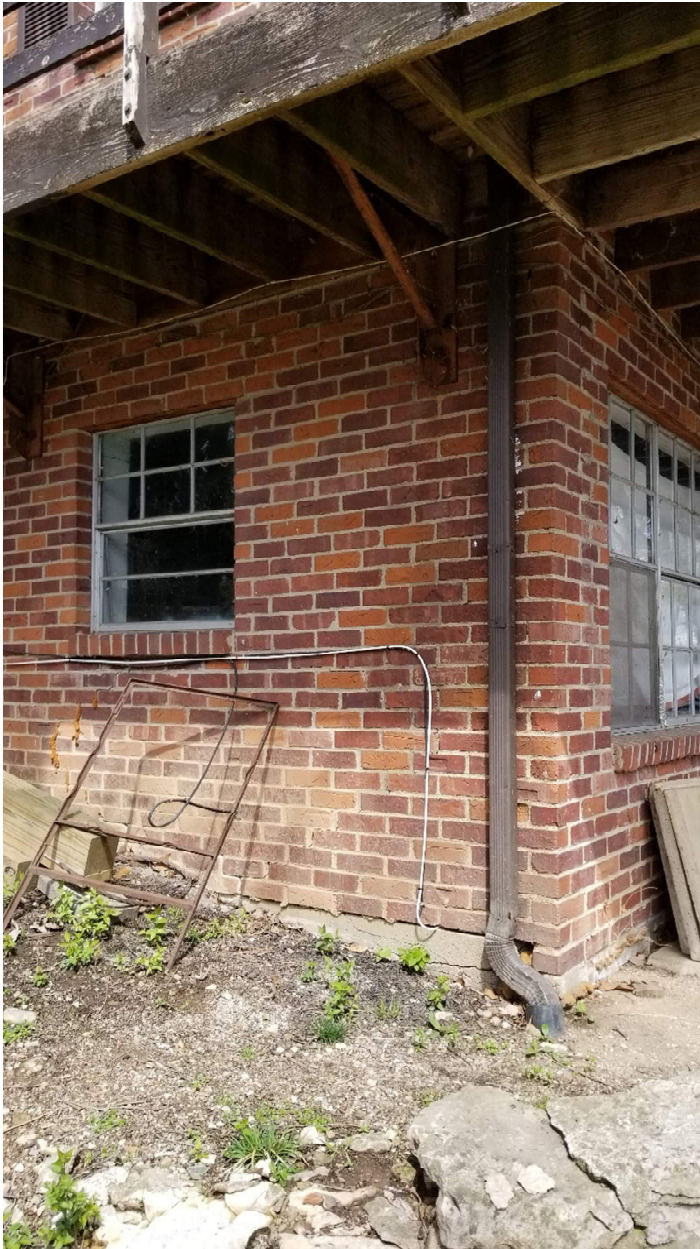
Figure 10

Cracks in foundation and brick at south rear corner.

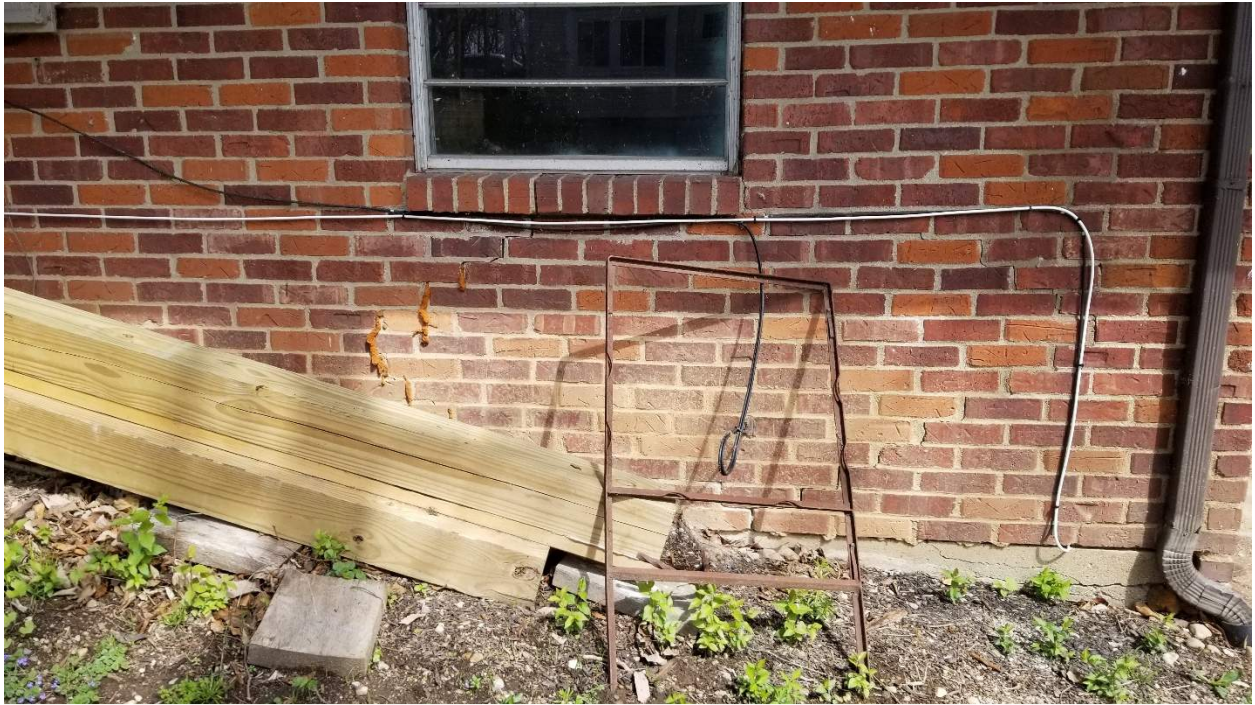
Figure 11

Cracks in foundation and brick at south rear corner.

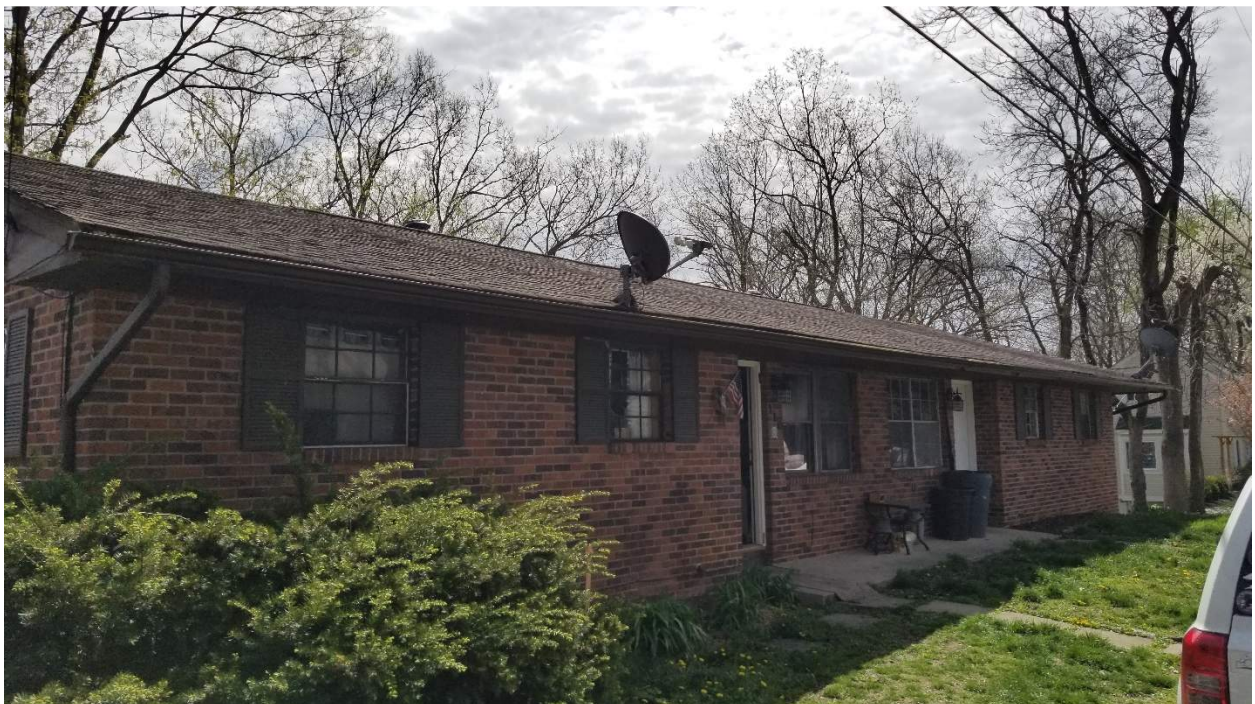
Figure 12

Unevenness in roof lines

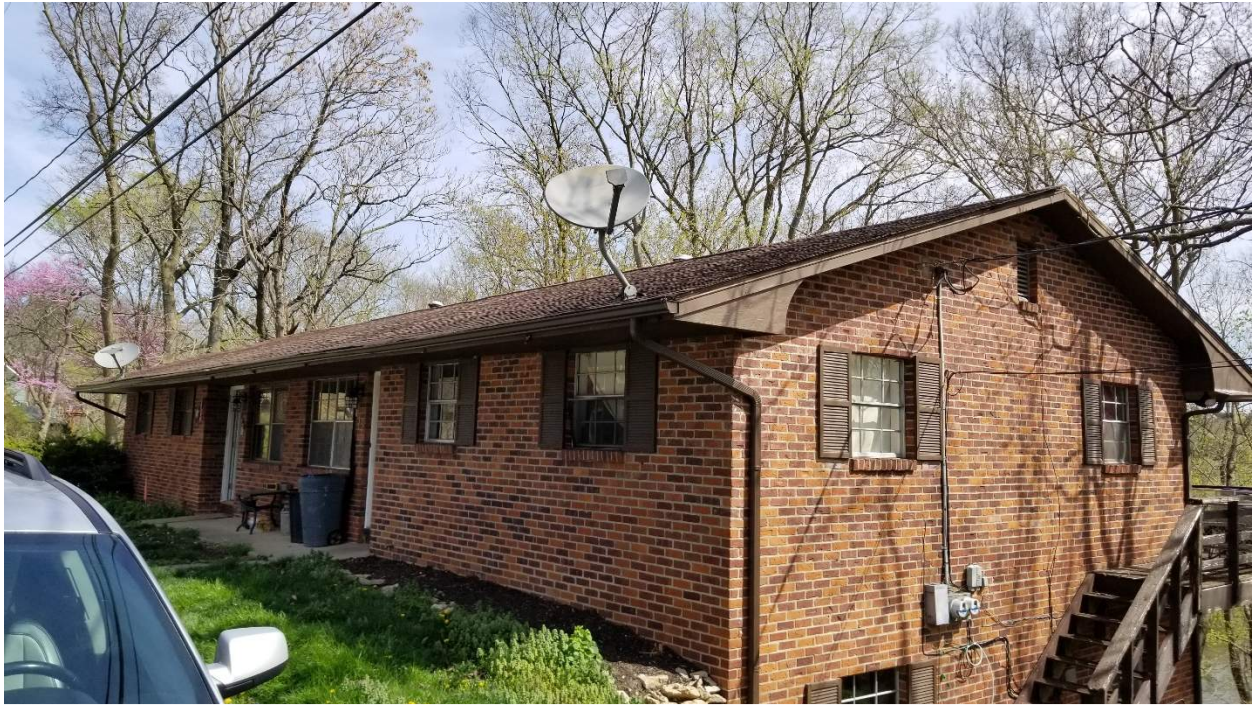
Figure 13

Unevenness in roof lines
