Memo

Re: Community Development Committee Recommendations - Maintenance of Historically Significant Stone Walls

Stone Wall Inventory

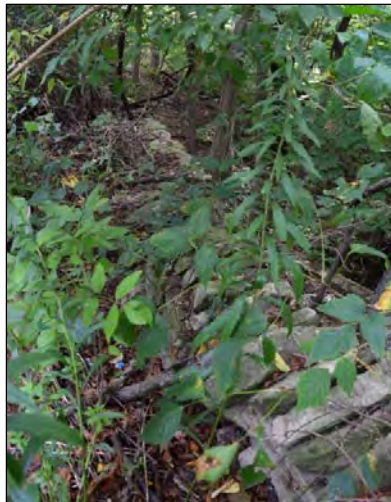
Today, this wall is located on the west side of Riverside Drive and runs parallel to Riverside Drive from 250 ft north of Tonti Drive and extends to the driveway of 7781 Riverside Drive. The wall is broken by the driveway of 7775 Riverside Drive and a drainage ditch.

Condition: Fair, Ruinous, Overgrown

Overview of wall, looking south

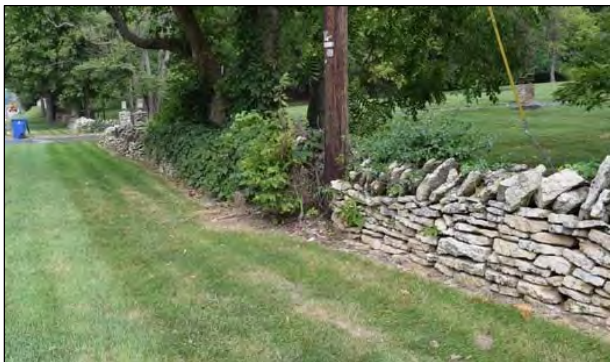
Condition: Good, Fair, Deteriorated/Poor, Ruinous, Overgrown**Integrity Notes:** Wall has fair integrity. The location and design are similar to the older stone walls, but the wall may have been repaired with non-original materials.**Historical Significance:** This wall may have originally dated to the pre-1900 period, but appears to have been repaired or rebuilt in the 1900s. This wall appears to have historical significance as part of Dublin's agricultural past and as part of Dublin's 20th century suburban growth.**District:** No**Distinctive Feature:** Yes**National Register:** Washington Township MRA**Associated OHI:** N/A

Overview of wall, looking north-northeast

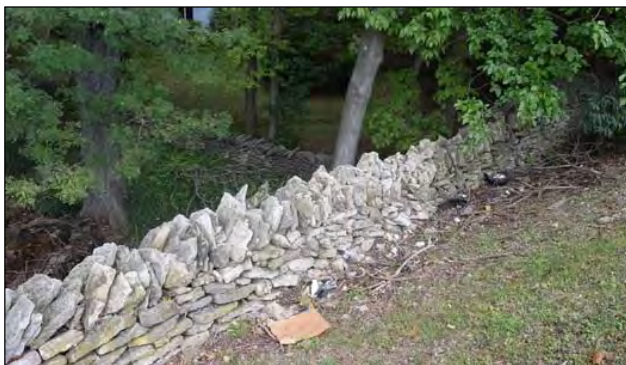
Condition: Good, Repaired**Integrity Notes:** Wall has/fair to poor integrity. Portions of the wall appear to have been moved back from the road and repaired with concrete.**Historical Significance:** Portions of this wall likely date to the pre-1900 period while others probably date to the period between 1900 and 1970. Thus, the wall has historical significance as part of Dublin's agricultural past and significance as part of Dublin's 20th century suburban growth.**District:** No**Distinctive Feature:** Yes**National Register:** Washington Township MRA**Associated OHI:** FRA-8853-2; FRA-8851-2

Overview of wall, looking north-northwest

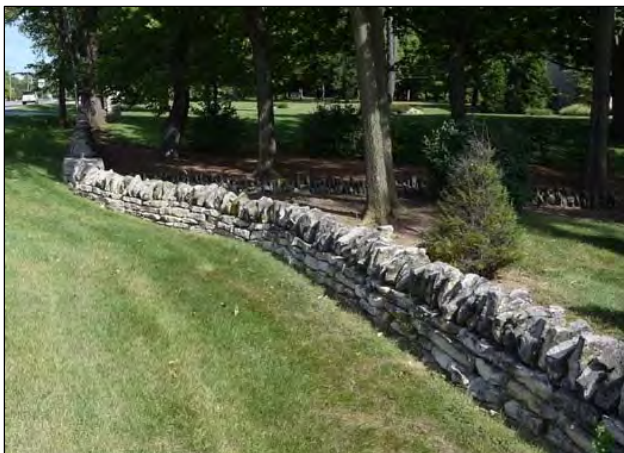
Condition: Good, Repaired**Integrity Notes:** Wall has fair integrity because it retains integrity of location and design but has been repaired with non-original materials.**Historical Significance:** This wall most likely dates to the pre-1900 period based on location, workmanship, design, and condition, and, as such, has historical significance as part of Dublin's agricultural past.**District:** N N/A**Distinctive Feature:** Yes**National Register:** Washington Township MRA**Associated OHI:** FRA-8791-1, FRA-8792

Overview of wall, looking north

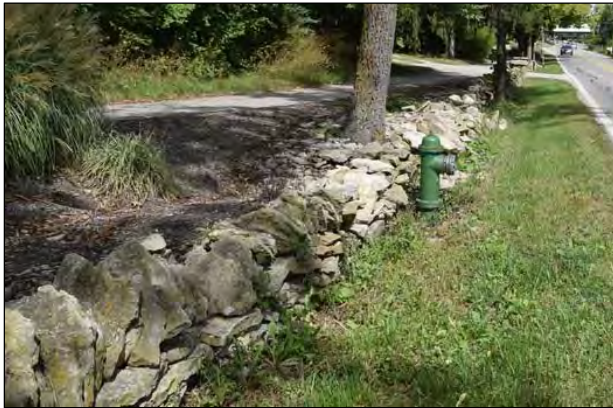
Condition: Good, Fair, Deteriorated/Poor, Ruinous**Integrity Notes:** The wall has poor integrity because some sections are deteriorated while others are in a ruinous state. The section near the hydrant may be a reconstruction to accommodate the utility installation.**Historical Significance:** This wall most likely dates to the pre-1900 period based on smaller stone size, location, and poor condition, and, as such, has historical significance as part of Dublin's agricultural past.**District:** No
National Register: Washington Township MRA**Distinctive Feature:** Yes
Associated OHI: N/A

Overview of wall, looking north

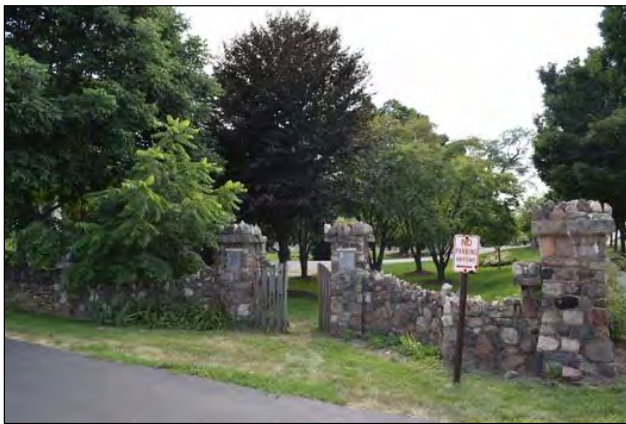
Condition: Good, Repaired**Integrity Notes:** Wall has fair integrity because it retains integrity of location and design, but appears to have been added to and repaired in the 1900s.**Historical Significance:** This wall dates to both the pre-1900 and post-1900 periods and as such has historical significance as part of Dublin's early settlement and later growth.**District:** Yes Contributes to Dublin High Street Historic District, Boundary Increase**Distinctive Feature:** Yes**National Register:** Washington Township MRA**Associated OHI:** N/A

Overview of wall, looking southwest

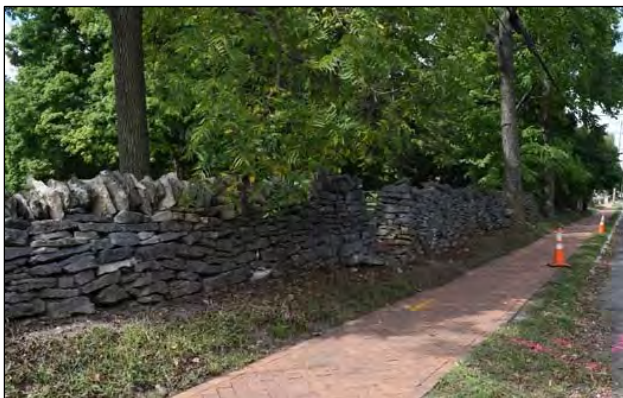
Condition: Good, Fair, Repaired/Rebuilt**Integrity Notes:** Wall has fair to poor integrity. The wall appears to be in the original location and constructed with traditional techniques and materials, but some sections have been recently rebuilt and repaired.**Historical Significance:** This wall dates to the pre-1900 period based on smaller stone size and location, and as such, has historical significance as part of Dublin's agricultural past. However, portions of the wall have also been recently rebuilt in the traditional style with non-original materials.**District:** Y Older portions Contributing to Dublin
High Street Historic District, Boundary
Increase**Distinctive Feature:** Yes**National Register:** Washington Township MRA**Associated OHI:** FRA-2536-1, FRA-2537-1

Overview of wall, looking North

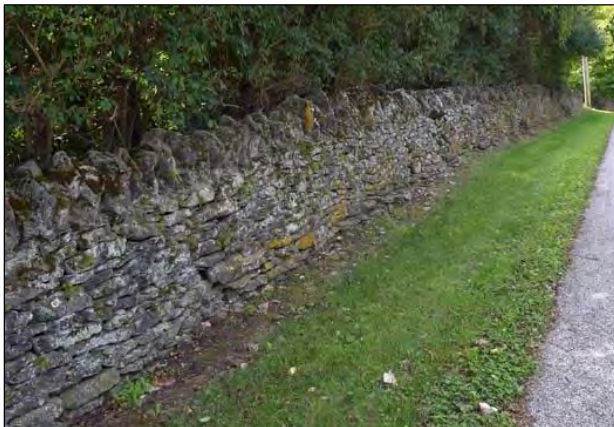
Condition: Good, Fair, Repaired, Overgrown**Integrity Notes:** Wall has fair integrity. The location and design appear original but some repairs and additions have been made using non-traditional materials and techniques.**Historical Significance:** This wall likely dates to both the pre-1900 period, based on smaller stone size, location, and condition, and the twentieth century, based on additions such as mortared pillars that are associated with a 1950s home. The wall appears to have historical significance as part of Dublin's agricultural past and as part of Dublin's 20th century suburban growth.**District:** Y Portions contributing to Dublin High Street Historic District, Boundary Increase**Distinctive Feature:** Yes**National Register:** Washington Township MRA**Associated OHI:** FRA-877-1

Overview of wall, looking west

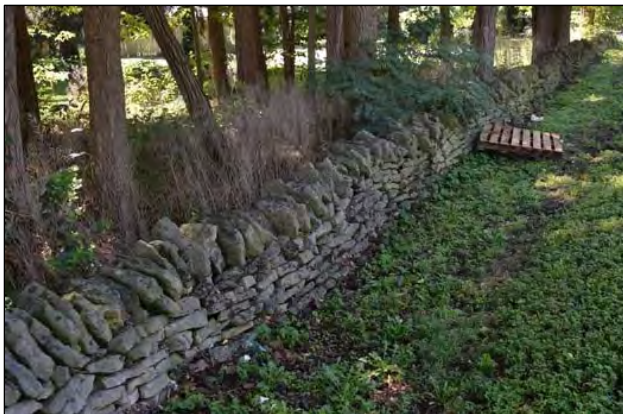
Condition: Good, Fair, Overgrown, Unknown/Private**Integrity Notes:** Wall has fair integrity. The location and design appear original but some repairs and additions have been made using non-traditional materials and techniques.**Historical Significance:** This wall likely dates to both the pre-1900 period, based on smaller stone size, location, and condition, and the twentieth century, based on additions such as mortared pillars that are associated with a 1950s home. The wall appears to have historical significance as part of Dublin's agricultural past and as part of Dublin's 20th century suburban growth.**District:** No**Distinctive Feature:** Yes**National Register:** Washington Township MRA**Associated OHI:** N/A

Overview of wall, looking south

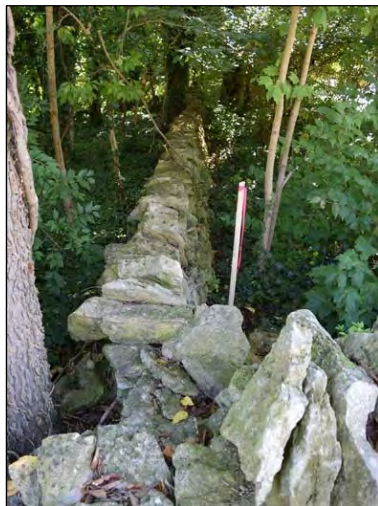
Condition: Good, Repaired, Unknown/Private**Integrity Notes:** Wall has good to fair integrity. The wall has integrity of location and design but some repairs have been made.**Historical Significance:** This wall most likely dates to the pre-1900 period based on smaller stone size, location, condition, and association with an 1847 home, and, as such, has historical significance as part of Dublin's agricultural past.**District:** No**Distinctive Feature:** Yes**National Register:** Washington Township MRA**Associated OHI:** FRA-1642-1

Overview of wall, looking east

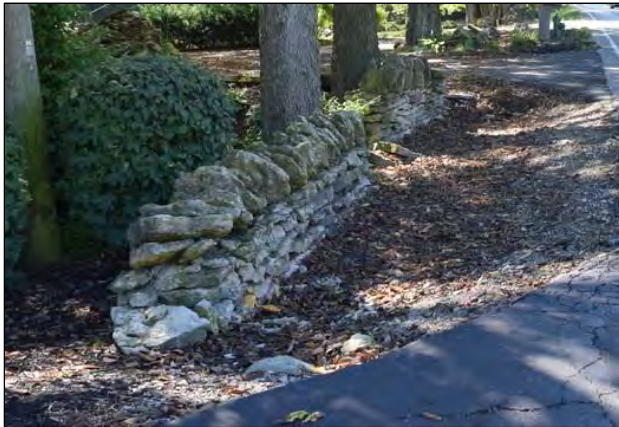
Condition: Good**Integrity Notes:** Wall has good to fair integrity in terms of location, design, and materials.**Historical Significance:** This wall most likely dates to the ca. 1900 and ca. 1970 based on larger stone size, location, condition, and association with a home built ca. 1955, although it may be on the location of an older wall or be rebuilt in the 1950s. If constructed in the period 1900-ca.1970 then the wall has historical significance as part of Dublin's 20th century suburban growth.**District:** No**Distinctive Feature:** Yes**National Register:** Washington Township MRA**Associated OHI:** N/A

Overview of wall, looking south

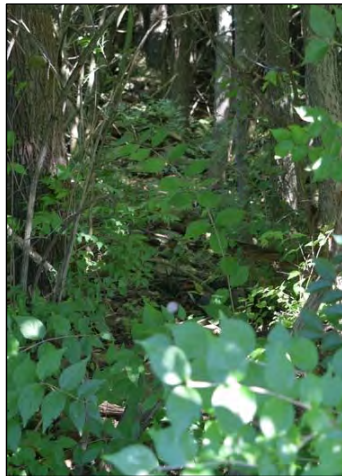
Condition: Ruinous, Overgrown**Integrity Notes:** Wall has poor integrity because of its ruinous condition.**Historical Significance:** This wall most likely dates to the pre-1900 period based on smaller stone size, location, and condition, and, as such, has historical significance as part of Dublin's agricultural past.**District:** No**Distinctive Feature:** Yes**National Register:** Washington Township MRA**Associated OHI:** N/A

Overview of wall, looking north

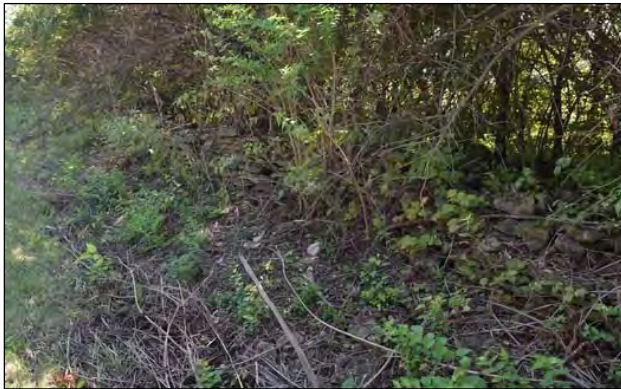
Condition: Ruinous, Overgrown**Integrity Notes:** This wall has poor integrity although the materials, and location appear original the condition is ruinous and the setting has been altered.**Historical Significance:** This wall likely dates to the pre-1900 period based on smaller stone size, location, condition, and association with a ca. 1900 barn, and, as such, has historical significance as part of Dublin's agricultural past.**District:** N/A**Distinctive Feature:** Yes**National Register:** Washington Township MRA**Associated OHI:** FRA-8838-1

Overview of wall, looking east-southeast

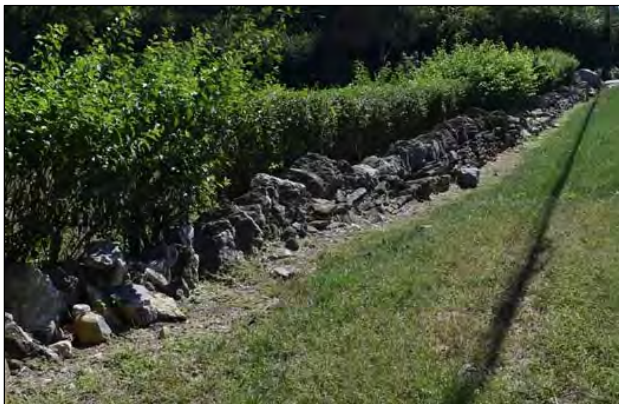
Condition: Good, Ruinous**Integrity Notes:** Wall has fair to poor integrity. The main body of the wall appears to have integrity of location, design, and materials, but the wall is in poor conditions in certain sections and in others appears to have been altered by construction of twentieth-century homes.**Historical Significance:** This main body of this wall likely dates to the pre-1900 period based on smaller stone size, location, and condition, and, as such, has historical significance as part of Dublin's agricultural past. However the wall appears to have been impacted by the construction of homes during the mid-twentieth century and may also has historical significance as part of Dublin's 20th century suburban growth.**District:** No**Distinctive Feature:** Yes**National Register:** Washington Township MRA**Associated OHI:** N/A

Overview of wall, looking south

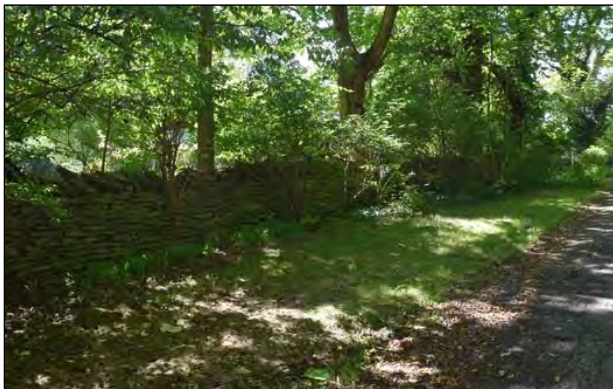
Condition: Good**Integrity Notes:** Wall has good to fair integrity of location, design, materials, and workmanship.**Historical Significance:** This wall most likely dates to the pre-1900 period based on smaller stone size, location, and condition, and as such, has historical significance as part of Dublin's agricultural past.**District:** N/A**Distinctive Feature:** Yes**National Register:** Washington Township MRA**Associated OHI:** N/A

Overview of wall, looking west

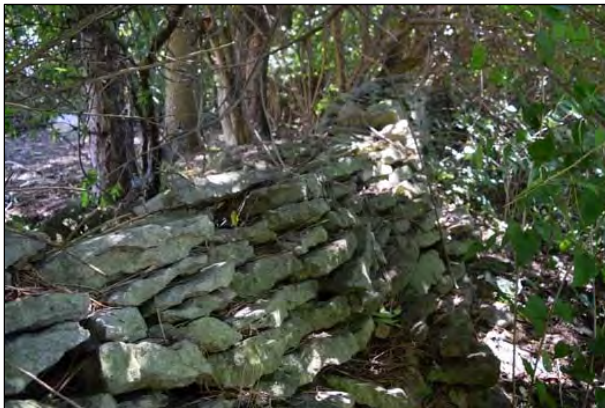
Condition: Deteriorated/Poor, Ruinous, Overgrown**Integrity Notes:** Wall has poor integrity as a result of its condition.**Historical Significance:** This wall most likely dates to the pre-1900 period based on smaller stone size, location, condition, and missing top course of vertical stones, and, as such, has historical significance as part of Dublin's agricultural past**District:** N/A**Distinctive Feature:** Yes**National Register:** Washington Township MRA**Associated OHI:** N/A

Overview of wall, looking south

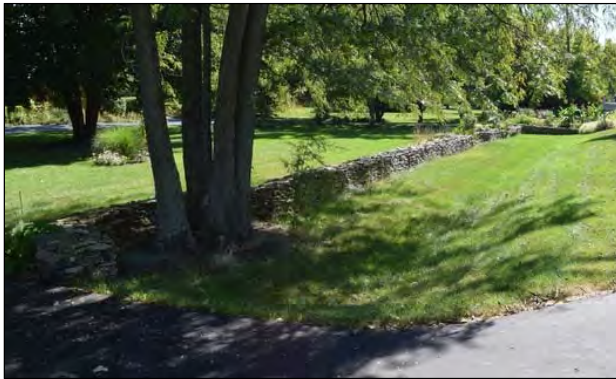
Condition: Good, Deteriorated/Poor**Integrity Notes:** Wall has good to poor integrity. The wall appears to have integrity of location and design for the periods in which it was built but the older section is deteriorated.**Historical Significance:** This wall most likely dates to the both the pre-1900 period based on poor condition of one portion, and to the period between 1900 and ca. 1970 based on the atypical design elements (flat top and planting nooks). As such the wall likely has historical significance to both Dublin's agricultural past and Dublin's 20th century suburban growth.**District:** No**Distinctive Feature:** Yes**National Register:** Washington Township MRA**Associated OHI:** N/A

Overview of wall, looking south

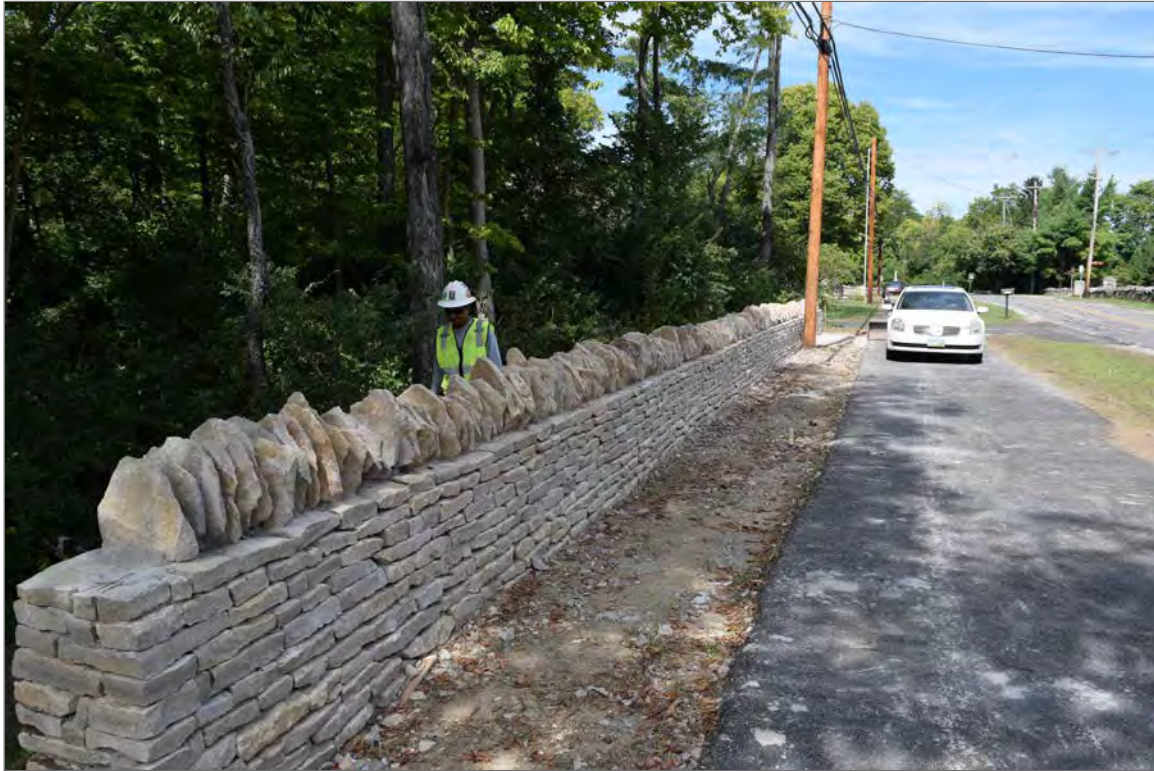
Walls built within the last 10 years tend to be of machine cut, square slabs, as depicted in Figure 95, and the walls built in 2016 as part of the trail project were constructed with mortar between the courses (Figure 96).

Figure 96. Wall in process of being rebuilt as part of trail project (W034 along west side of Dublin Road south of downtown, looking north). Note top course set in mortar.
