Project: Demolition Request  
Address: 36/38 North High St.  
Owner: Robert A. Lombardi  
Applicant: Robert A. Lombardi

## **Demolition Request for 36/38 N. High St., Dublin, OH 43017**

**Re: Structural Assessment for 36-38 N High Street , Columbus OH**

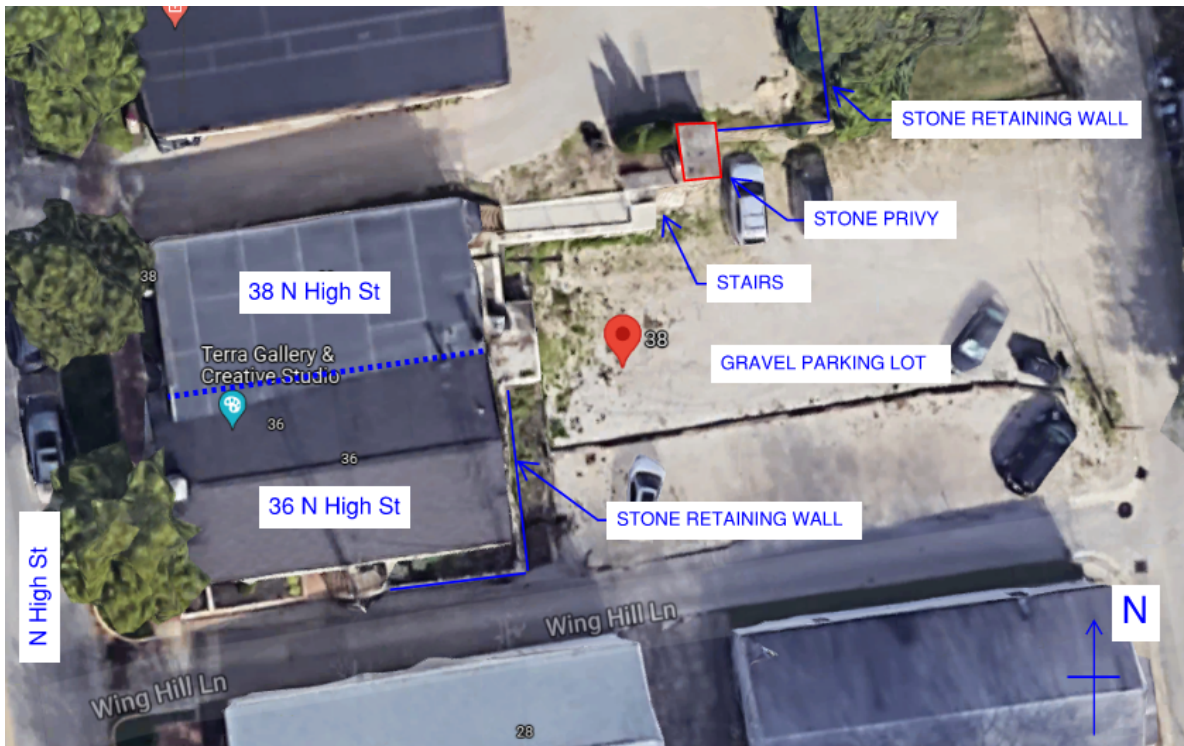
Several stepped cracking was observed at the south-east corner and along the east wall of the building. The cracking at the south-east corner in addition to the stepped crack the shifting of the was also noted. The stepped crack is indicative of building experiencing settlement. With the historic stone retaining wall being in close

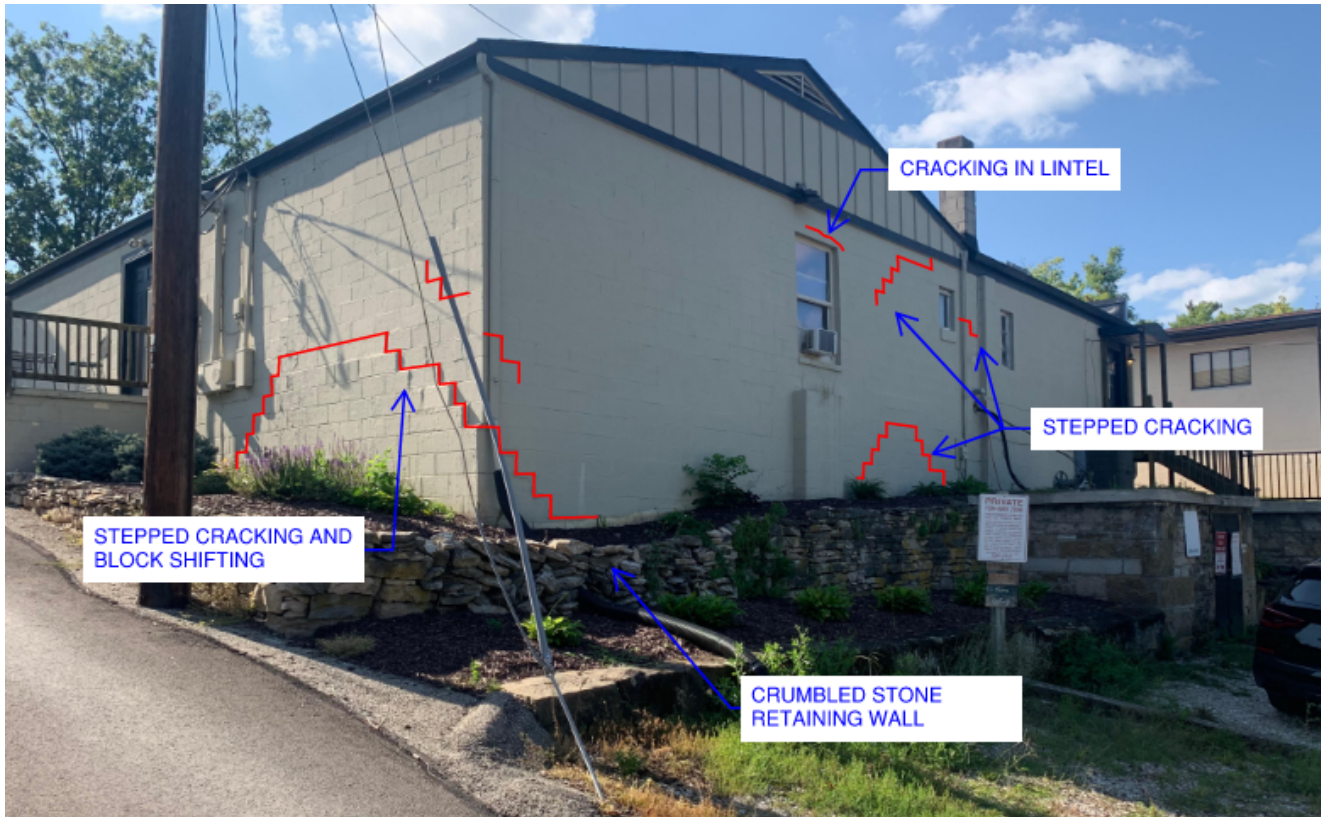
proximity the settlement of the building can be attributed to the lateral shifting of the soil. The construction of the retaining wall is just dry-laid stone with no binding mortar to it which would limit its lateral strength. The retaining wall was probably designed only to retain soil and not building surcharge load and hence the building is under stress due to foundation settlement which could lead to more cracking and settlement with time and eventual collapse of wall it is a public hazard and safety concern.

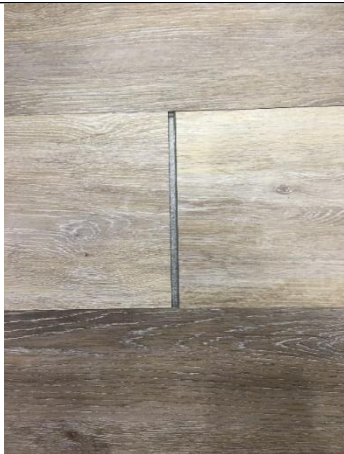
Photo 1 – Flooring planks separate about 1/4"

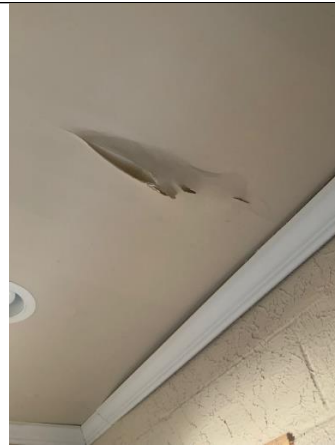
Photo 2 – Ceiling separation about 1/2"

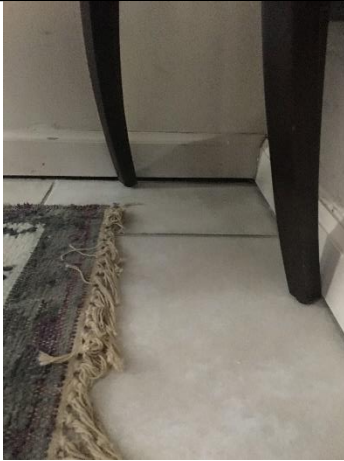
Photo 3 – Base board separate about 3/4"

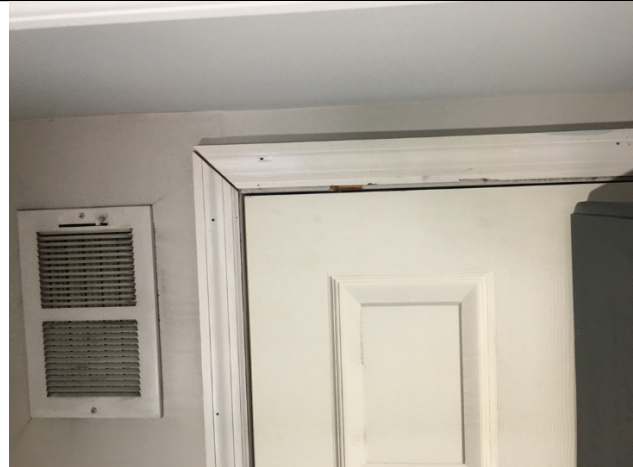
Photo 4 – Door frame joint separation about 1/4"

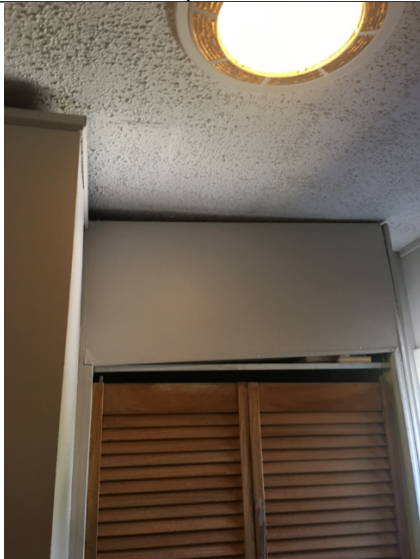
Photo 5 – Partition separation about 1"

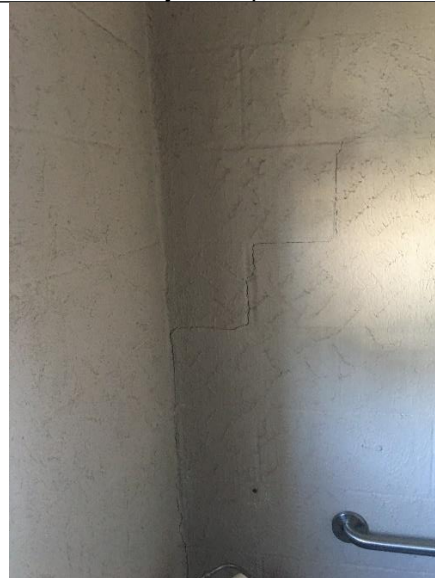
Photo 6 – Stepped cracking in demising wall
