Proposal for reconstructing stone retaining wall at 36-38 N. High St. 20 linear ft. on south elevation and a 6ft. return on the east elevation.

James Cox, Owner, Vic Art Masonry

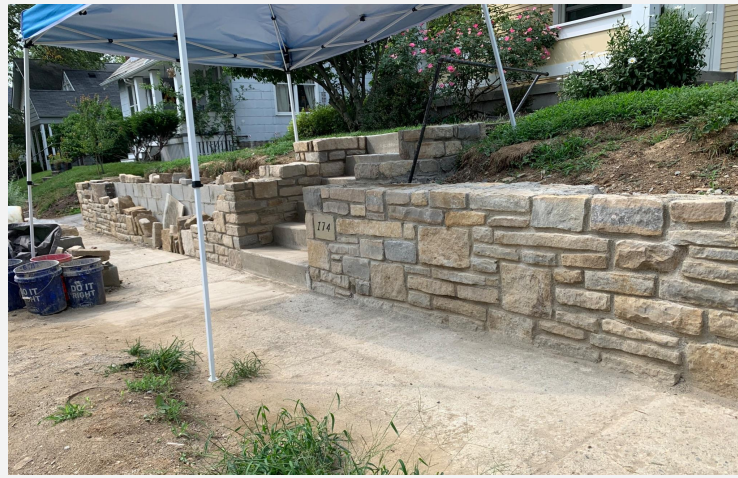
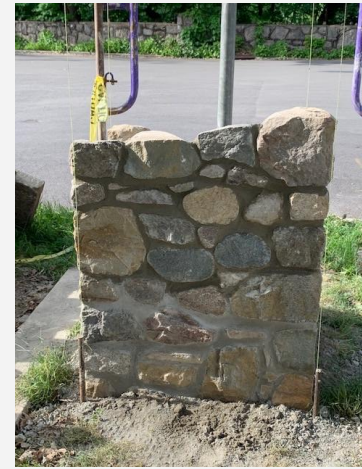
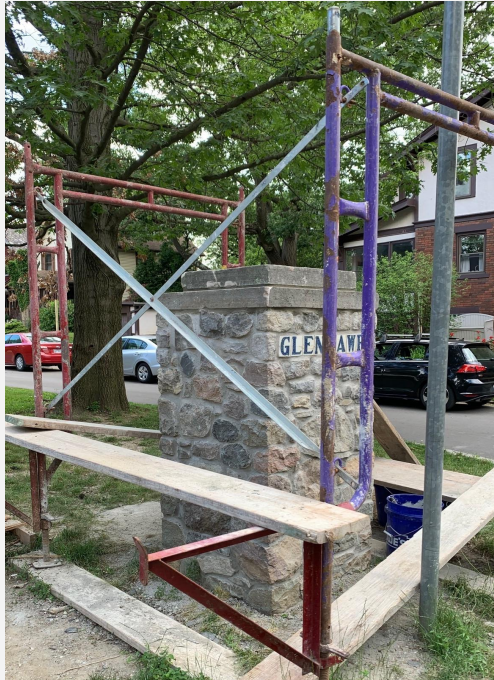
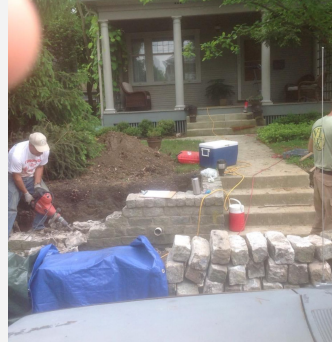
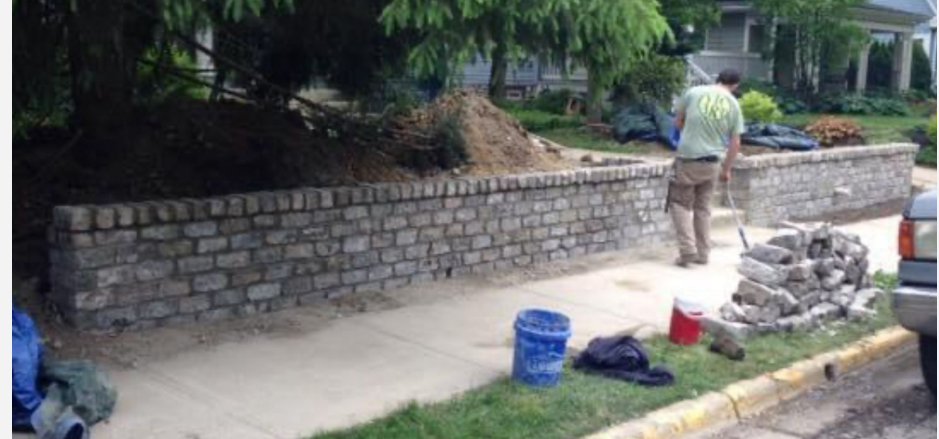
- The South wall appears to be built mostly with a dry work technique for stone construction, which consists of using random, mostly field limestone, locally quarried or basically picked out of a local ravine, even right off site when excavation was done for the structures on the property.

- The majority of the stones are undressed. They were installed in the wall without much shaping of the stone, which are generally referred to as random rubbles. The wall isn't however 100% random rubble as it has squared, dressed stones on the corner and some cut dressed stones on the top of the wall, which are set in mortar. The stones on top set in mortar but they are not struck.

- The corner looks like it was rebuilt and poorly executed with the repair work, poorly tied into the adjacent work. Lots of stacked vertical joints and a lot of the stones weren't set levelled.

- Approximately 30%-40% of the stones are delaminating or breaking apart between the sedimentary layers and will not be suitable for re-building this wall. They are too thin and too short.

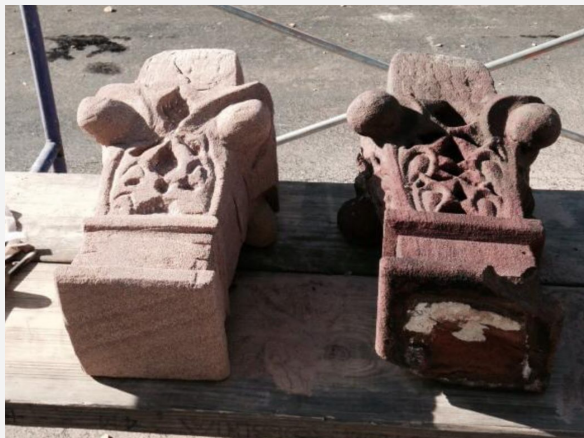
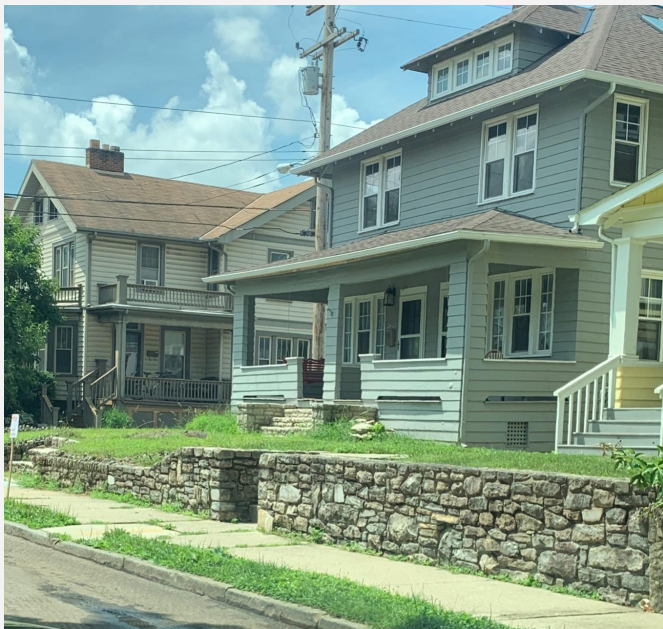
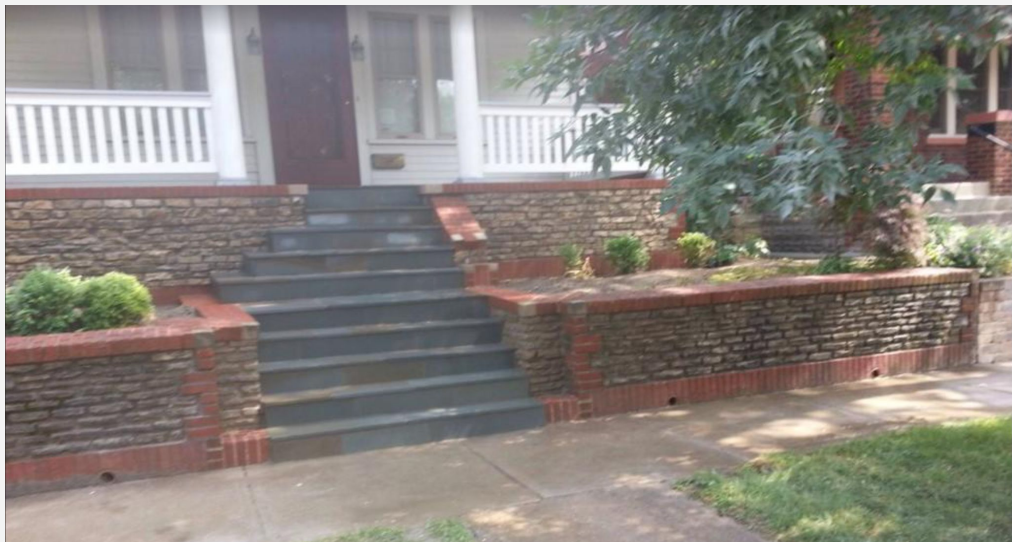
- B. Reconstruct the wall with as much original materials as possible. Dressed corner pieces to be reused in original locations. We can only assume how the wall was originally built. Evidence of mortar work can be found all over the wall but this could have been done after the original wall was. Note that the main body of the wall looks to be dry laid.

- A. Excavate the area behind the wall as we disassemble it and clean all salvageable stones of mortar and excess organic material. We plan to use low pressure to wash material, 150 PSI> wash with a 40 degree fan tip held no closer than 1 ft. away. The cleaned stones will be stocked for reuse. Spoils will be kept on site adjacent to wall on the area of higher elevation. Ohio utility protection service to be contacted before any digging.

- C. We will reconstruct in the original style as is reasonable. We will reference the rest of the wall, which is in better conditions, as we re-build this failing section.
