MEMO

Date: September 21, 2017

Re: REVISED Demolition Application Review of 5927 Rings Road Addition

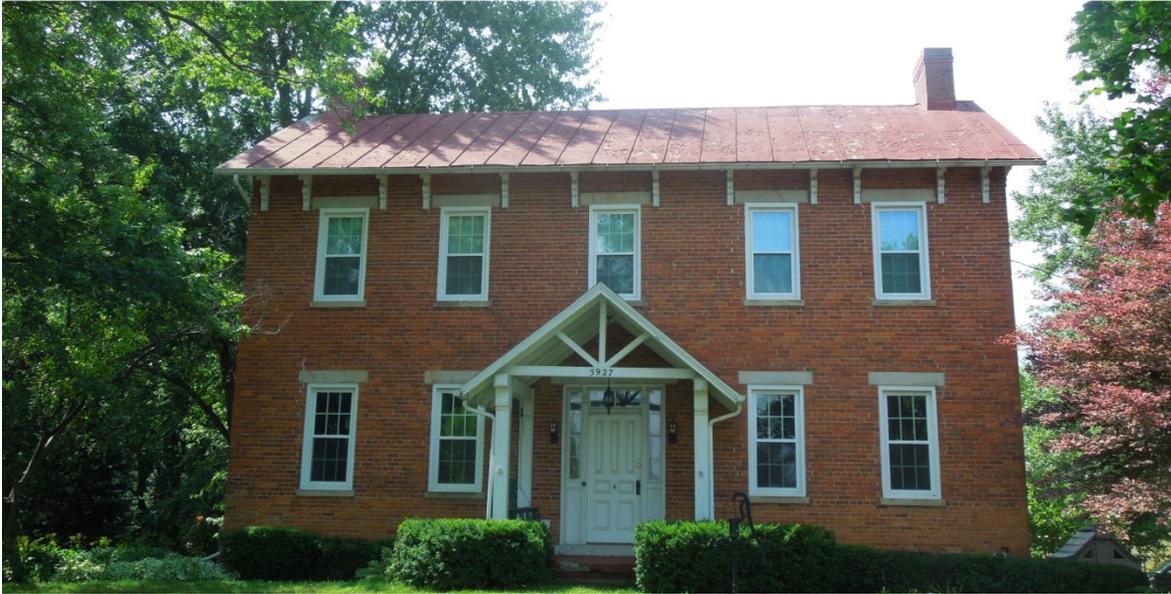
1. Current view of the 5927 Rings Rd. from the north. Character-defining features include the front door with transom and sidelights, the six-over-six light sash windows with stone sills and lintels, the seam metal side-gable roof with decorative Italianate brackets and the brick walls and stone foundation.

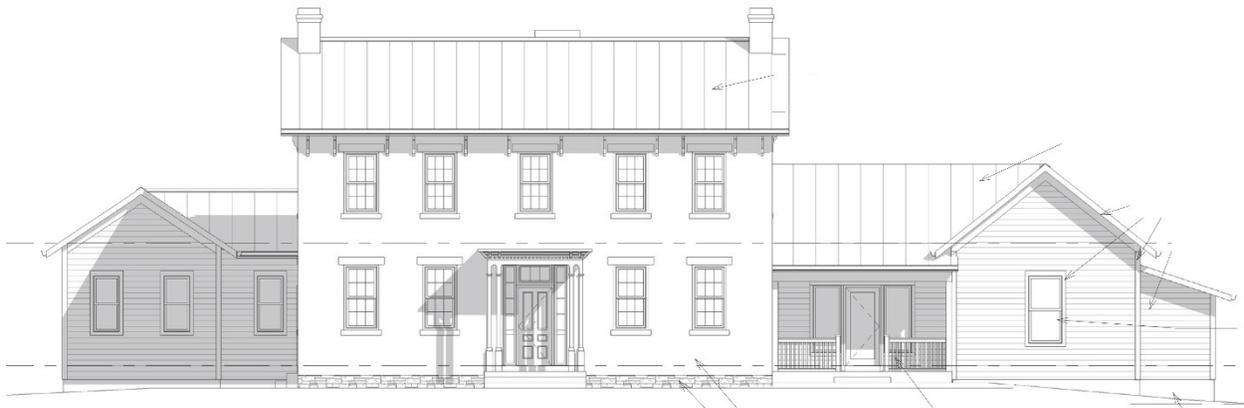
2. Rendering of historic house and proposed additions. The east addition is appropriate in size, scale, massing, etc., but the west addition is almost as wide as the historic core and has the potential to overpower it. If the applicant cannot reduce the size of the addition and/or push it back farther from the main house, landscaping can lessen this impact. A landscape rendering would be helpful.

landscaping to help reduce its presence. Landscape renderings (straight ahead, from the east, from the west, etc.) of the street views of the historic home would be helpful to see how the garage addition will impact the historic home. The second submittal had landscape plans which were not revised for this new submittal; I doubt they have changed, but I would ask for clarity. Ideally, a combination of both evergreen and deciduous trees of varying sizes could help screen the new additions from the road and lessen their impact on the historic structure.

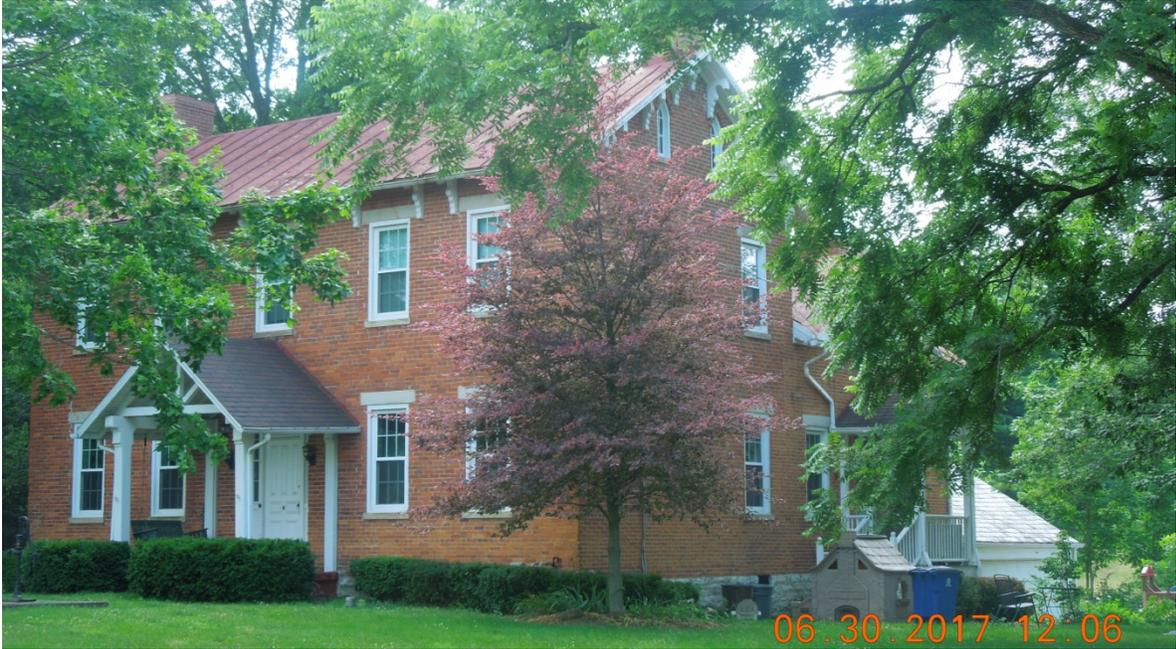
According to the structural addendum, the additions to the main house have sustained significant damage from insects, water infiltration, wood deflection, rot, and mold infestation. There is substantial structural damage to the foundation of this portion of the building; photographs indicate that the joists have diminished due to rot, pests, and the addition of HVAC, electrical, and plumbing lines which were cut into structural members. The loads and joist spacing will not meet current building standards and the structural members would have to be replaced or reinforced with new members. This would be impractical and cost-prohibitive.

Information in the structural addendum also indicates that the additions have sustained substantial structural damage in the roof from water infiltration and rot. While the wood trim can easily be replaced, the brick chimney is more problematic. The interior end brick chimney in the historic brick addition has sustained structural damage and is listing. Although this condition might be remediated by repairing the top portion of the chimney, the structural damage probably goes to the foundation and would require removing the whole chimney structure and rebuilding it. This is not economically feasible and it is inadvisable from a preservation perspective to rebuild something exactly like the original (a reconstruction) because it gives a false sense of history.

The applicant also proposes to demolish the attached slate-roof garage to the rear of the historic house. While the garage has some nice features such as the slate roof, it is clearly not original to the historic structure and has some structural issues. The roof ridge is bowed, indicating that the roof structure is failing and needs to be replaced. In addition, the slate shingles are weathered to the point that they are trapping moisture within the roof structure. The wood rafters, sheathing boards, and purloins are all rotted due to moisture and need to be replaced. Overall, replacing these elements piecemeal to a non-contributing element is not cost-effective and does not make sense from a historic preservation perspective.

3. Current view of 5927 Rings Rd. from the northwest. Note the one-story brick extension to the rear as well as the wood-frame slate-roof attached garage. These extensions/additions will be demolished in the current proposal.

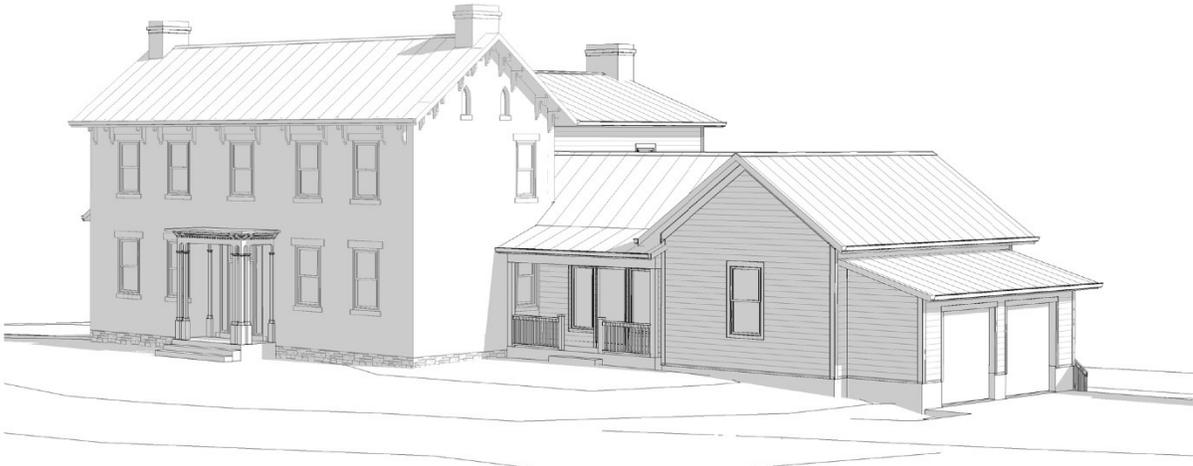
4. Rendering of historic house and proposed additions from the northwest. The mudroom/porch addition has been pushed back so two historic windows will be maintained. And the height of the rear addition is reduced so it does not overpower the historic core. However, the west addition is almost as wide as the historic core and has the potential to overpower it. If the applicant cannot reduce the size of the addition and/or push it back farther from the main house, landscaping can lessen this impact. A landscape rendering would be helpful.

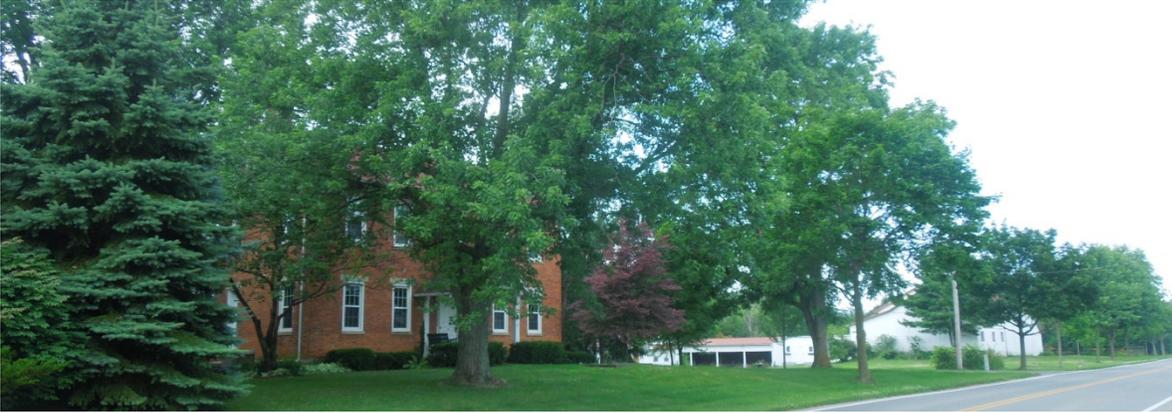
5. Current view of 5927 Ring Rd. from the northeast with main house and outbuildings

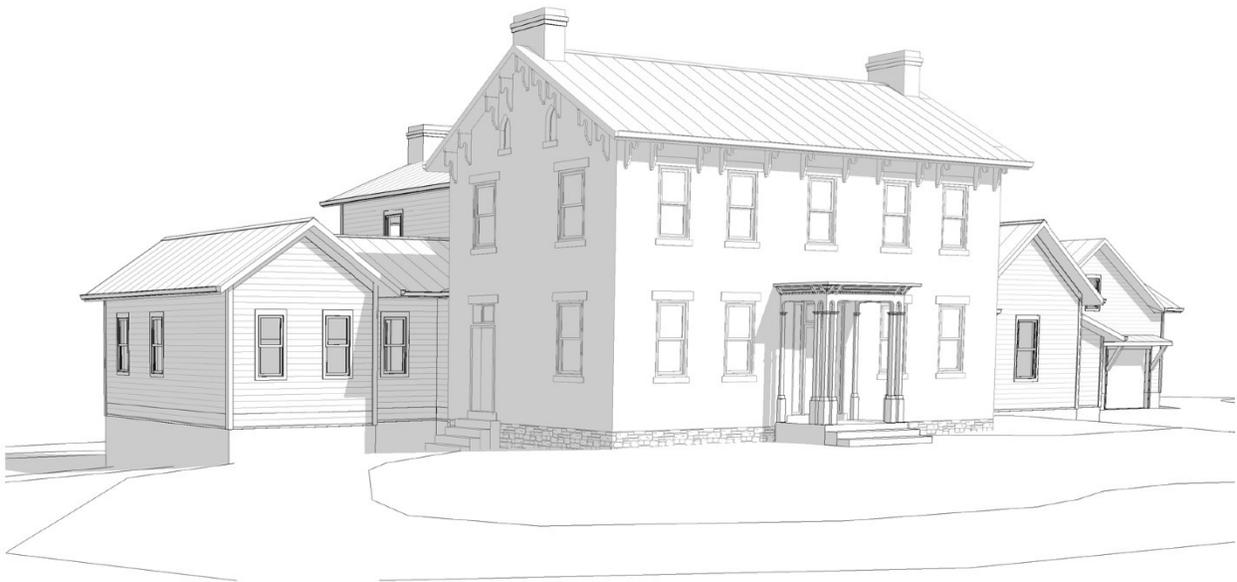
5. Rendering of historic house and proposed additions from the northeast. The east addition is appropriate in size, scale, massing, etc. The west addition is hidden behind the main house but is almost as wide as the historic core and has the potential to overpower it. If the applicant cannot reduce the size of the addition and/or push it back farther from the main house, landscaping can lessen this impact. A landscape rendering would be helpful.
