Karen Bokor, B.S., M.Arch.
DESIGN CONSULTANT

HISTORICAL ANALYSIS AND DESIGN REVIEW:

Property Address: 55 S Riverview Street
Dublin, Ohio 43016

HISTORICAL ANALYSIS:

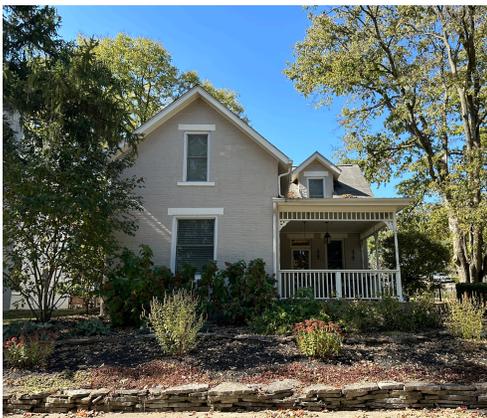
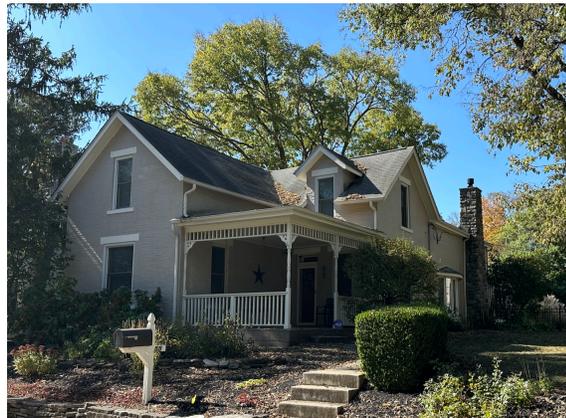
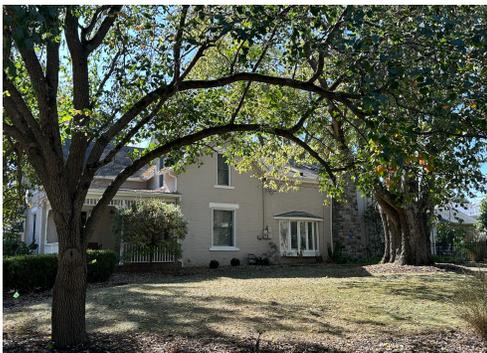
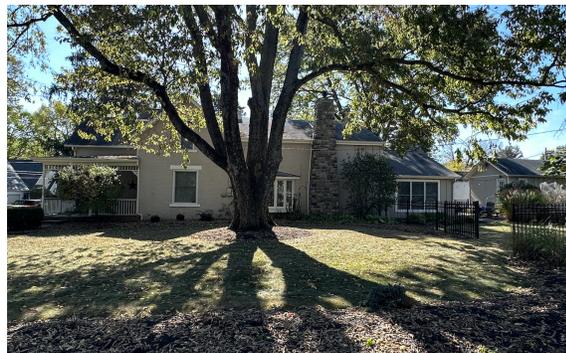
The subject property at 55 Riverview Street in Historic Dublin is an example of early American Vernacular. Built in the early 1900s, the existing structure is a front facing gable with a deep front porch. Several minor additions have been done in its lifetime including front porch updates, roof and window updates, and a modest addition to the rear of the home appears to have been done in 2017.

The front facade and porch are very well done in massing and proportion and are contributing to the street scape of Riverview Street. Both the front and side gables provide a strong street presence and are the dominant feature of this historical building. The structure appears to be well maintained. Another notable characteristic of this home is the stone chimney.

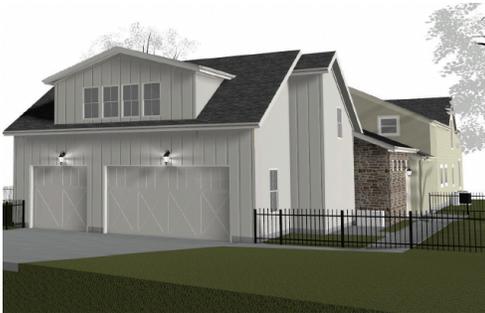
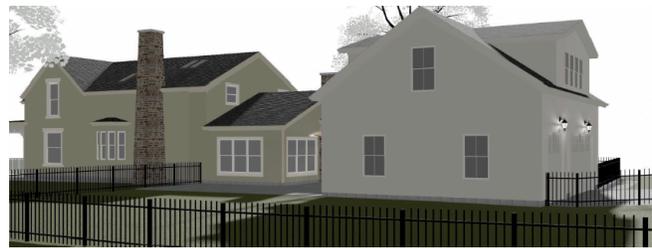
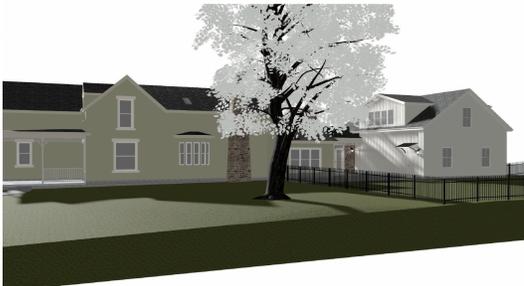
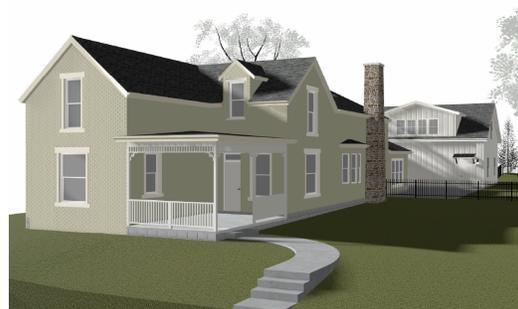
The use of the hyphen to separate new and old, the deference to the height of the original structure in the addition, and the use of dormers are in keeping with the principles of adding to historical structures. However, the construction materials are too heavy in places and overwhelm the original, existing structure, and surrounding structures both new and old. The proposed scalloped shingles, though excellent in quality and design, may be too busy given the variety of materials and textures already proposed in this project. If the shingle choice is important to the owner I would recommend simplification of the facade materials.

The renderings below illustrate the massiveness of the proposed garage addition in comparison to the original structure as well as the complicated and competing massing and roof lines on the west elevation and the addition decorative brackets on the heavy stone hyphen. The east elevation of the garage should have windows as well to add scale and detail.

- Revise the roof lines and massing of the garage and hyphen to lessen the competing forms and revisit the conceptual design to create a more simplified and elegant solution.
- Study the materiality of the hyphen to lighten the connection to the attached garage. The use of stone and transom windows is heavy and not in keeping with the character and with the concept of a hyphen to connect structures.

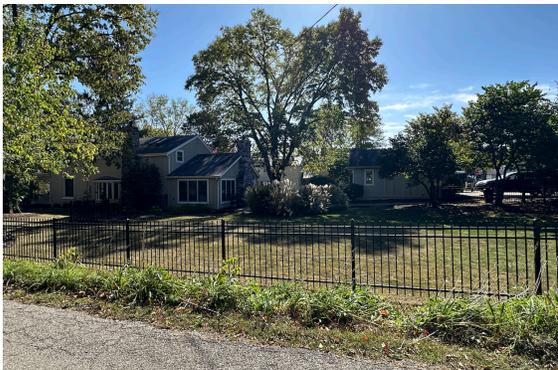
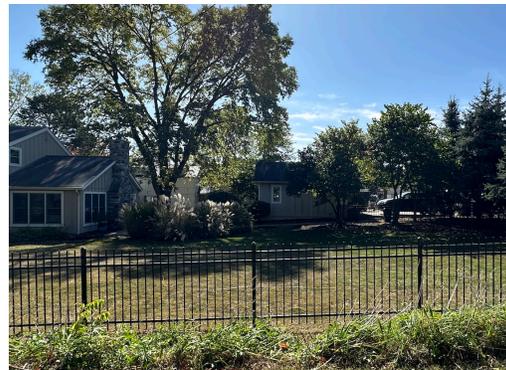
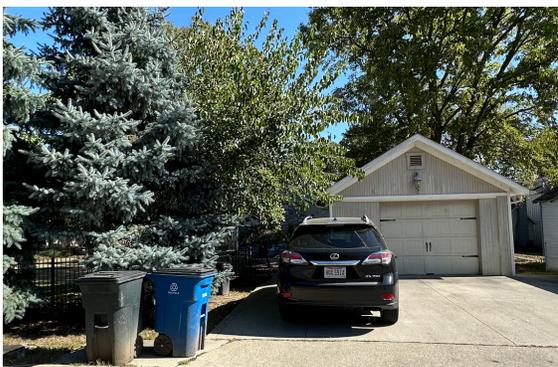
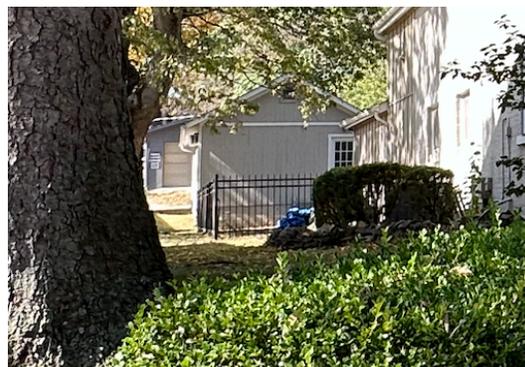
Views of existing Garage:

The existing garage is a detached structure with the approach from S Blacksmith Lane and was built in 2007 and replaced a shed. It is a simple wood structure on block, wood sided and small for today's lifestyles and vehicle sizes. There does not appear to be anything significant about this structure and nothing historical has been found in reference to this outbuilding. There are some nice details such as the hardware and trim detail but otherwise does not appear to have any significant historical or architectural elements.

Below are views of the existing garage. There is no significant impact to the street and the structure is not very visible from the sides or front of the property, only from S Blacksmith Lane.

This structure, while currently classified as Contributing, could easily be replaced with another garage, attached or detached, and maintain all characteristics that currently categorize it as Contributing. For this reason I would consider it ~~Non-Contributing~~. I would, however, consider that this portion of the site is the appropriate location for a garage and would support this request for the designation to be changed to ~~Non-Contributing~~ providing it is done with the approval of a new garage.

- The request for reclassification of the garage from Contributing to Non-Contributing is appropriate in the context of the proposed addition. The design of the new, attached garage however, should be simplified and better proportioned in keeping with the original conceptual design..

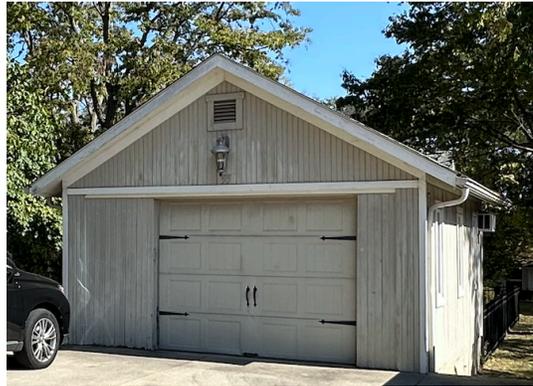
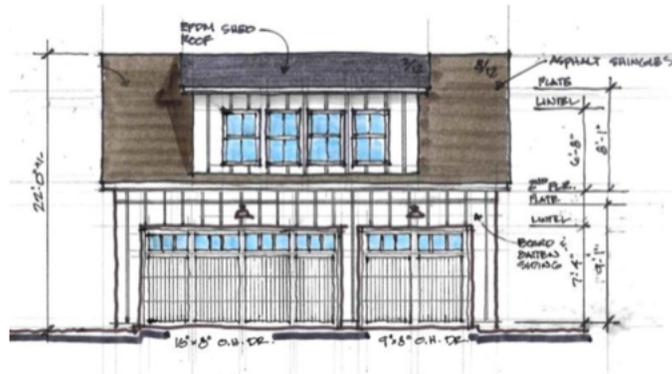
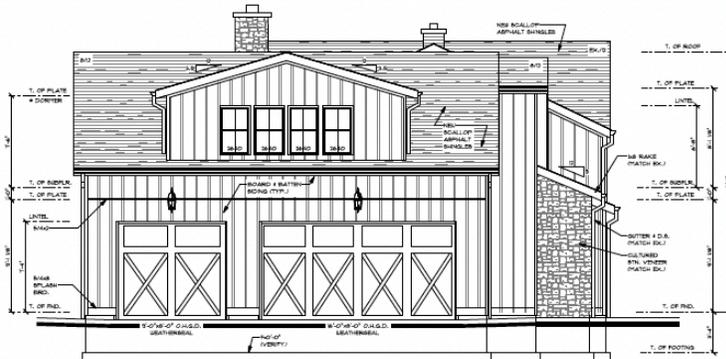
WEST ELEVATION
SCALE: 1/4"=1'-0"

Below is the comparison the existing garage, the original conceptual proposal and the current proposal. The first design was a more elegant and proportional solution with its shed dormer and simplified forms and is much more in keeping with the neighboring structures.
