To: Nichole Martin, AICP
Planner I, City of Dublin

From: Christine Trebellas, AICP, LEED Green Associate
Historic Preservation Consultant

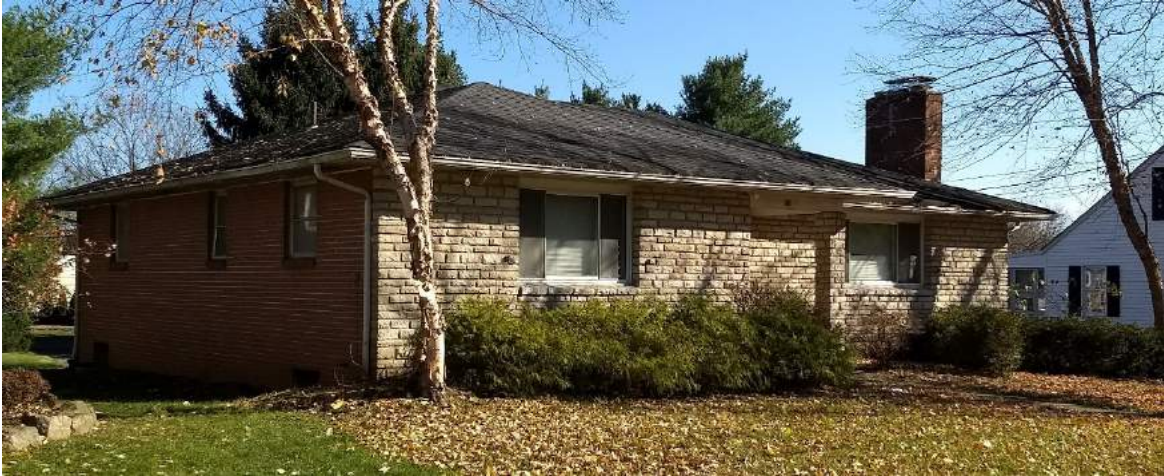
1. Ranch-style house at 86 Franklin Street from the northwest.
