MEMO

From: Christine Trebellas, AICP, Registered Architect, LEED Green Associate
Historic Preservation Consultant

Date: March 15, 2021

Re: 110-112 S. Riverview Street, First Review

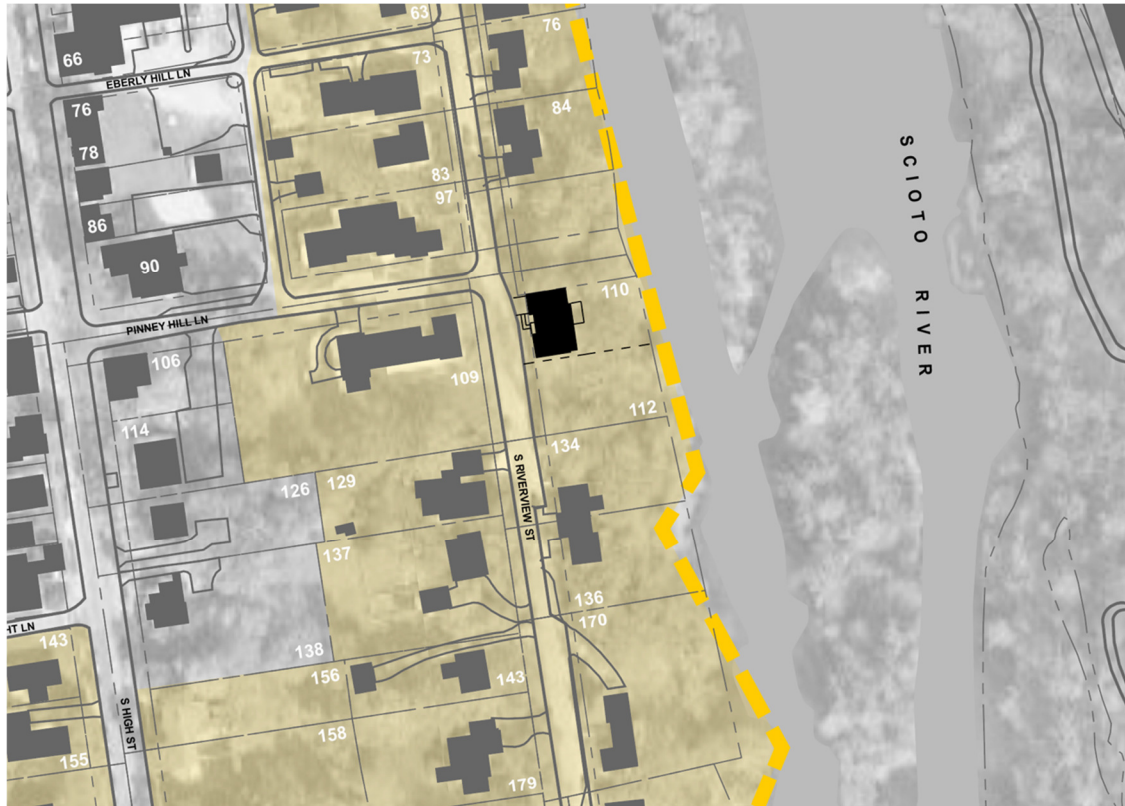
Figure 2. Detail site plan showing the proposed building and site contrasted with the adjacent structures and properties. (Original Adobe Illustrator sketch using ArcGIS Data provided by the Franklin County Auditor, extracted September 9th, 2020 with proposed 110 S Riverview Design by Melaragno Design Company; not to scale.)

- It is not clear where this structure lies on the site in relation to other neighboring structures (See Figure 2). A site plan which shows neighboring structures would be helpful. Ideally, it should be set back the same distance from the road as neighboring structures.

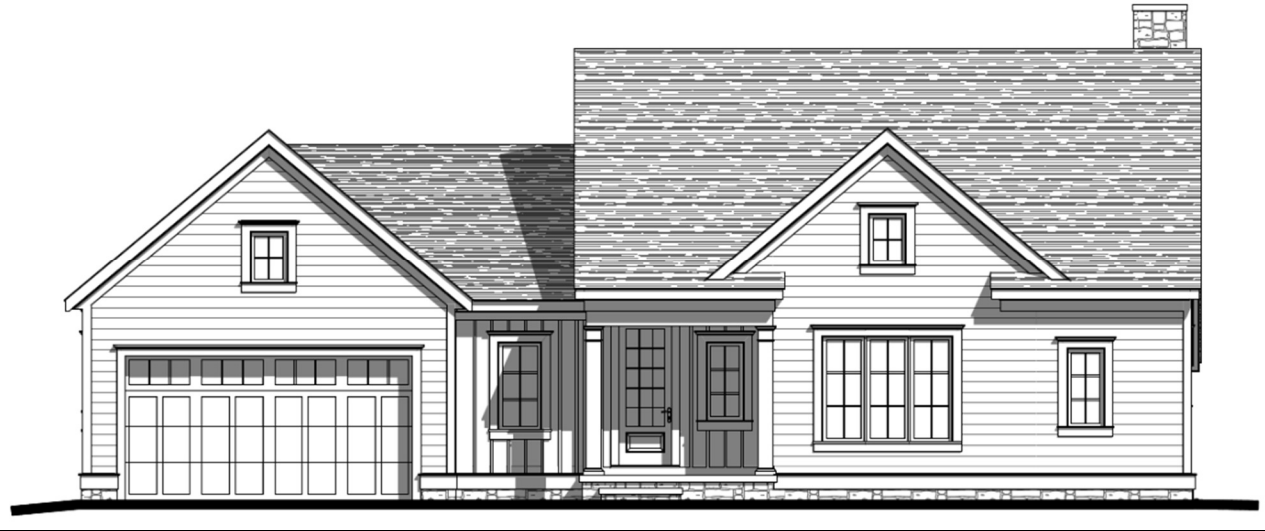
West (Front) Elevation

- Vertical board and batten siding should be reserved for outbuildings such as garages and hyphens (or connectors) to those outbuildings. Traditionally, it would not appear on the façade of a building. The vertical board and batten siding by the entry should be removed and replaced with horizontal siding more appropriate for the main house and compatible with other buildings in the area.

- As mentioned above, garages or barns were traditionally relegated to the rear of a property. Since this is not possible due to site constraints, the garage should at least be setback from the main house to lessen its impact from the street. While a garage close to the street may be suitable for a new subdivision, it is not appropriate for a historic district where houses did not originally have attached garages.

- Provide information regarding building materials such as siding, stone veneer, roofing, windows and doors to ensure the new material is compatible with structures in the historic district. Currently, the windows appear to be fixed or casement windows. Sash windows and horizontal siding are traditional to buildings in the historic district and would help maintain the historic context of the district. (This applies to all elevations.)

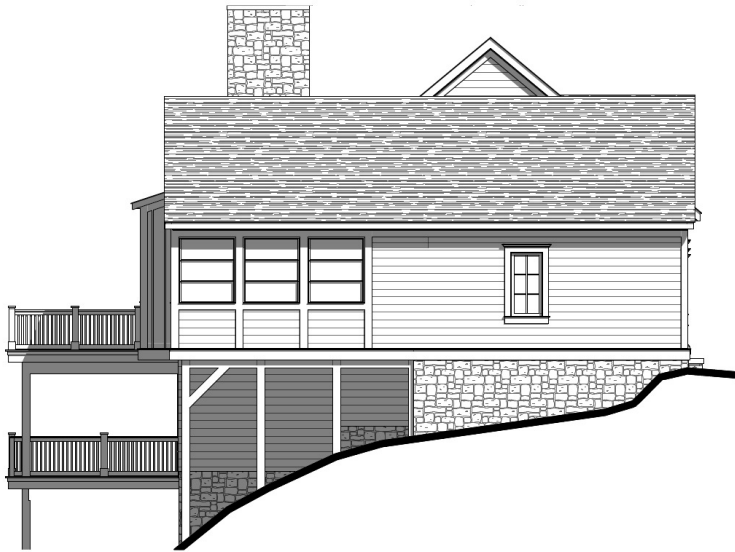
North Side Elevation

- The sunroom area needs to be more fully developed in terms of windows, siding material, and foundation. The supports appear too spindly to support the weight of the sunroom. The plan shows a fireplace in the sunroom, but there is no foundation or chimney for it. The windows do not appear to be compatible with others in the historic district—sash windows are preferred but sunroom additions could also have casement windows. And since sunrooms were usually additions or enclosed porches, the siding material generally varied from that of the main house or at least had a visual seam.

- Remove the cantilever for the rear portion of the kitchen and living and dining rooms. Traditionally, this area would not be a cantilever but part of the main house with a solid foundation.

- Create a uniform foundation line. The stone foundation of the main house should continue all the way under the main house since they would have been built at the same time.

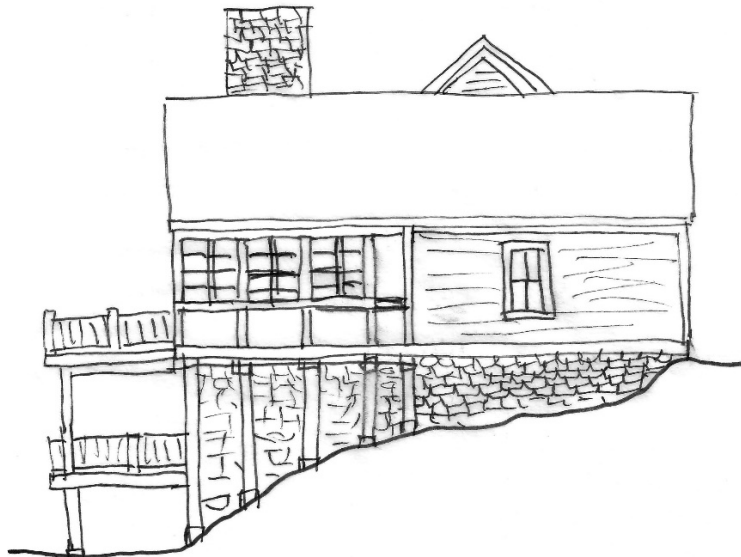
Sketch of revised north elevation with casement windows in sunroom and stone foundation. Note the different material for the sunroom.

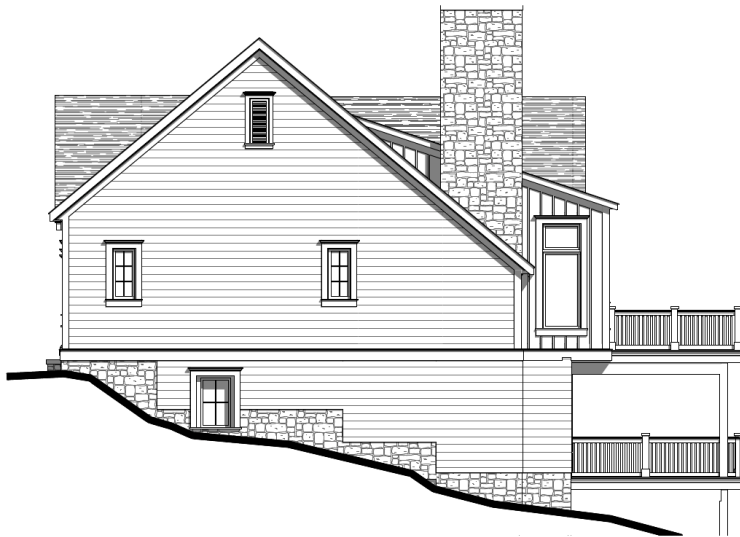
South Side Elevation

- The elevation needs to be more fully developed in terms of foundation, siding, and roofline to be more compatible with the traditional one-and-a-half-story homes in the area.

- The chimney needs a stone foundation to support it. Even though it is on an exterior wall, it appears to be enclosed by the main house.
- The window in the lower level poses some design issues and may not be sized properly. Since this is a bedroom, it needs to be an egress window per the 2019 Ohio Residential Code. And, given the grade changes, it may also need a code-compliant window well.

- As in the north elevation, create a uniform foundation line. The stone foundation of the main house should continue all the way under the main house since they would have been built at the same time.

- Remove the cantilever for the rear portion of the kitchen and living and dining rooms. Traditionally, this area would not be a cantilever but part of the main house with a solid foundation. In addition, this area should have the same horizontal siding of the main house and not vertical board and batten, which traditionally appeared in outbuildings.

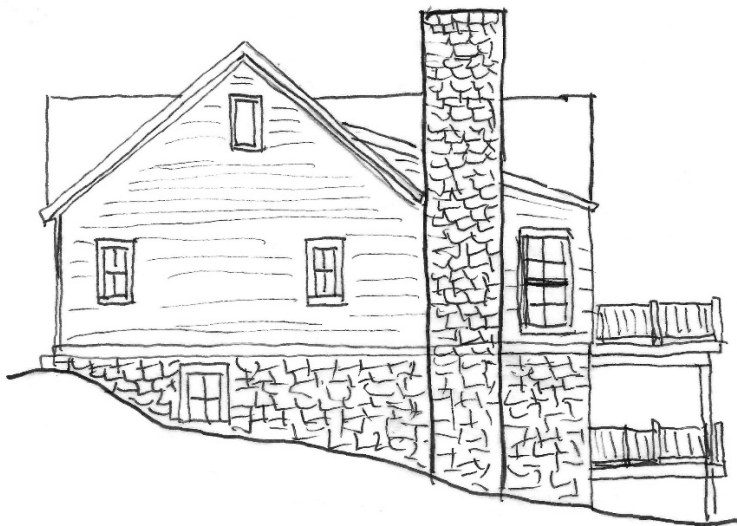
Sketch of revised south elevation with continuous stone foundation, horizontal siding, and no cantilever. Note that the lower level window may need to be revised based on code and life safety issues.

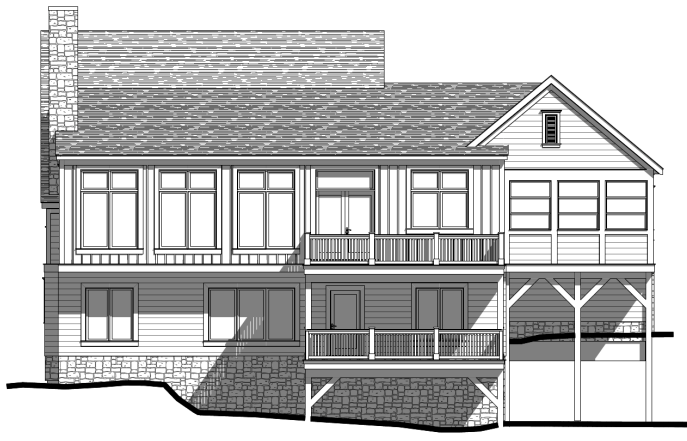
East (Rear) Elevation

- The windows should match the others on the front and side elevations. Provide information regarding the type of windows to ensure they are compatible with the historic district. Sash windows are traditional to the area, but sunroom additions could have casement windows.

- There should be a stone foundation for the garage as well as a foundation and chimney stack for the fireplace in the sunroom.
- The sunroom structure appears too spindly to support the weight of the sunroom above. Consider using square piers or heavy timbers which align with the visual bays above.

- Remove the cantilever for the rear portion of the kitchen and living and dining rooms. Traditionally, this area would not be a cantilever but part of the main house with a solid foundation. In addition, this area should have the same horizontal siding of the main house and not vertical board and batten, which traditionally appeared in outbuildings.

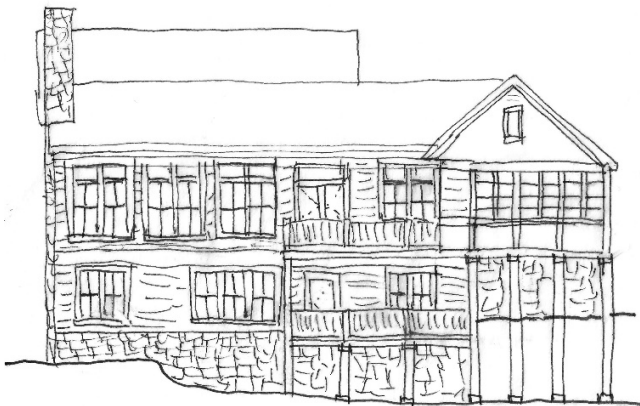
Sketch of rear elevation with a continuous stone foundation, horizontal siding, sash windows, and no cantilever. If there is to be a fireplace in the sunroom, there should also be a chimney stack and foundation (not shown).

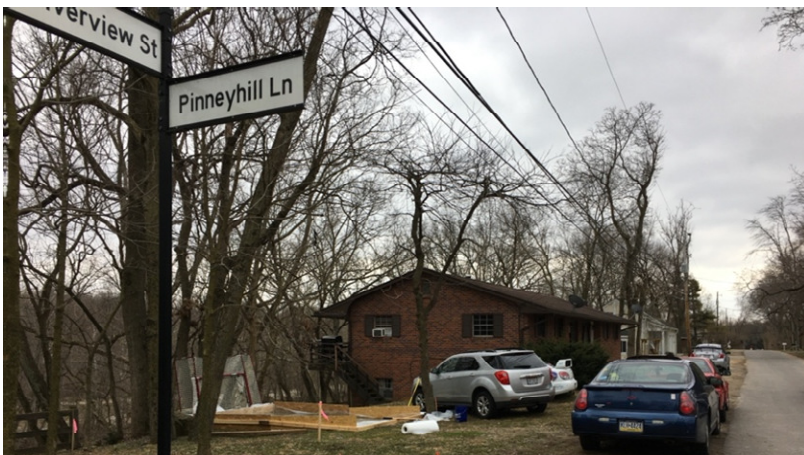
Figure 5. View of 110-112 S. Riverview Street looking south from the intersection of Riverview St. and Pinneyhill Lane. Note the existing side yard and the utility area north of it. (Preservation Designs, March 2021)
