MEMO

Date: May 17, 2021

Re: 110-112 S. Riverview Street, First Demolition Review and Second New Construction Review

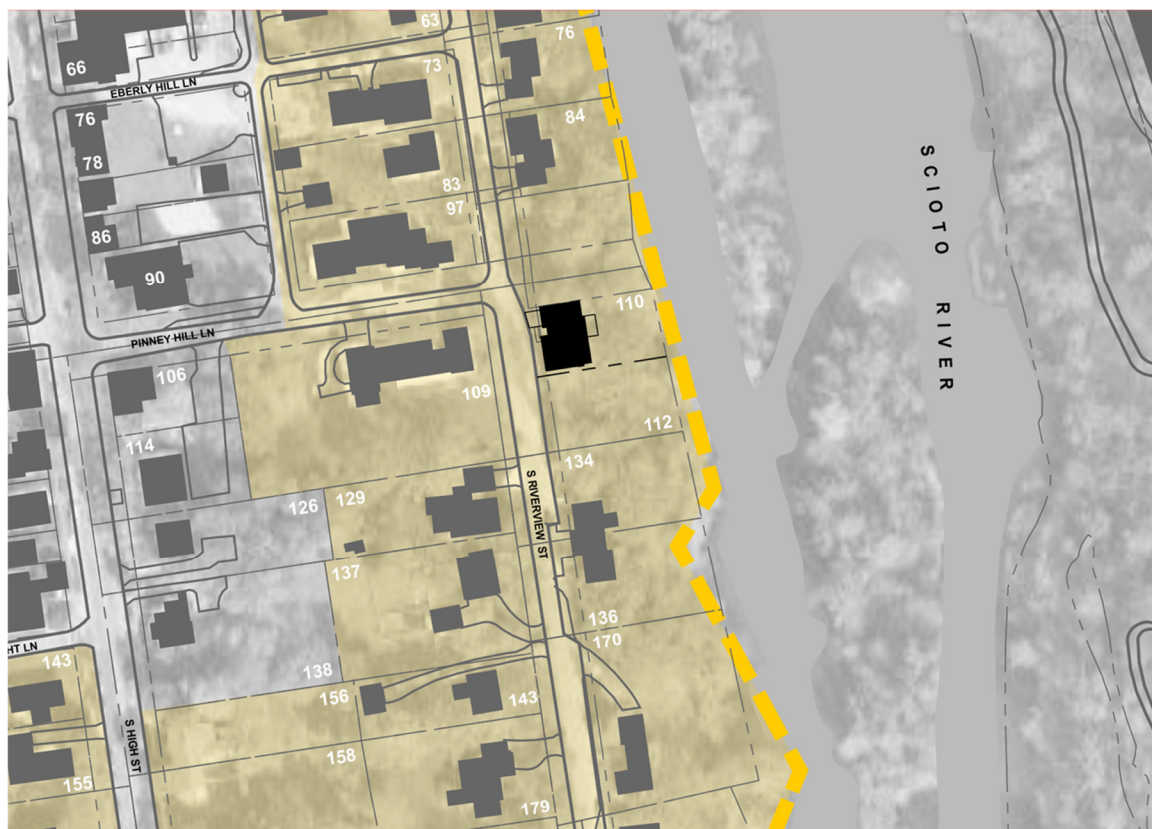
Figure 3. Detail site plan showing the proposed building and site contrasted with the adjacent structures and properties. NOTE: The above map is an approximation and cannot and should not be considered definitive as a properly surveyed and detailed site plan. (Original Adobe Illustrator sketch using ArcGIS Data provided by the Franklin County Auditor, extracted September 9th, 2020 with proposed 110 S Riverview Design by Melaragno Design Company; not to scale.)

- It is not clear where this structure lies on the site in relation to other neighboring structures (See Figure 3). A site plan which shows neighboring structures would be helpful. Ideally, it should be set back the same distance from the road as neighboring structures.
- The site study does not indicate a step to the entry stoop; please confirm the stoop and step are outside of the right-of-way line. The Historic District Code Amendment 153.174 (h)(2) states, "Stoops and steps shall not encroach within the right-of-way."

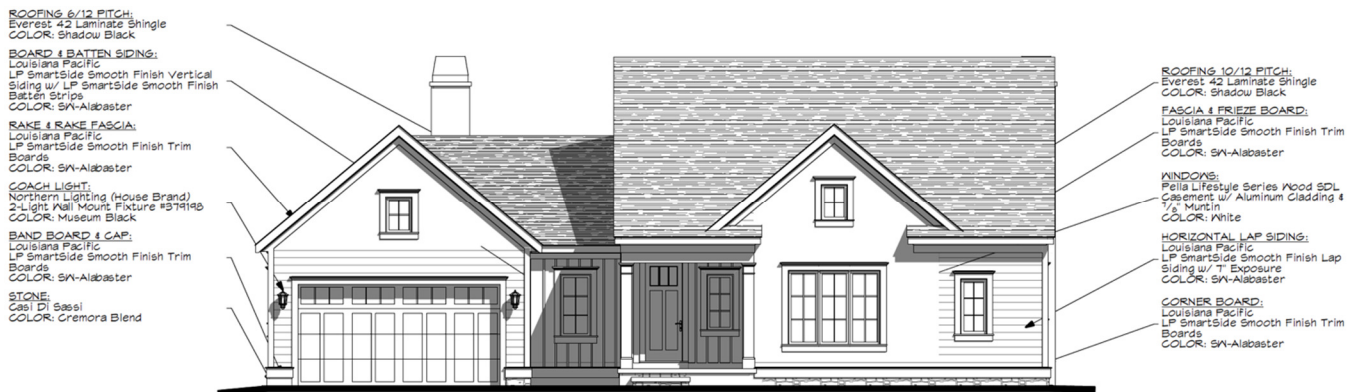
West (Front) Elevation

- Currently, the windows are listed as fixed or casement windows. Sash windows and horizontal siding are traditional to buildings in the historic district and would help maintain the historic context of the district. (This applies to all elevations.)
- Vertical board and batten siding should be reserved for outbuildings such as garages and hyphens (or connectors) to those outbuildings. Traditionally, it would not appear on the façade of a building. The vertical board and batten siding by the entry should be removed and replaced with horizontal siding more appropriate for the main house and compatible with other buildings in the area.

- Consider reducing the gable of the garage roof to give it less prominence (see sketch below). Traditionally, garages and other outbuildings were relegated to the rear of the property.

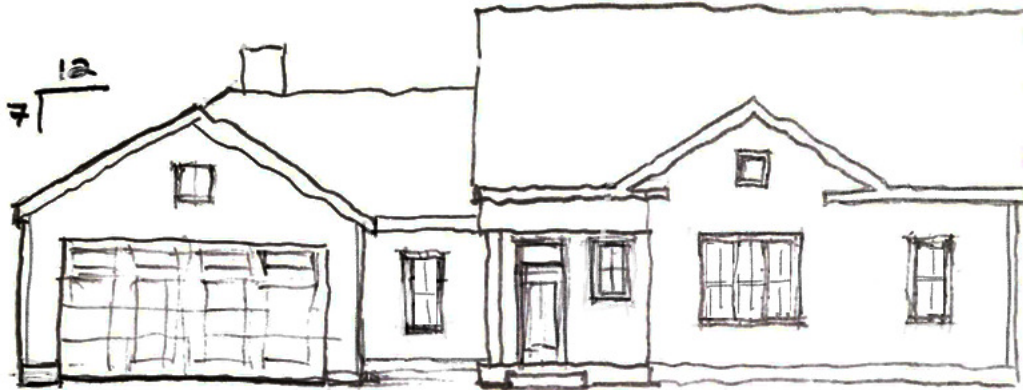
Sketch of revised west elevation with the “original” house on the right, its garage on the left, and the connector between them. This sketch uses an alternative massing design to consider. Sash windows are traditional to the area; consider changing the window type to double-hung. Note the simplified detailing around the windows and the entry porch.

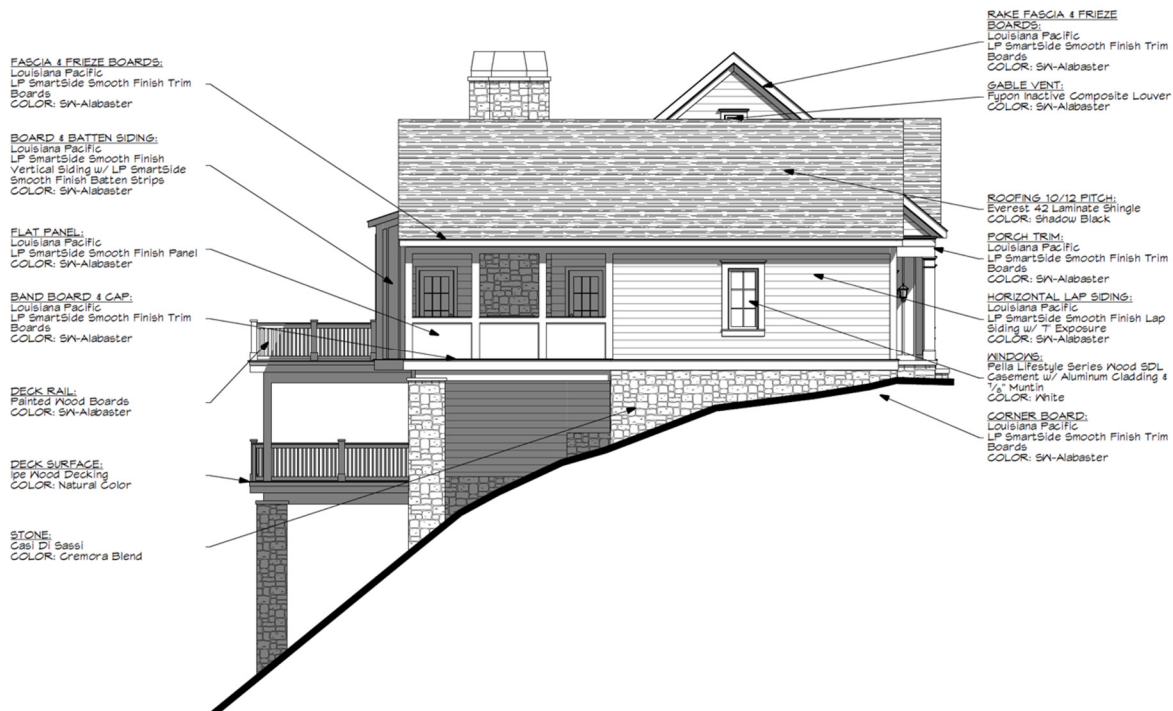
North Side Elevation

- The open porch chimney would traditionally extend to the ground. The Historic District Code Amendment 153.174 (i)(2) states, “Chimneys on exterior walls shall extend fully height from the ground.... Cantilevered and shed-type chimneys are prohibited.” This would help create a more uniform foundation along the lower level (see sketch below).

- On the open porch, consider raising the bottom of infill railing panels to provide a <4” gap from the porch flooring, and extending the flooring out slightly over the band board. This detail is traditional and would have allowed water pooled on the open porch to drain.
- Remove the cantilever for the rear portion of the kitchen and living and dining rooms or extend the lower level out to match the wall above. Traditionally, this area would not be a cantilever but part of the main house with a solid foundation.

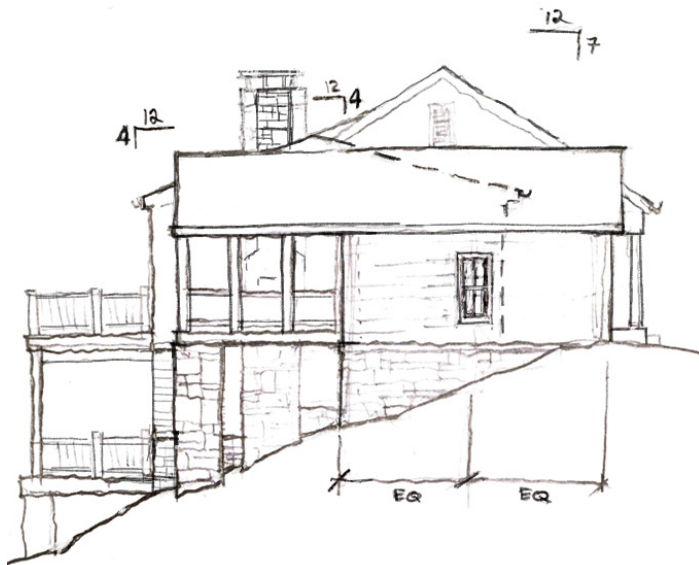
Sketch of revised north elevation using the alternative massing. The “original” house and its garage have one matching roof slope while the connector and the rear addition have a different matching roof slope. Note that the open porch’s chimney continues to the ground. The rear cantilever is removed, making both levels flush.

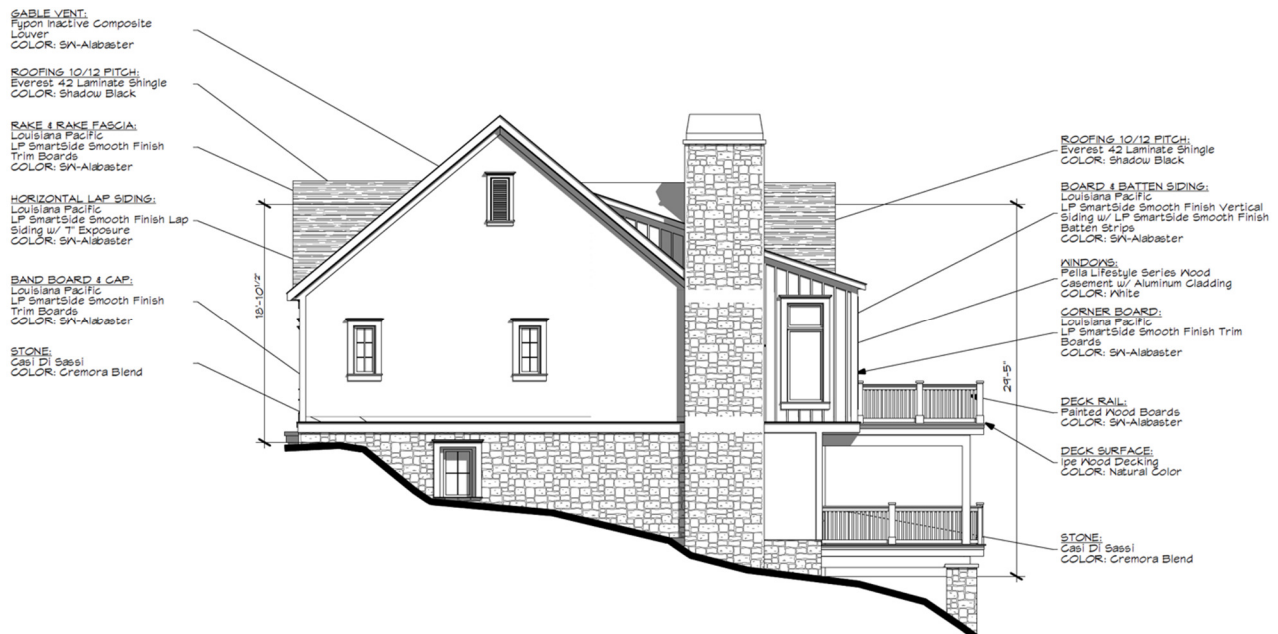
South Side Elevation

- The southern chimney’s position appears out of place and should read as part of the main house, not an afterthought or addition. Consider the massing alternative (see sketch below) as it places the chimney on the wall of the “original” house (before the eave).

- Remove the cantilever for the rear portion of the kitchen and living and dining rooms. Traditionally, this area would not be cantilevered. In addition, this area should have the same horizontal siding of the main house and not vertical board and batten, which traditionally appeared in outbuildings.

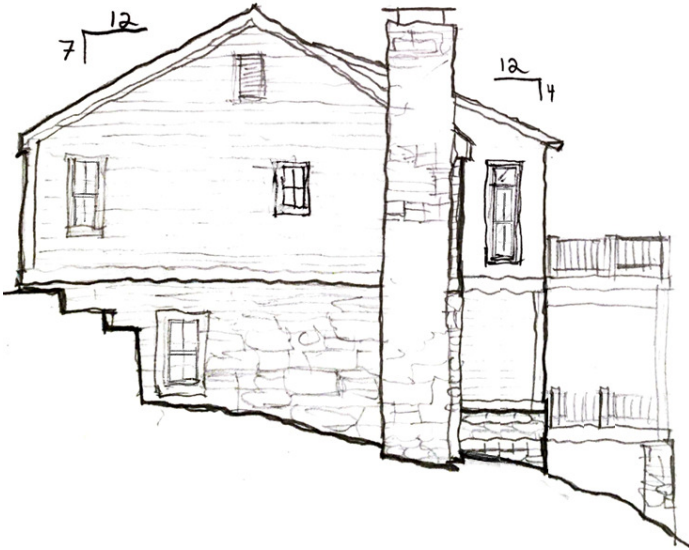
Sketch of revised south elevation with continuous stone foundation, and horizontal siding; this sketch uses the massing alternative at the end of this report. Making the rear building element an “addition” could reduce the amount of stone foundation on that portion only. Note that the lower level window needs to be compatible in size and type to the windows above.

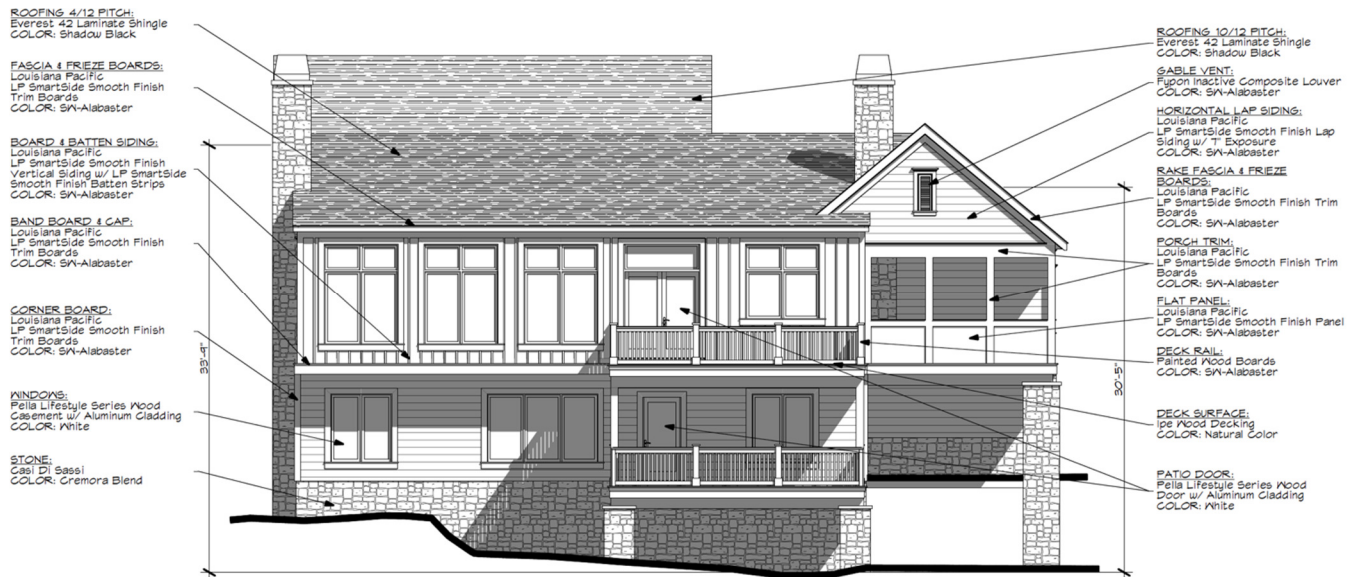
East (Rear) Elevation

- Although a rear elevation, the windows should match those on the front of the house, preferably sash windows, to create a cohesive structure (see sketch below).
- Remove the cantilever for the rear portion of the kitchen and living and dining rooms. Traditionally, this area would not be a cantilever but part of the main house with a solid foundation. In addition, this area should have the same horizontal siding of the main house and not vertical board and batten, which traditionally appeared in outbuildings.
- The chimney stack for the fireplace in the sunroom should extend all the way down to the ground plane.

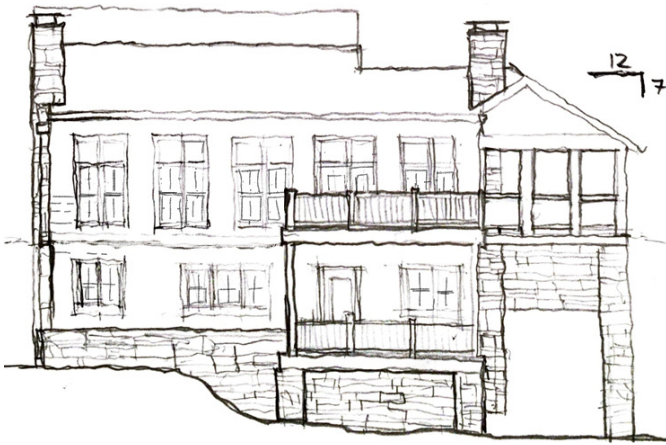
Sketch of rear elevation based on the alternative massing option. (Note the continuous stone foundation on the “original” house and garage and a lowered stone foundation on the “addition.”) Elsewhere is horizontal siding. The “addition’s” window should be the same type as on the “original” house (double-sashed), and both chimneys should have more simple caps. Note that the open porch’s chimney continues to the ground.

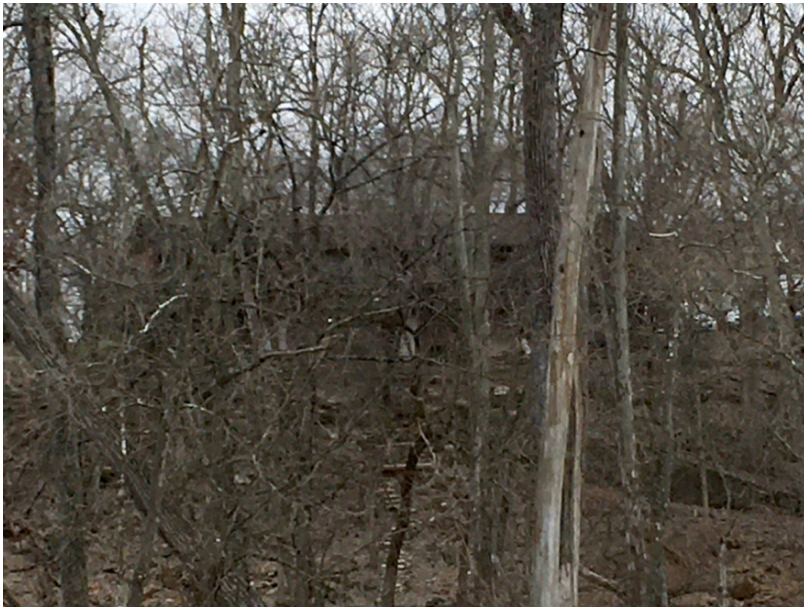
Figure 5. 110-112 S. Riverview Street taken from across the Scioto River. While much is obscured, this photo shows the existing access paths down to the river. The proposal should address site issues such as existing landscape features which will be maintained or removed (Preservation Designs, March 2021)
