97 S. Riverview

ARCHITECTURAL REVIEW BOARD
APPLICATION
Dublin, Ohio

September 3, 2013

We are requesting the demolition of a house (and the accessory structures) at 97 S. Riverview for the purpose of redevelopment to a new single-family home consistent with the Bridge Street corridor and Dublin Vision Plan.

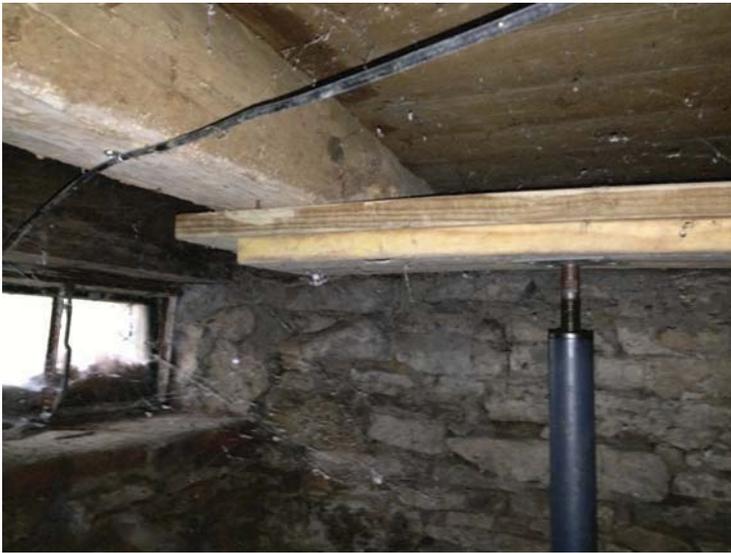
First floor shores

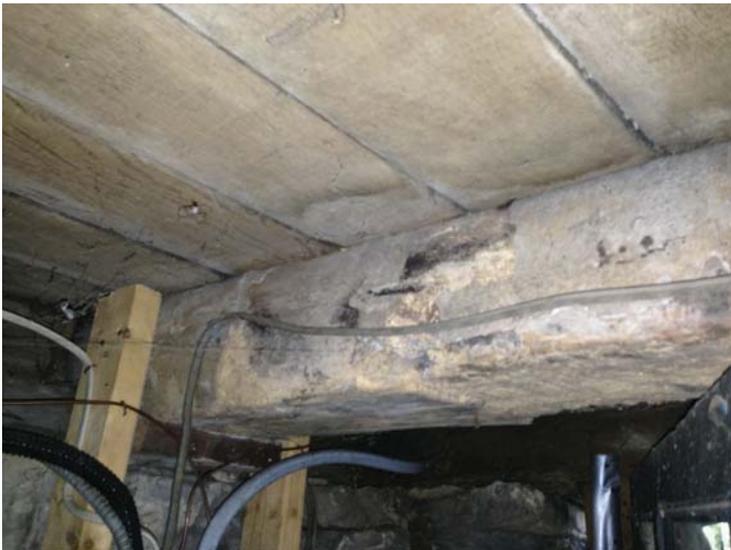
“From a structural point of view, the house has numerous areas of concern. Most of the first floor framing members (visible in the crawl space and cellar) show evidence of insect infestation and some dry rot, are sagged visibly in some areas, and have been reinforced and shored up in an attempt to alleviate this damage. This has resulted in the floors of both the first and second levels being somewhat out-of-level, and it is clear that the framing is of questionable loading capacity. The roof over the second level bedrooms is also a concern, as seen both from the exterior and from the interior second level. The roof and ceiling have both sagged visibly, again being indicative of undersized framing and the resulting loading concern. The walls of the exterior porches are also quite out of level, both at floor line and roof line, and it’s quite likely that their foundations are shallow and subject to settlements and frost heave.

Insect infestation and shoring

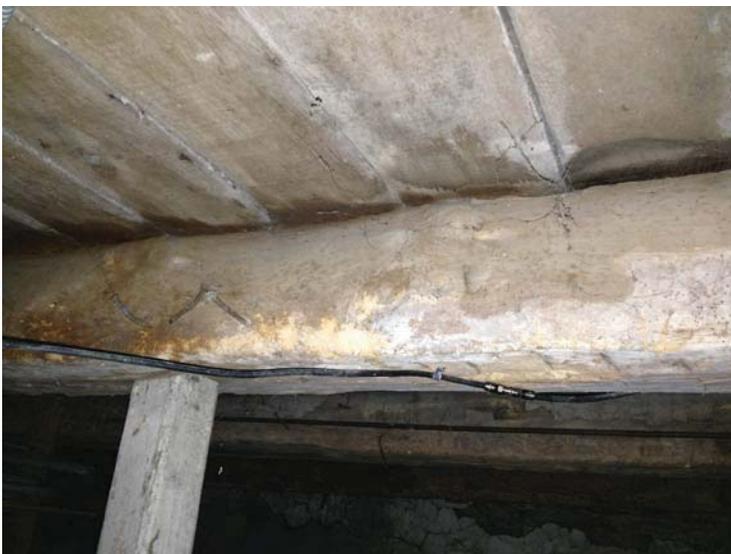
Insect infestation

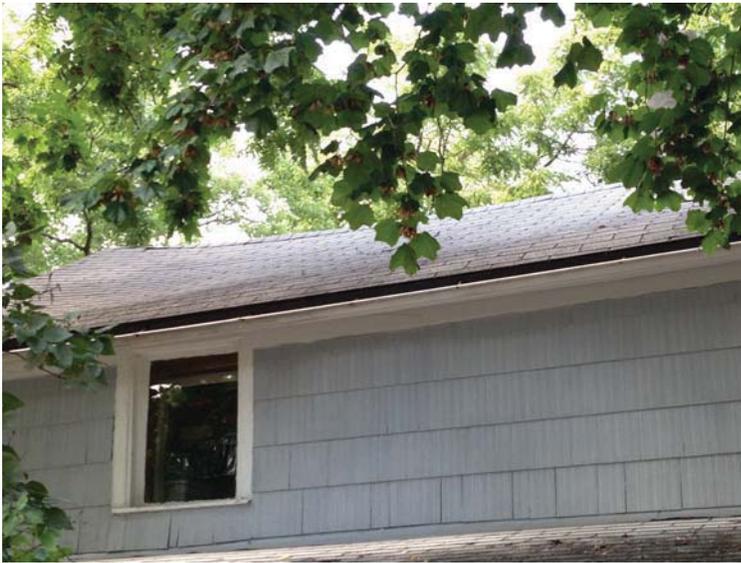
The roof needs significant repair or replacement due to sagging beams and major water damage. The roof structure is visible sagging into upper level attic space.

Sagging roof

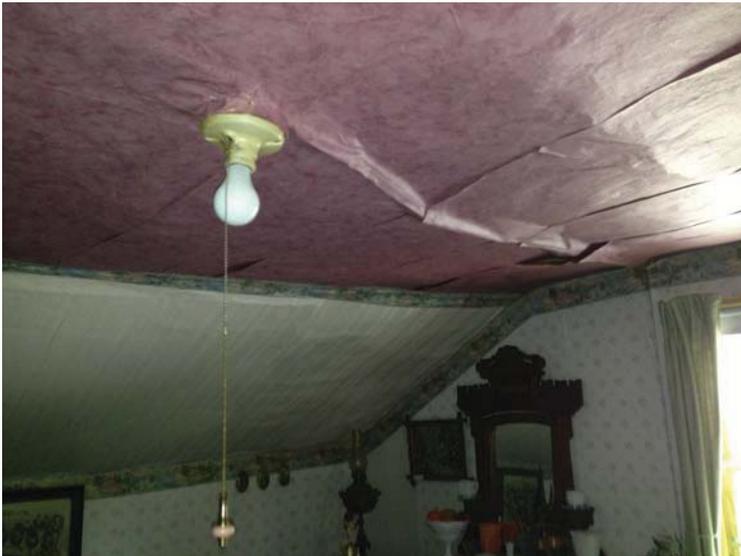
The foundation deterioration and decay of the wood structure has caused the floors and roof beams to sag and settle. Walking on the sloping floors and the ability to push move the ceiling with your arms make it feel unsafe to be in the home.

Sagging ceilings

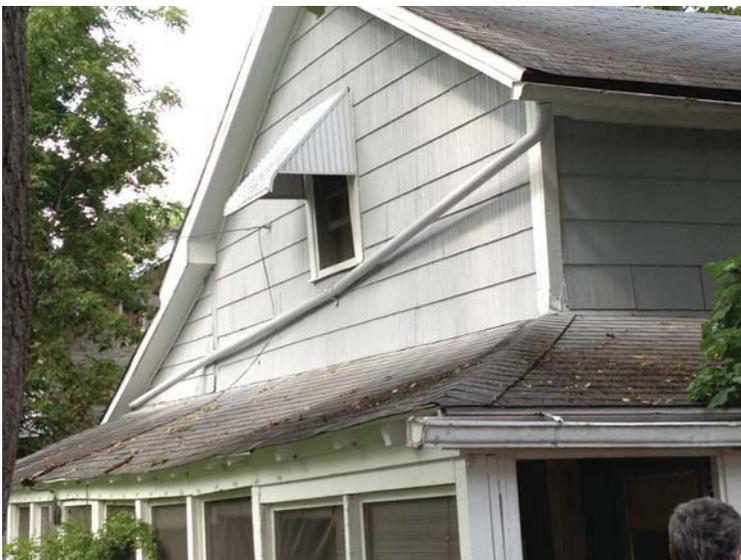
Out-of-level porches

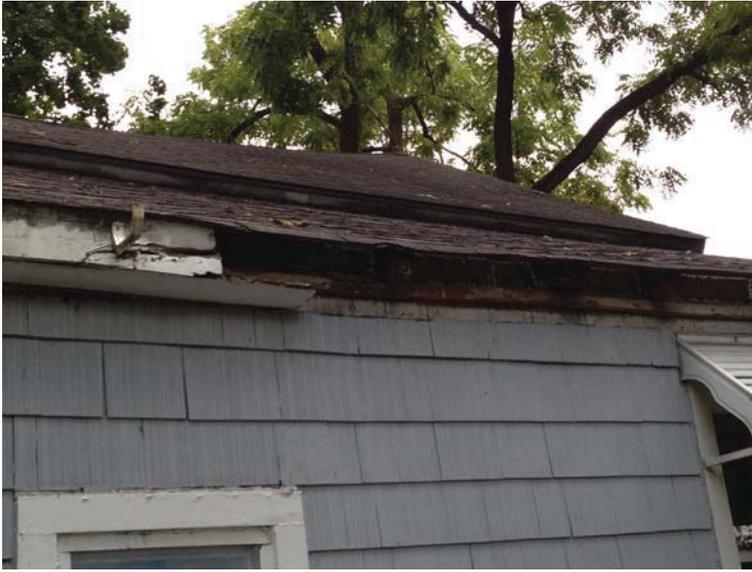
In addition, maintenance of the home has been lax, resulting in missing soffits and rotted ends of rafters. Overall, the home is in relatively poor condition. Repair of these items to conform to current residential code standards would require significant replacements of floor framing and foundations, along with quite a bit of miscellaneous reconstruction. While this is technically possible, it would almost assuredly not be economically viable or realistic for a residence in this poor condition.

Missing soffits and rotten rafter ends

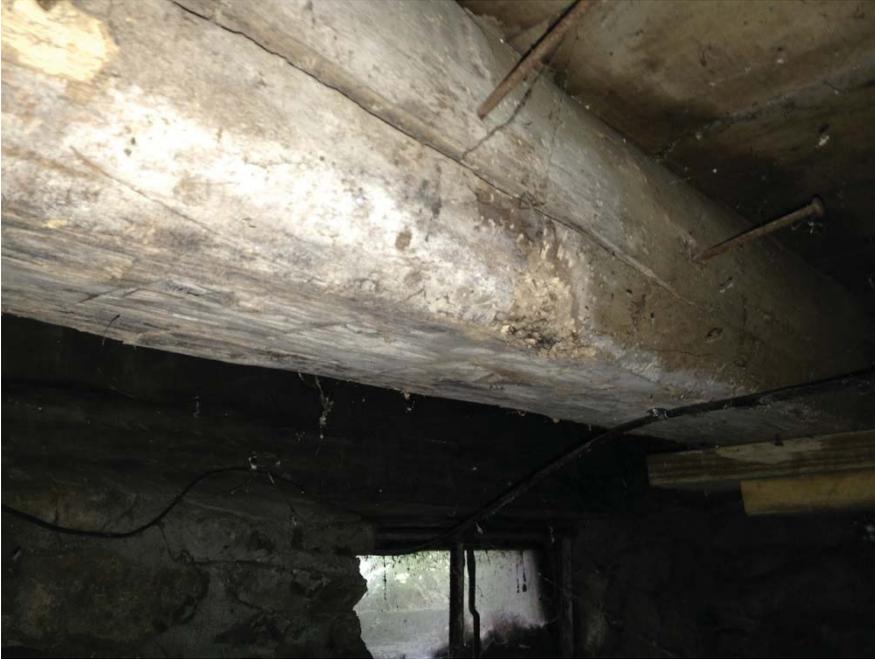
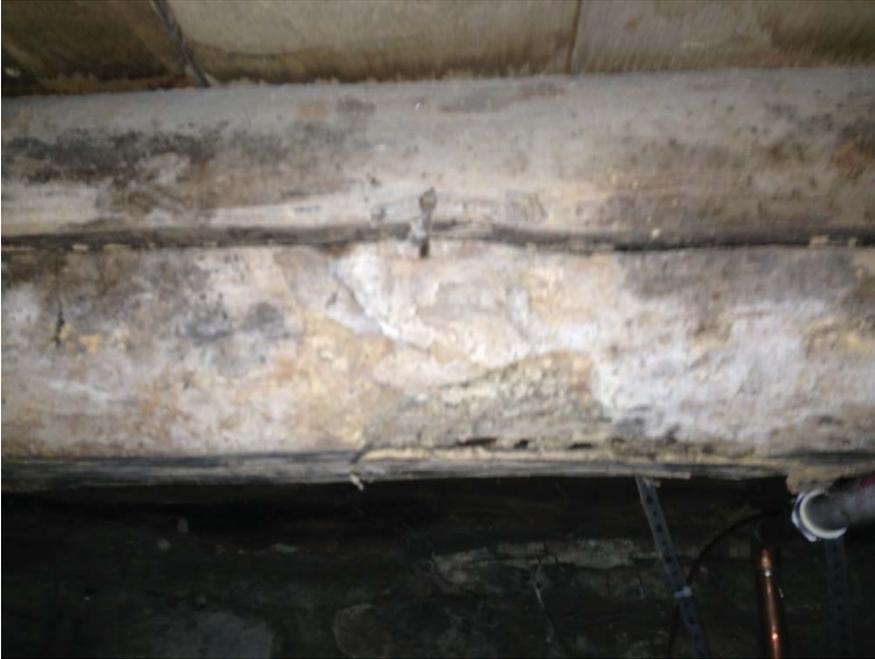
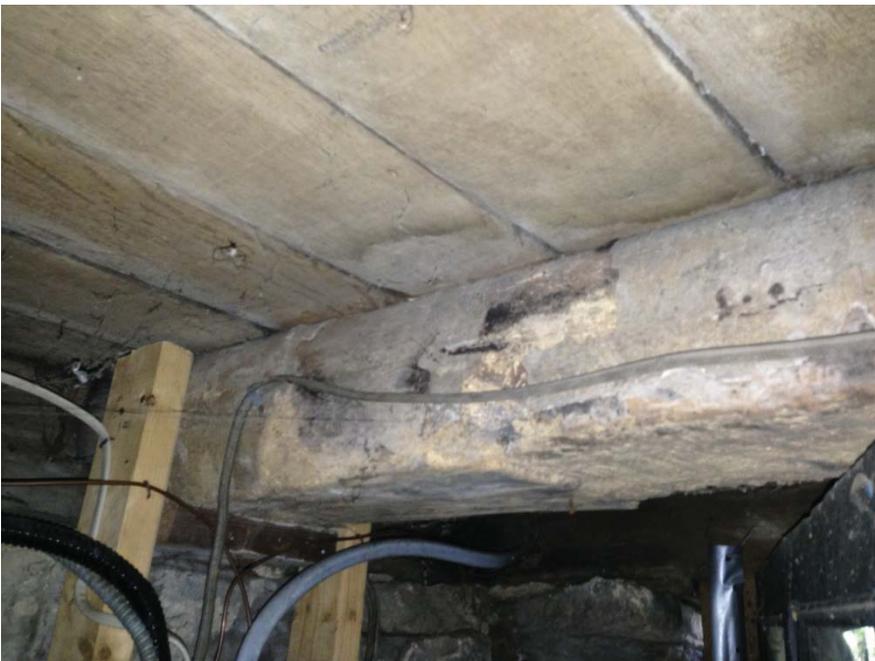
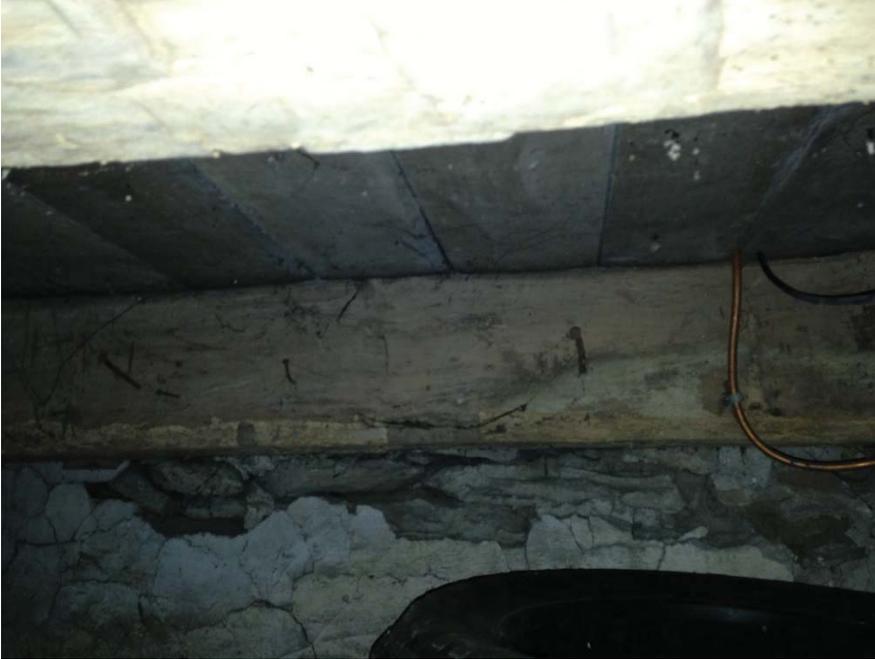
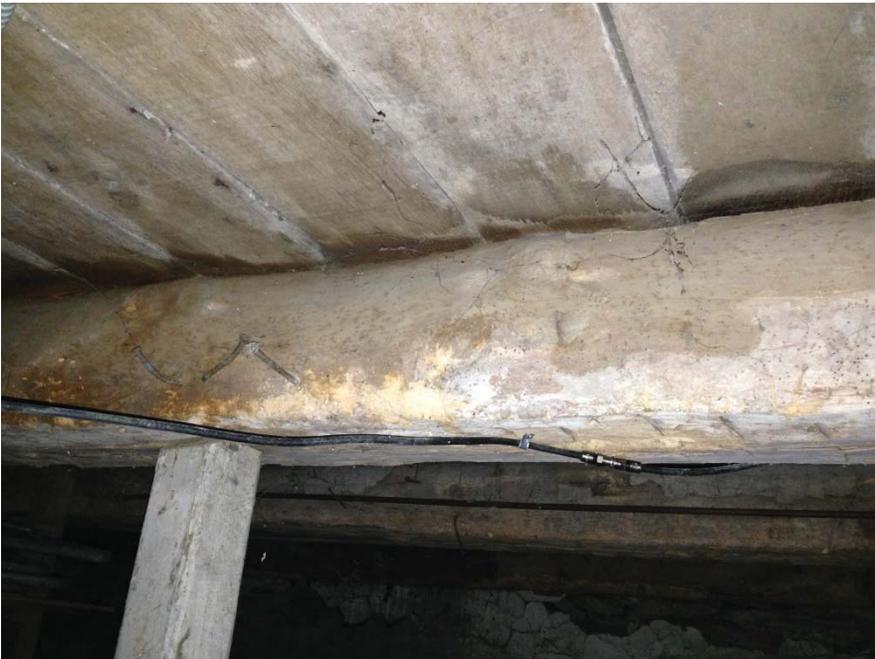
The foundation is crumbling, and the beams have cracked and have been damaged by insects and age. All the windows and doors need replaced. A significant amount of wood trim needs replaced, as it is rotting or completely missing.

Framing/Beam Damage

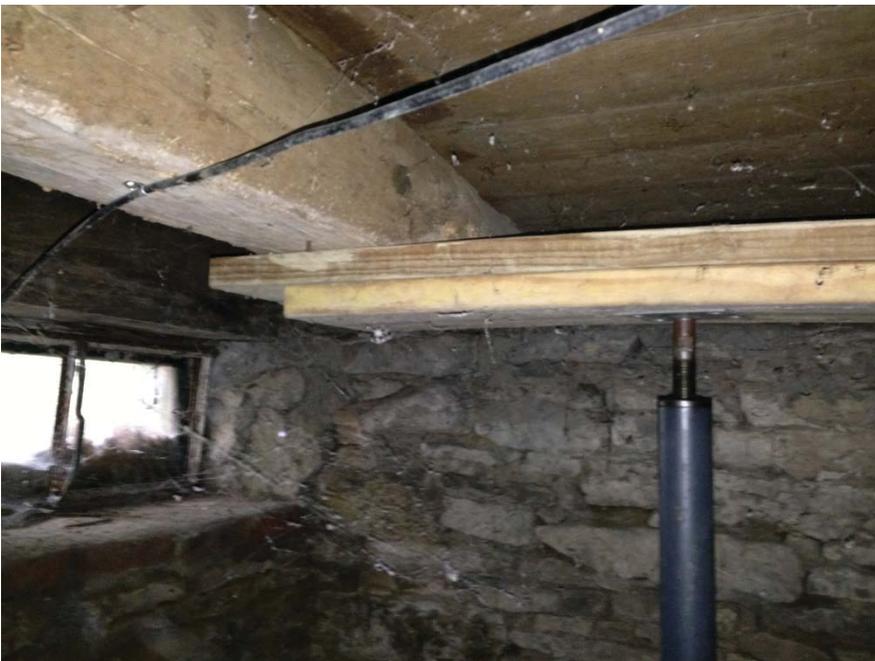
Framing/Beam Shoring

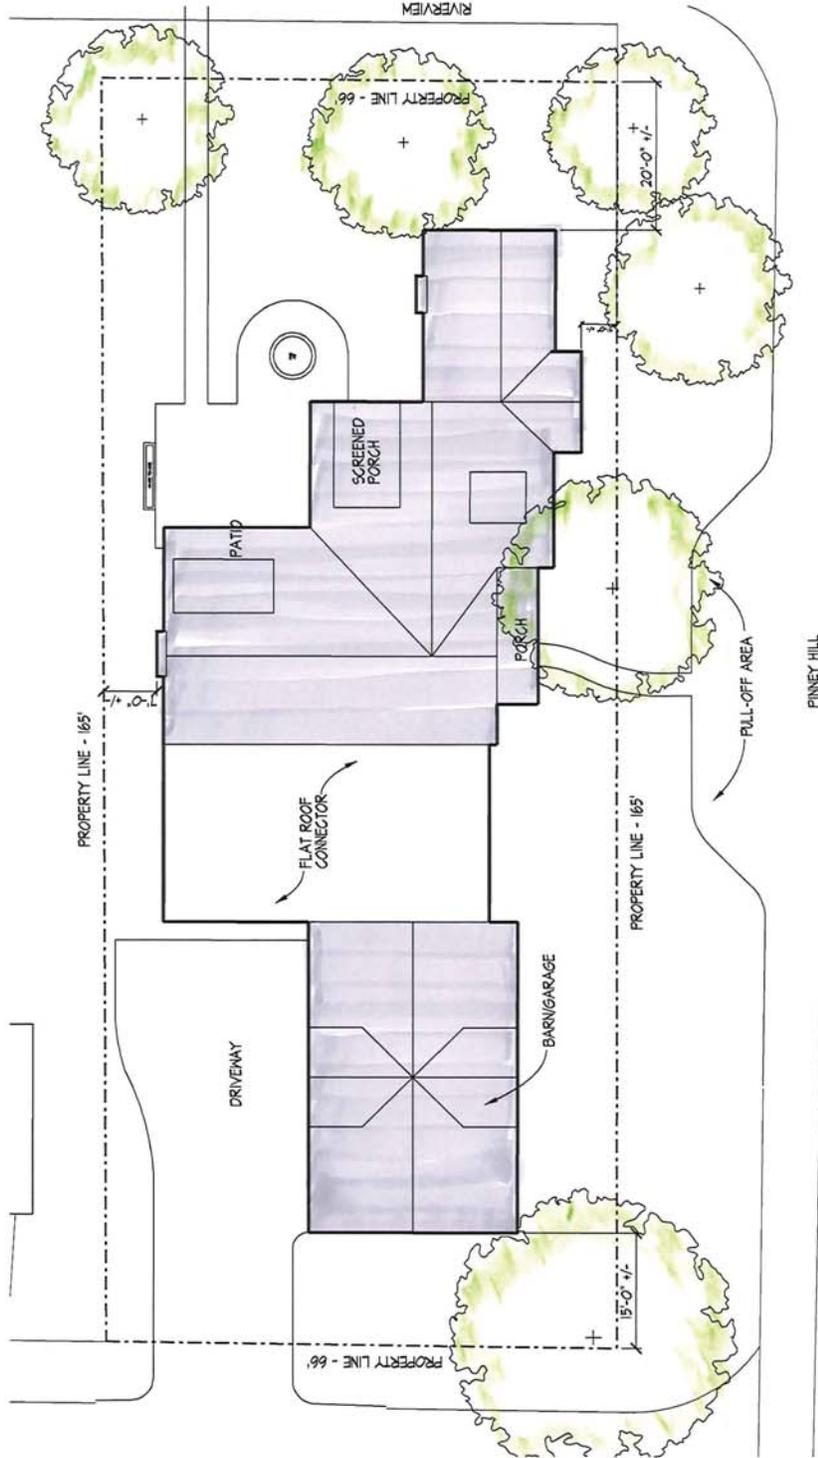
LOT COVERAGE CALCULATIONS:

LOT SIZE : 165' X 66'		
TOTAL AREA: 10,890 SQ. FT.		
BUILDING FOOTPRINT (INCLUDES FRONT PORCH): 4238 SQ. FT.	39%	
REAR DRIVE: 1134 SQ. FT.	10.5%	
SEMI-PERMEABLE PATIOS & WALKWAYS: 742 SQ. FT.	7%
