# **Asbestos Survey Report** **The Former Residence Located at:**

190 North High Street, Dublin, Ohio, 43017

February 2, 2016

On January 11, 2016, an asbestos survey was conducted on the vacant single-family residential building with attached garage located at 190 North High Street, Dublin, Ohio. A floor plan of the building was not available for review prior to the survey. The scope of work for the survey included the sampling, assessment, and analysis of all suspect Asbestos Containing Materials (ACMs) within and on the existing structure prior to demolition.

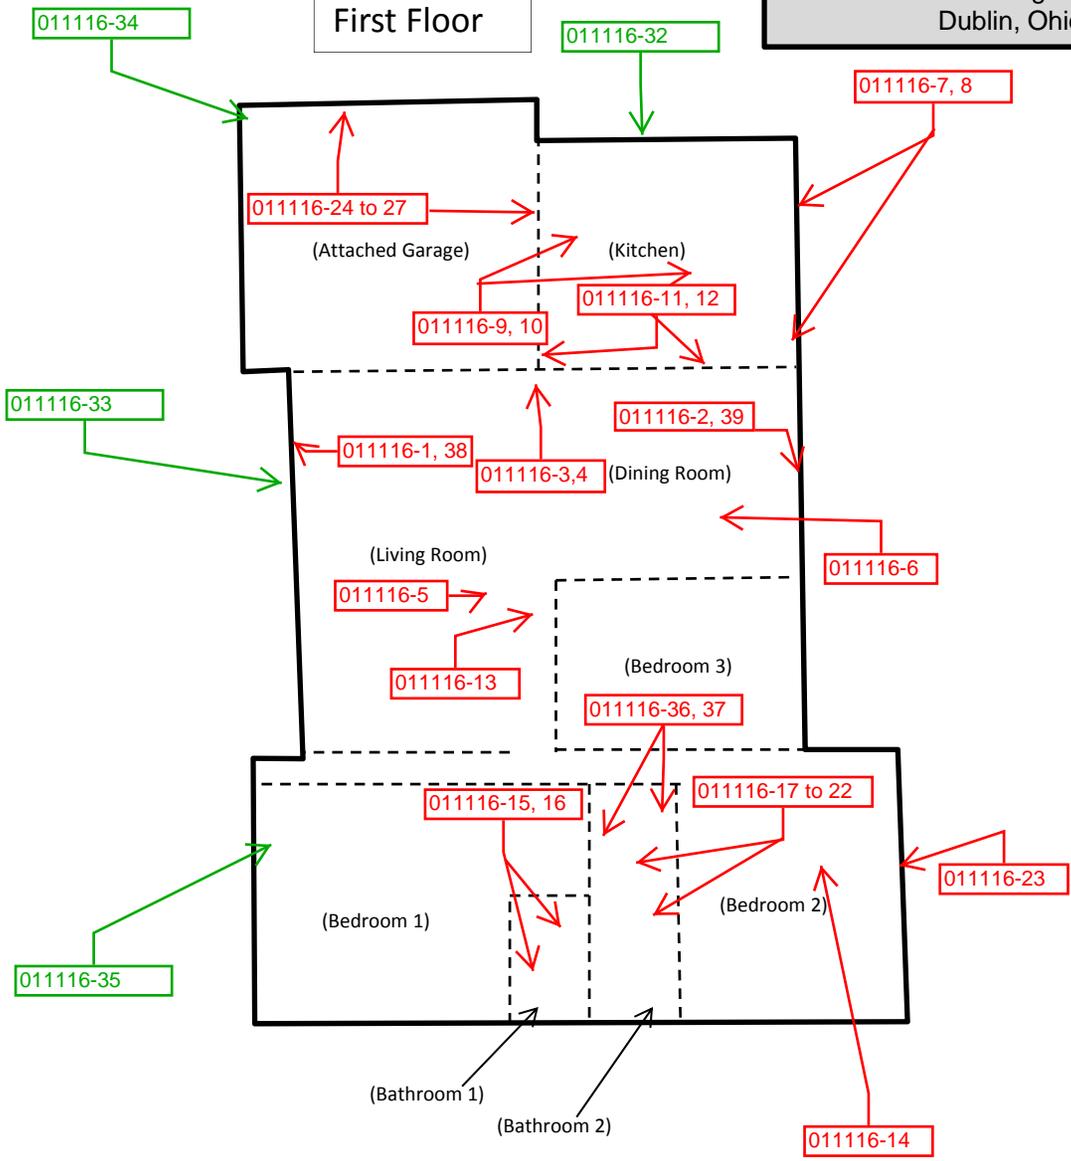
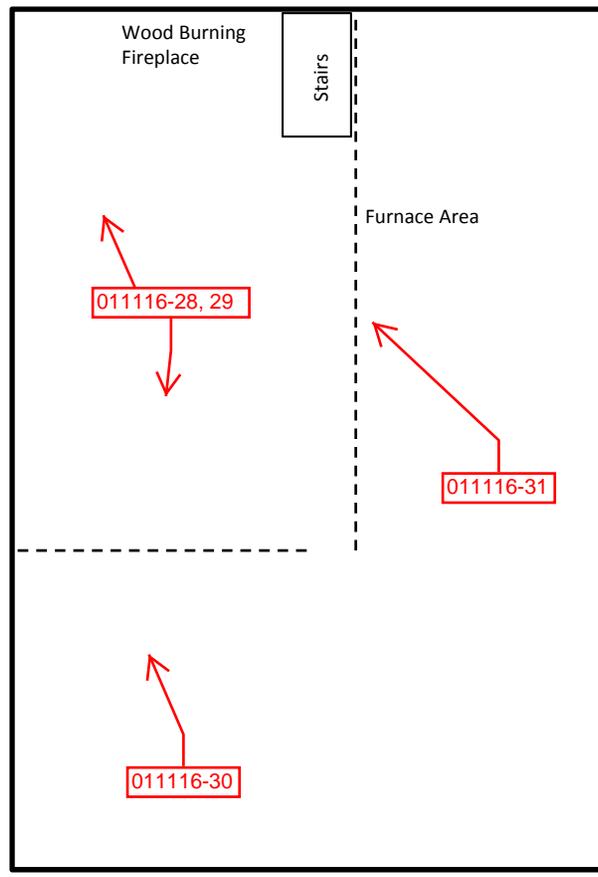
# Sample Location Maps

## First Floor

## Basement

- Interior Wall
- Interior Sample Location
- Exterior Sample Location

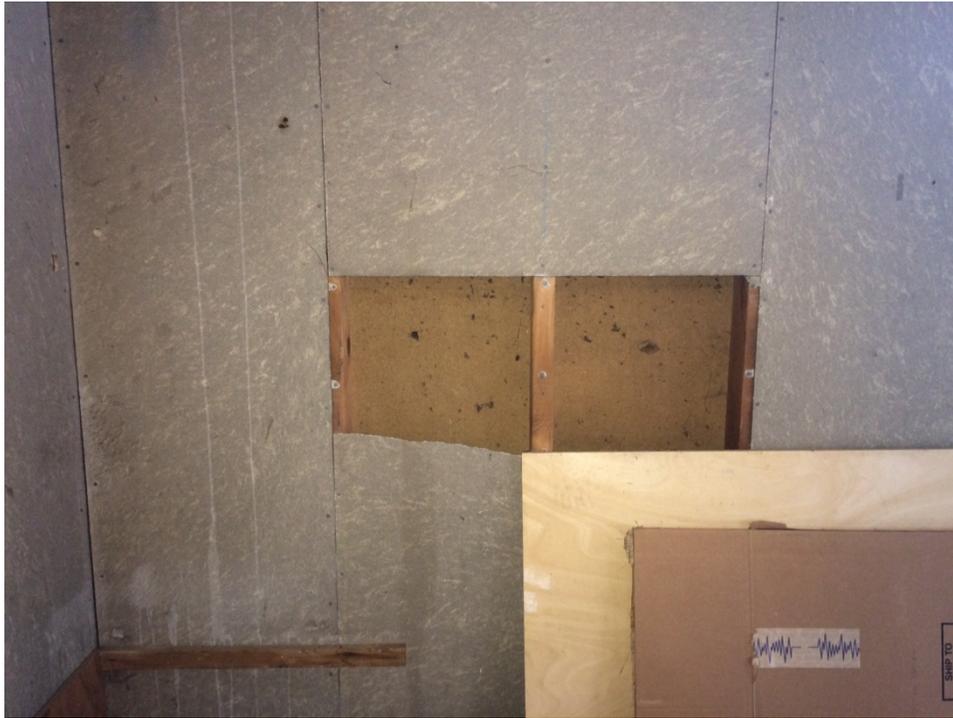
The gray cement wall board located on the interior walls and ceiling within the garage is a Category II Non-Friable ACM and would potentially become friable during normal demolition activities. As such, this wall board should be removed prior to demolition per the Asbestos NESHAP and ODH regulations.

Photograph 1 – Gray cement wall board containing 20% chrysotile asbestos covering all walls and the ceiling within the attached garage. Samples 011116-24 and 011116-25.

The white duct tape located along the metal duct seams is a friable material and the interior gray cement wall board within the garage is likely to become friable during normal demolition activities. These materials should be removed by a licensed abatement contractor prior to demolition per the Asbestos NESHAP and ODH regulations.

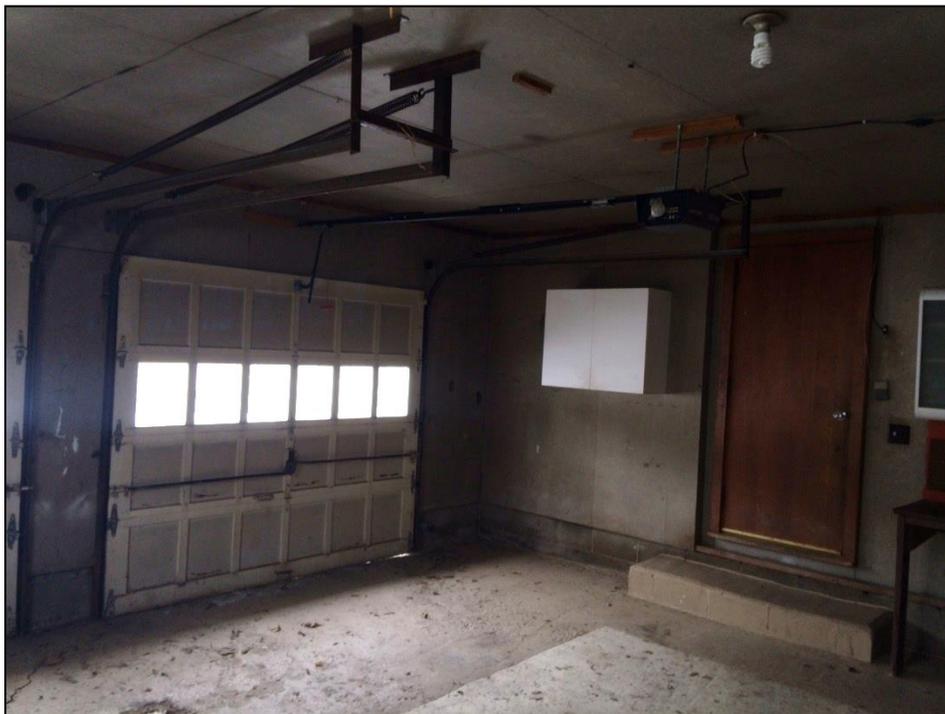
Photograph 2 – Gray cement wall board containing 20% chrysotile asbestos covering all walls and the ceiling within the attached garage. Samples 011116-24 and 011116-25.

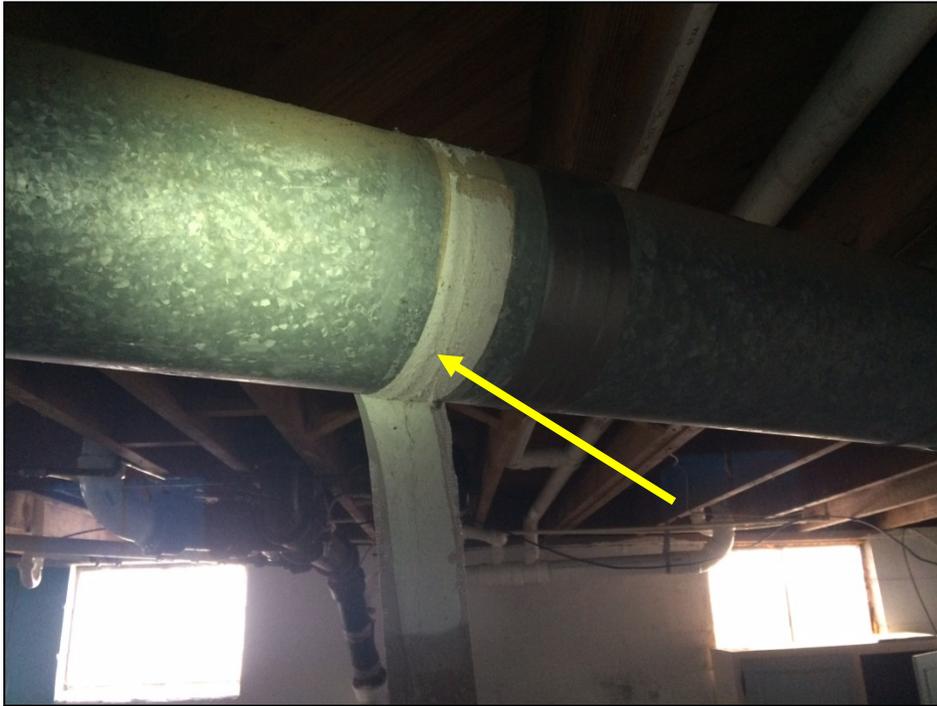
The white duct tape located along the metal duct seams contains 40% to 60% asbestos. Such material is considered to be friable and should be removed per the Asbestos NESHAP and ODH regulations.

Photograph 3 – Asbestos-containing duct tape (white) on duct seams in basement containing 40-60% chrysotile asbestos. Samples 011116-32 and 011116-33.

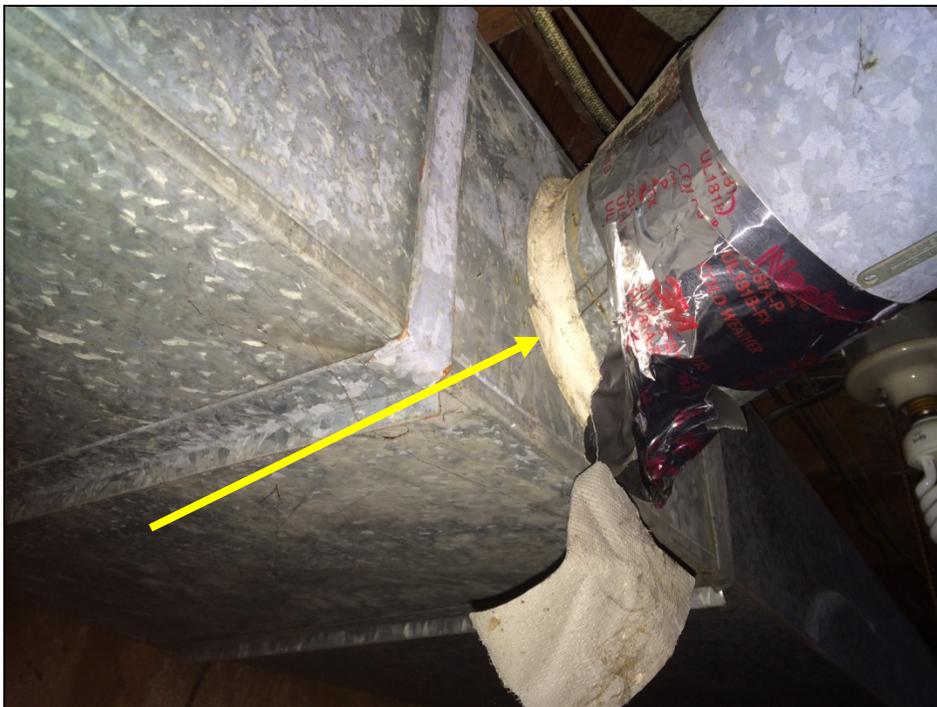
Photograph 4 – Asbestos-containing duct tape (white) on duct seams in basement containing 40-60% chrysotile asbestos. Samples 011116-30 and 011116-31.

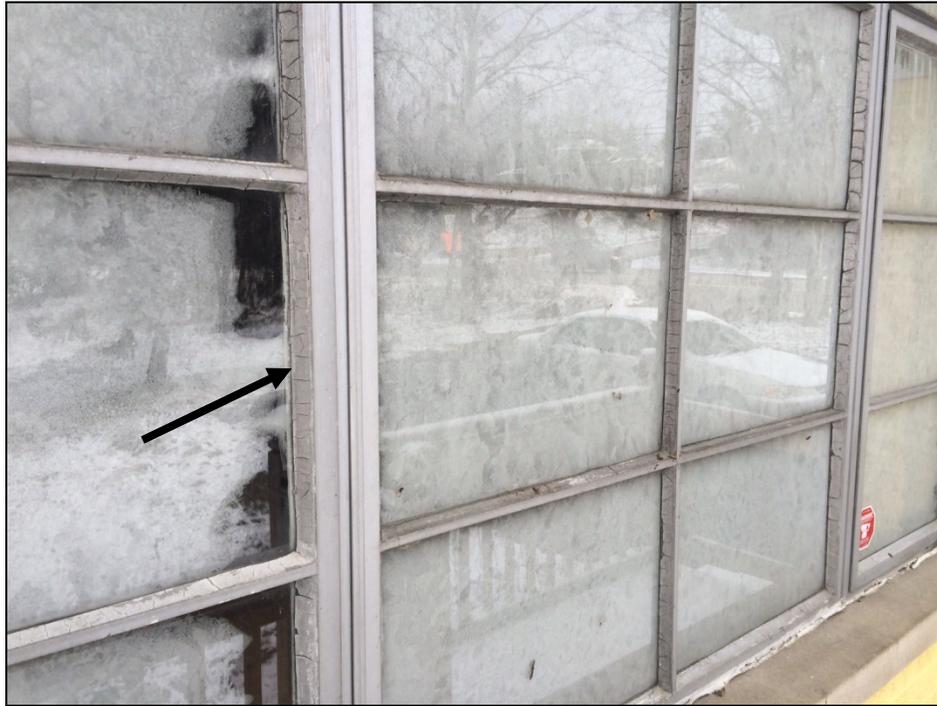
Photograph 5 – Non-regulated exterior gray window glazing containing <1% chrysotile asbestos. Samples 011116-32 and 011116-33. Asbestos content within the glazing was confirmed via point-counting.
