MEMO

Re: Stone Retaining Wall located on 40 N High and partially on 38 N High; Review
of Status, Options and Recommendations

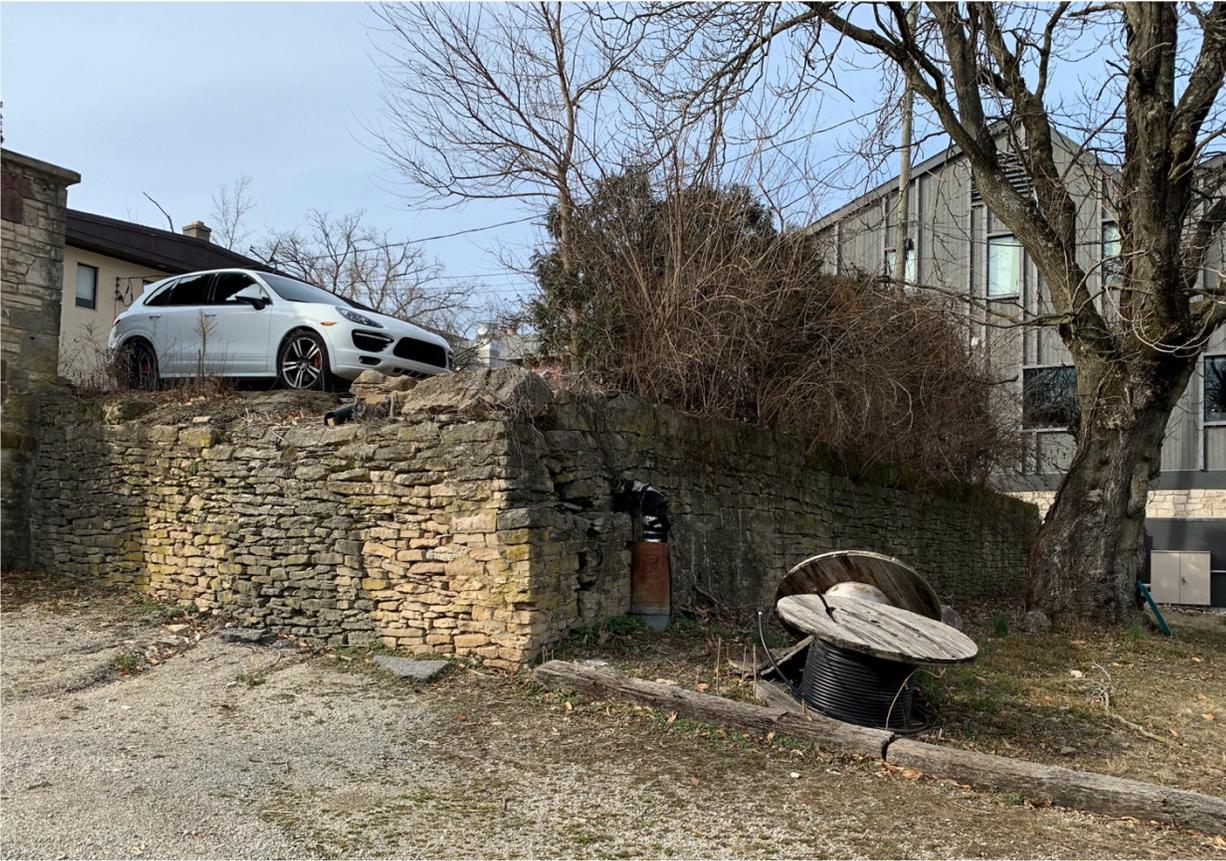
Figure 1. Photograph of the dry-stone retaining wall taken from 38 N High's rear lot looking north-northwest. The bowing wall can be seen in line with the auto's front wheel, as can the lower stones shifted east just north of the southeast corner. The sewer pipe and dry wall joints infilled with mortar lie to its immediate north. (Preservation Designs, February 8, 2023).

The wall shows continued deterioration due to plant infestation and development. Plants growing on or near the wall have compromised its structural integrity. In addition, the wall was not designed to support the weight of cars parking above. And past alterations such as the installation of the sewer pipe near the southeast corner and grouting the area with mortar have further diminished its structure. Other areas of concern include a vertical crack just north of the southeast corner and a visible bulge in the south wall as outlined in the Korda report. (See Photographs 1–4 for further information.) Without substantial additional research, it is impossible to know when errors were made leading to the wall's present deteriorating state. And this information would have no impact on our proposed course of action.

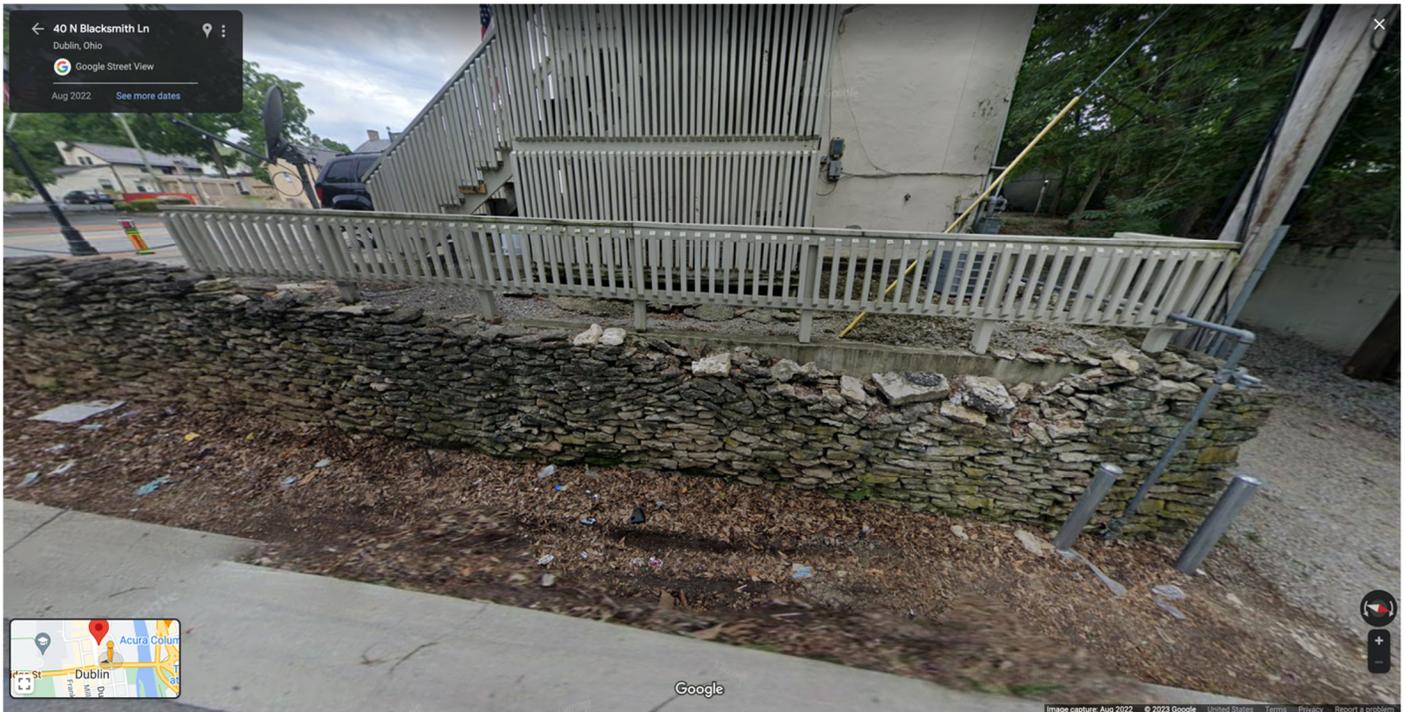
Figure 2. Photograph of a concrete retaining wall with dry stone facing, taken at the northwest corner of N Blacksmith Lane's intersection with E Bridge Street, looking west. This retaining wall best represents the outcome if Option 2 were chosen; having a single wythe of dry stone loosely stacked against the concrete would need better detailing (including structural ties) to prevent failure and physical loss (Google Maps Street View, August 2022, downloaded February 25, 2023).

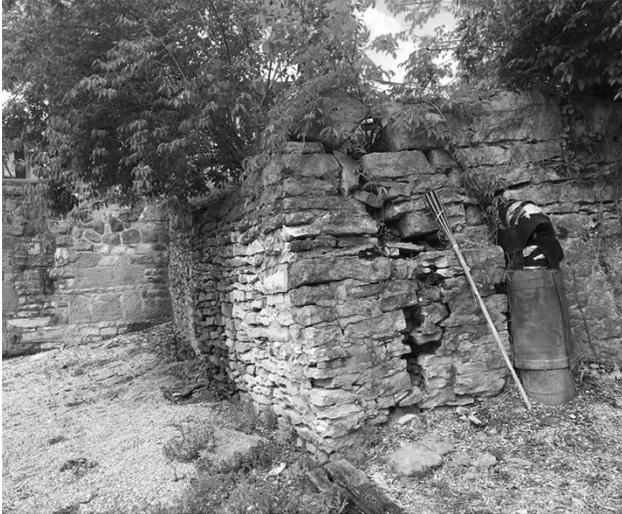
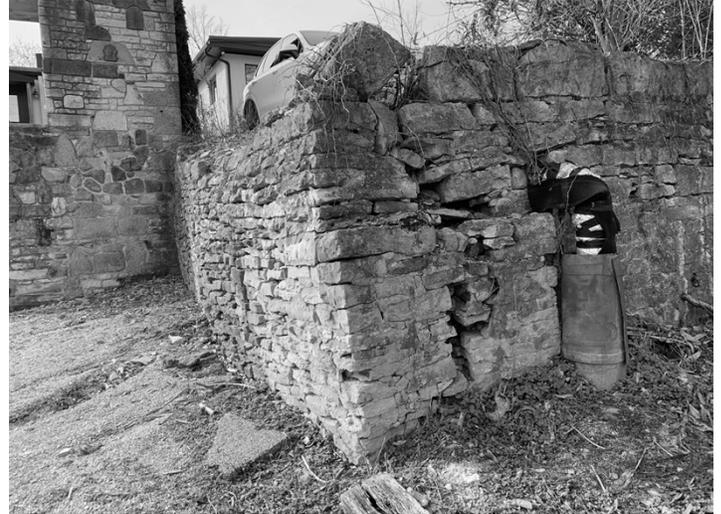
1) Southeast corner of wall, looking west (May 2021).

2) Southeast corner of wall, looking west (February 2023).

While taken almost two years apart, there is little difference between the two, except the runoff from the base of the bulge appears to have progressed on 38 N High's gravel area. The bulge on the south wall may have increased, but since the photo angle is not exact, this may be a visual illusion. Similarly, the bottom portion of stone at the southeast corner just as the thrust east at the corner may have increased slightly.

Without intervention, the stone wall will fail -- most likely on the south elevation or at the southeast corner. While it is impossible to predict a date of failure since it involves variations in weather, temperature, and usage, regular monitoring by city personnel (such as measuring the growth of the bulge every couple of weeks) could help estimate when and where the failure will occur. For example, photographic comparison might indicate the south elevation's bulge has progressed since May 2021 [Photograph Section, photos 1 and 2].

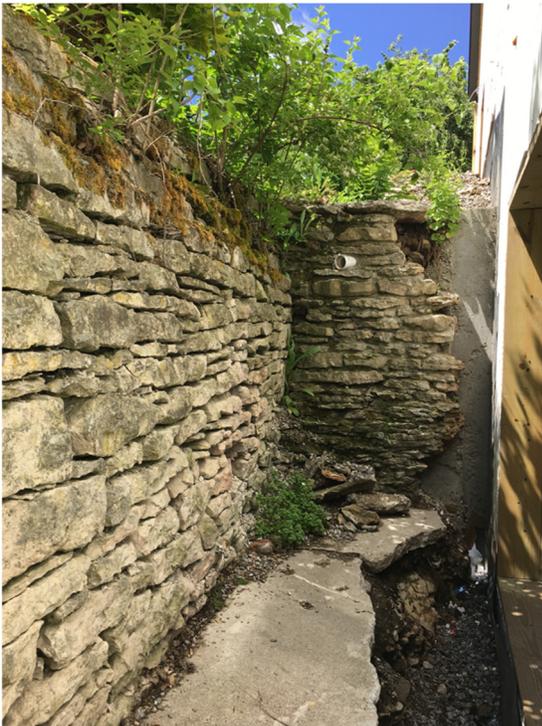
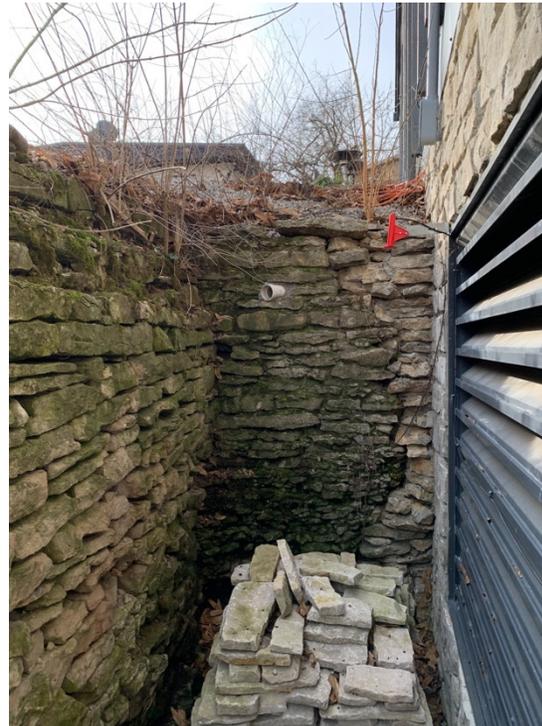
3) North end of wall, facing West (May 2021).

4) North end of wall, facing West (February 2023).

Both photos show the short jog on the wall's north end, and how it runs into the new COhatch building. The COhatch contractor appears to have constructed a partial wing wall of concrete, facing it with local stone and mortar to intersect the older wall. The approximately 3-foot-wide stone leg's condition cannot be easily understood partly due to the moss growing between stones. This entire section feels damp, and excess construction material should be removed.

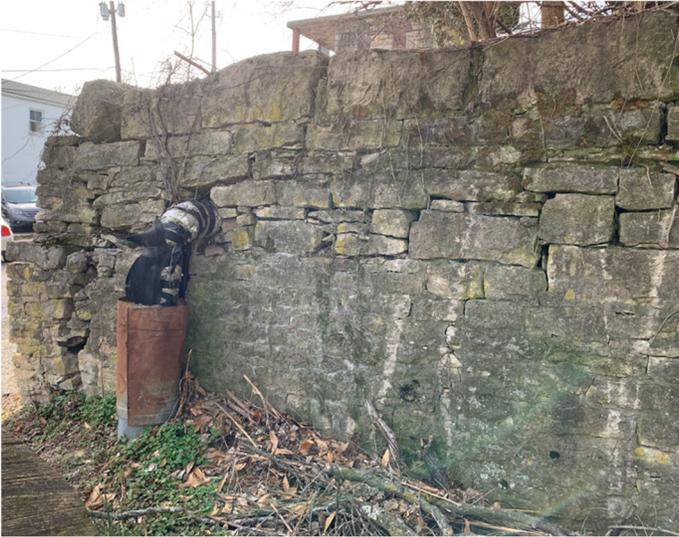
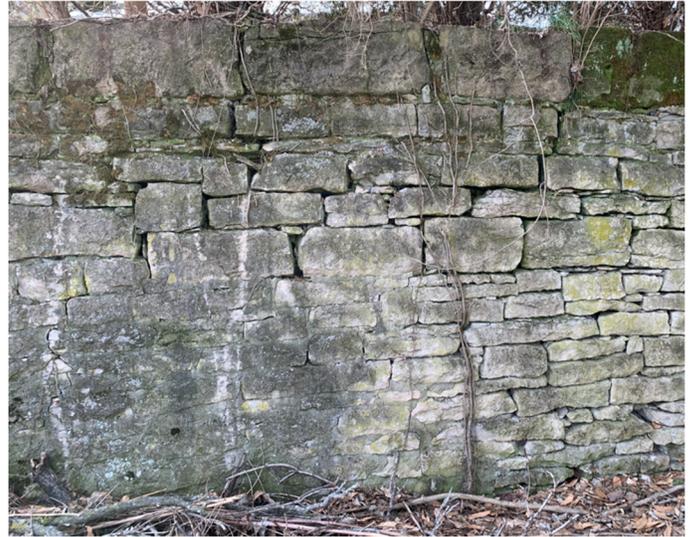
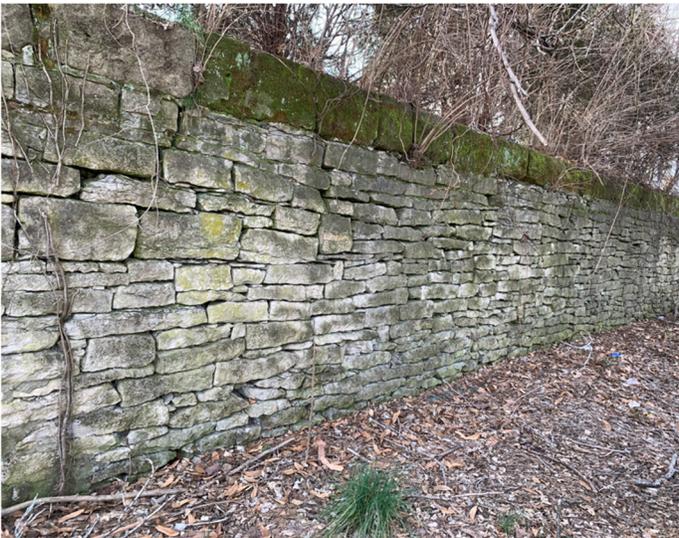
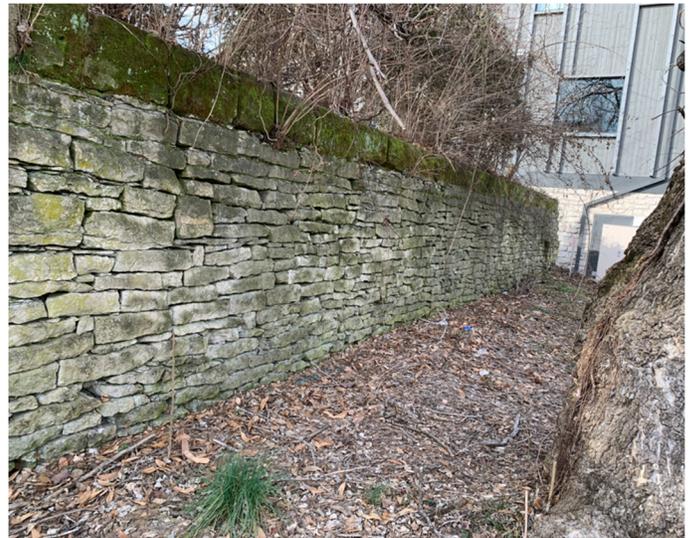
5) East wall detail, looking southwest (February 2023).

6) East wall detail, looking west (February 2023).

7) East wall detail, looking northwest (February 2023).

8) East wall detail, looking north-northwest (February 2023).

The four images above are meant to show the overall appearance of the wall's east elevation not blocked by the tree or debris. Photos 5 and 6 show a large area of mortared infill on the bottom half of the wall. The large block stones on the top of the wall visible in most of these photos appear to be missing from the south elevation. It is believed the large stones sitting on 38 North High behind the building might correspond to the missing top row of stones from the wall's south elevation.
