## Stone Walls

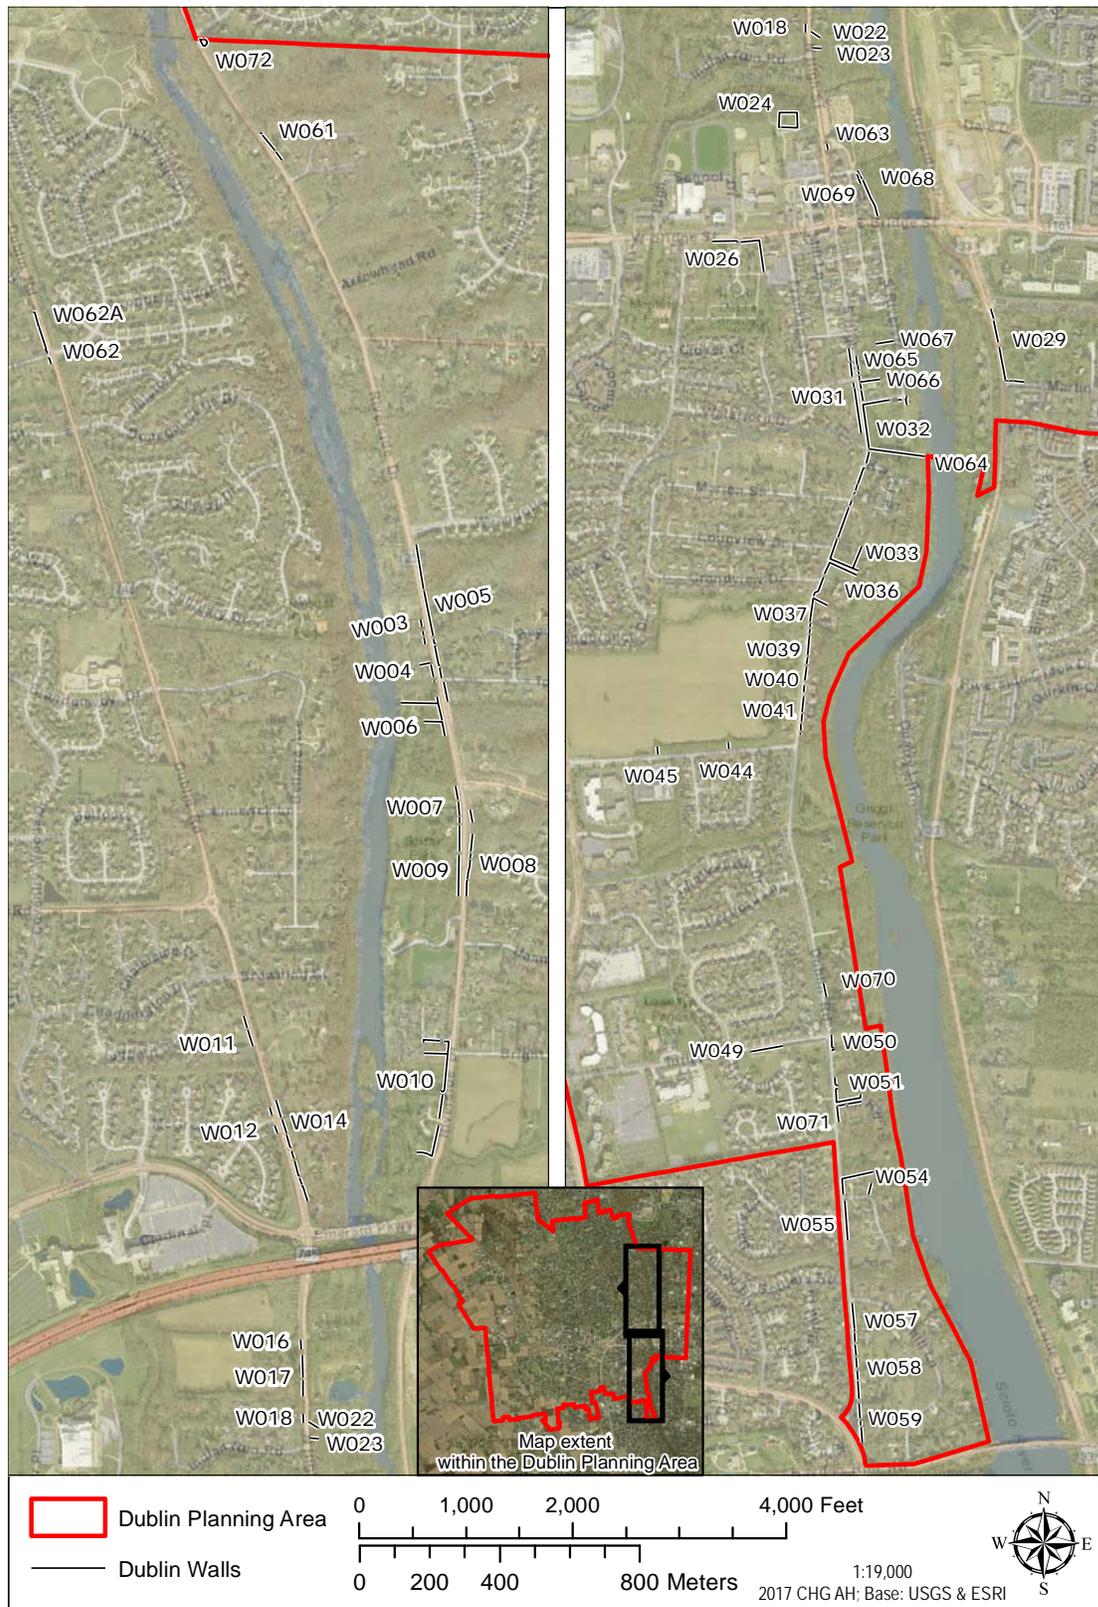
Figure 91. Locations of all extant, surveyed stone walls

A spatial inventory of stone walls was included with the NRHP nomination for the Washington Township MRA (Klimoski 1979) and served as the basis for the list of previously documented stone wall resources. Fifty-nine separate historical stone wall remnants were drawn on a 1:24,000 USGS topography map as part of the nomination package. Each of these stone walls was coded in the GIS, given a unique identifier starting with the letter W, and included in a summary table with basic locational and descriptive information that was generated for the field survey. Each recorded location was visited and, if a wall was present, it was described, measured, and photographed. During the field survey it became apparent that some of the previously recorded walls had either been mapped inaccurately or were no longer in existence. In addition, the field team discovered stone walls that were older in appearance, but which had not been recorded in the Washington Township MRA. These unrecorded walls were also documented and added to the master list of surveyed stone walls. Note that recently constructed walls, such as those that were obviously created as part of a transportation or housing project, were not included in the survey. The location of all extant, surveyed stone walls are shown in Figure 91.

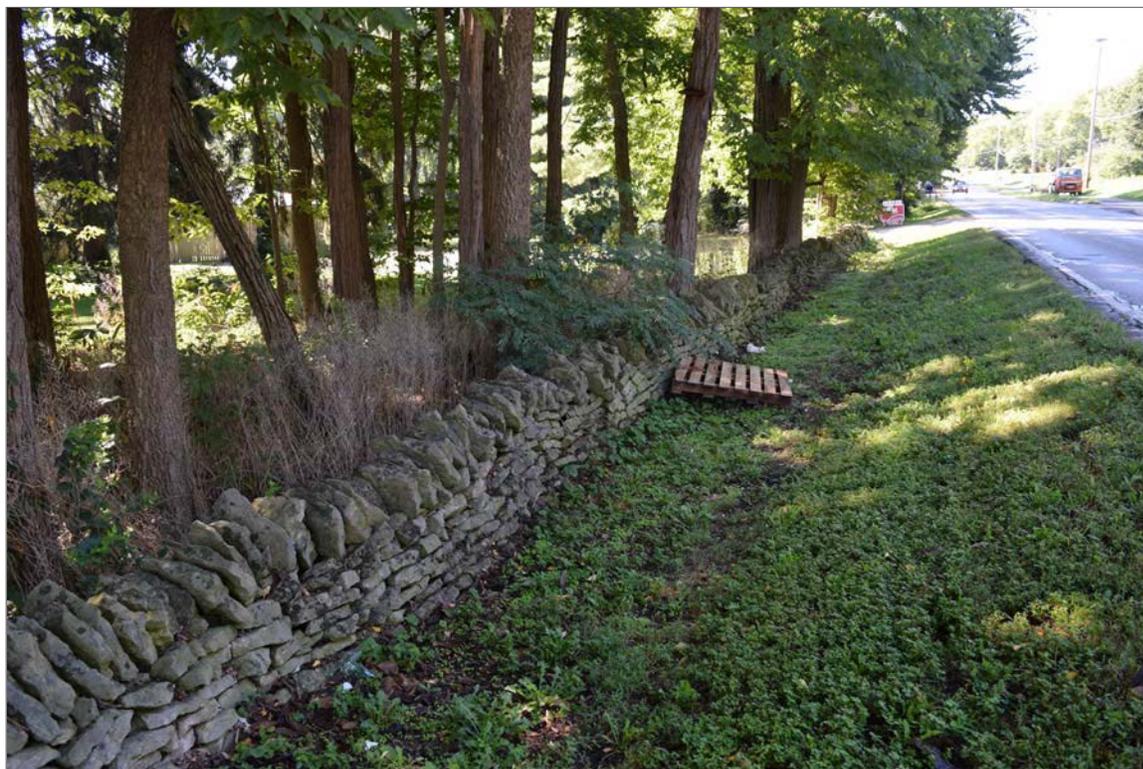
Figure 92. Example of lower wall with slightly smaller stones (Wall W033 along Riverside Drive, looking south

Surveyed traditional dry-laid stone walls are all very similar in appearance and construction, but vary in terms of the size of the limestone slabs used and overall dimensions. Walls were made of either small limestone slabs (under three inches thick and less than one foot long, as shown in Figure 92) or they were made from slabs of limestone that were larger (see Figure 93). It is suspected that the size of the stone in the vertical top course may be related to the age of the wall, either as the result of mechanical breakdown of the rock or changing

construction practices through time. Walls made with the smaller stones are typically no more than three feet in height. Walls made with the larger stones are wider and taller, averaging over three feet in height. This is an interesting difference in light of stone mason Eli Pinney's recollection that the walls were designed to fence cattle and were typically between 42 and 48 inches in height (Valentine and Bauer 2016). Pinney's description matches the description of nearly identical dry-laid stone walls found in Kentucky's Bluegrass region. Hart (1998:185) notes that stone livestock fences became more popular in the 1840s after timber had been depleted in the Bluegrass Region. The fences were typically five feet in height "with smooth sides that tapered from a width of three feet at the base to eighteen inches at the top" (Hart 1998:187). Hart (1998:187) also states that by the 1880s dry-laid stone walls became more expensive to construct and maintain because of labor costs so that their popularity diminished, except to those who could afford to construct them as status symbols. By the 1920s and 1930s many stone walls in the Kentucky Bluegrass region were removed so that roadways could be widened for the automobile (Hart 1998:187). It is possible that the difference in height among Dublin's stone walls is related to age or relocation. It may be that as walls deteriorated or were moved, they were not built as high because they no longer functioned as livestock fences. In conjunction with this practice of partially rebuilding walls, it is possible that only the top vertical courses were reset to maintain the original appearance of the walls. In Dublin, very few traditional dry-laid stone walls are missing the top vertical course. Some walls without this vertical top course appear to once have had it since the rest of the wall construction is the same as those walls with vertical top courses. It is also interesting to note that only a very few of the traditional dry-laid stone walls in Dublin have repairs or patches of cement along the lower courses, although some have had the top vertical course set in cement.

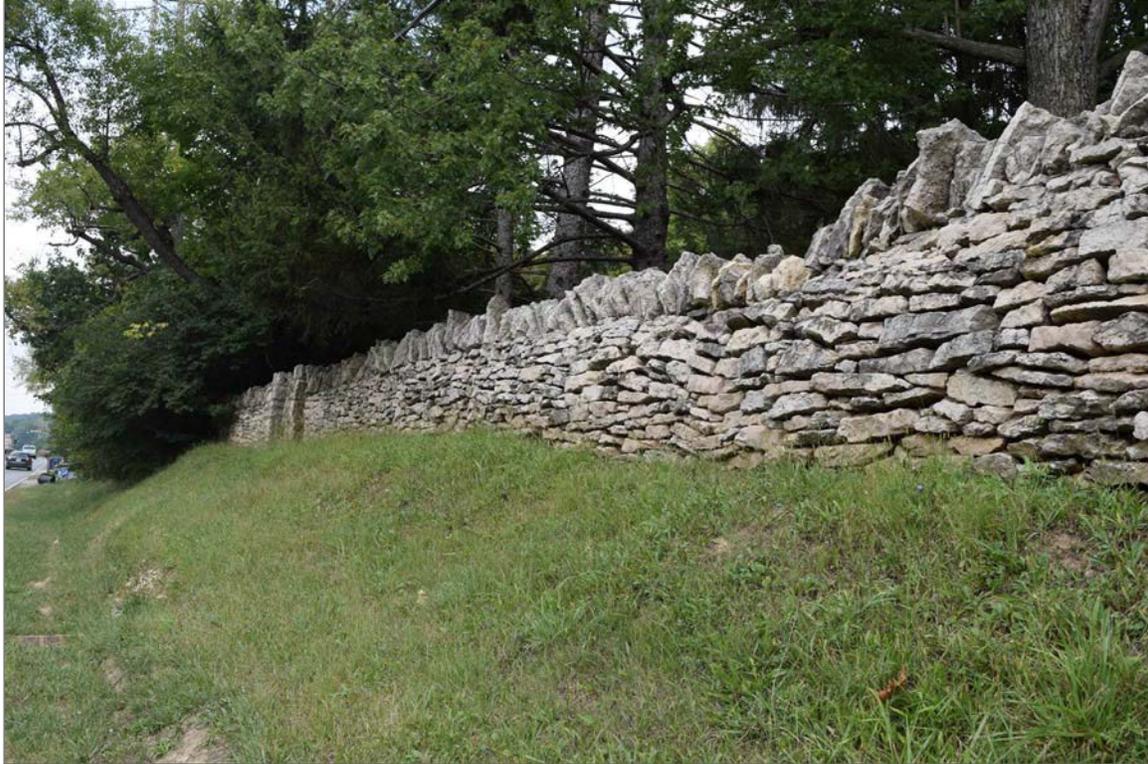
Figure 93. Example of taller wall with larger stones (Wall W005 along Riverside Drive, looking north)

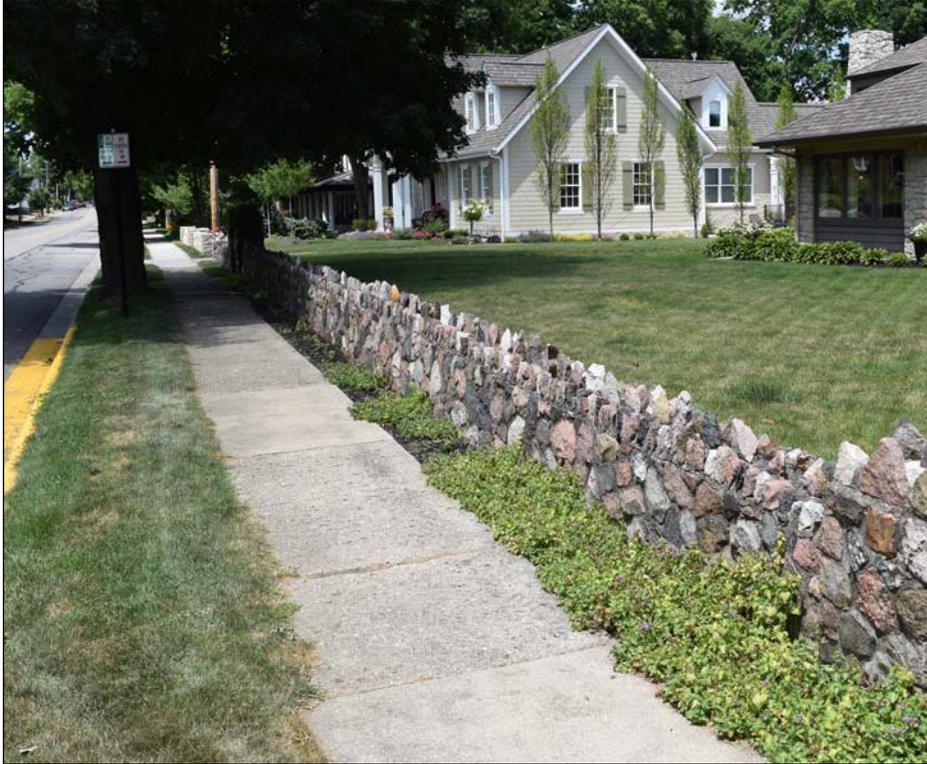
Figure 94. Example of an atypical stone wall (W065A) in front of 824 S. High Street, looking northeast

Dublin's atypical stone walls appear to be related to individual property owner's preferences rather than any larger trend. In general, these walls tend to be along residential property boundaries, are mortared, and may feature rounded rather than tabular stone. A greater diversity of raw material types is also common. Figure 94 depicts one of the atypical stone walls of Dublin.

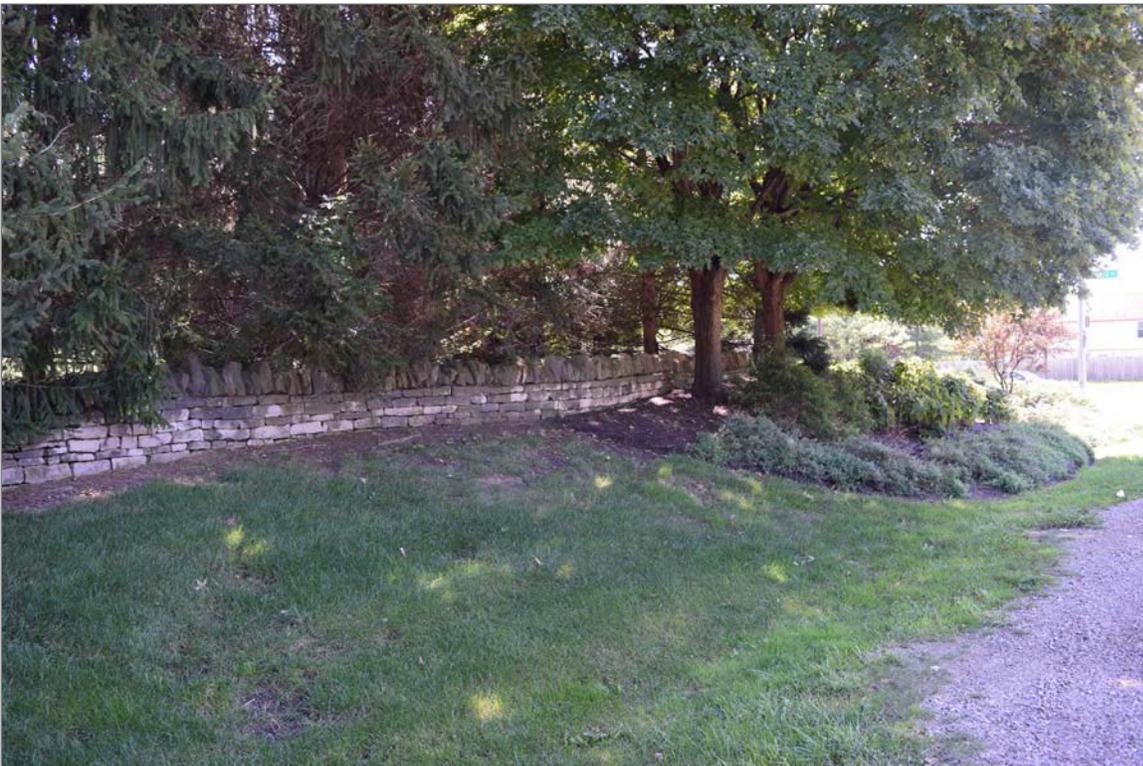
Figure 95. Modern wall with square, cut stones, near intersection of Dublin and Frantz Roads, looking southeast

Walls built within the last 10 years tend to be of machine cut, square slabs, as depicted in Figure 95, and the walls built in 2016 as part of the trail project were constructed with mortar between the courses (Figure 96).

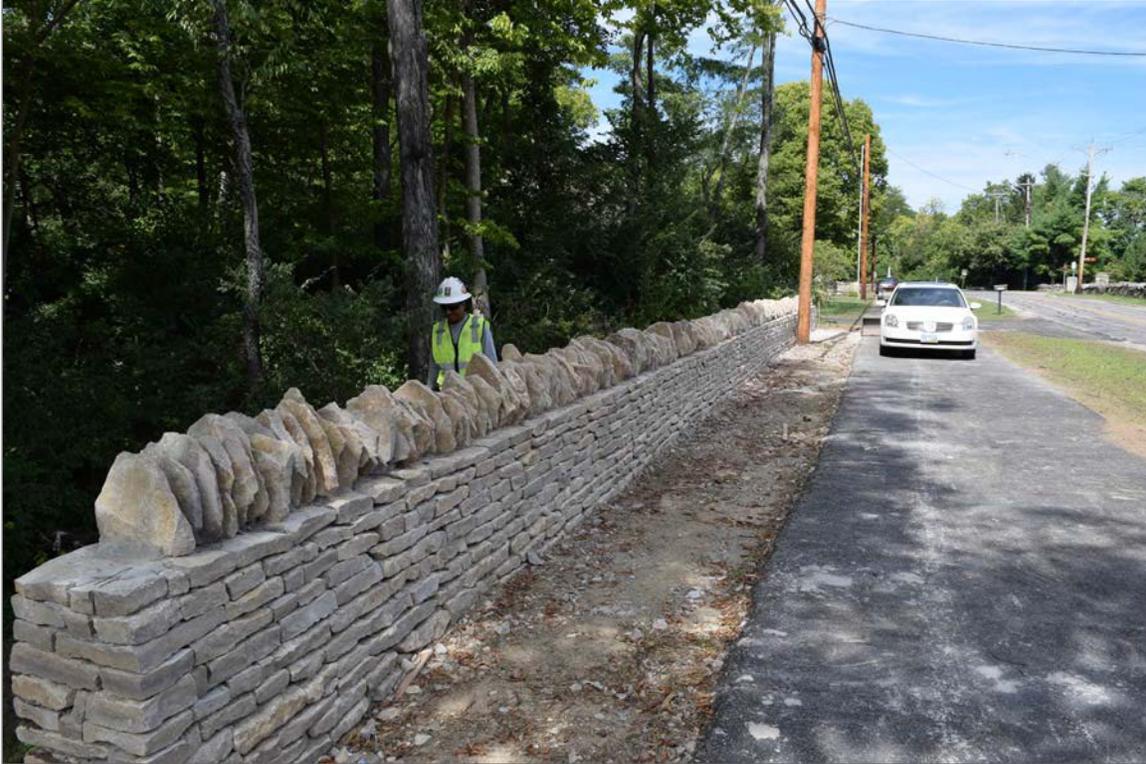
Figure 96. Wall in process of being rebuilt as part of trail project (W034 along west side of Dublin Road south of downtown, looking north). Note top course set in mortar.
