Building: 3

6725 Perimeter Loop Rd, Dublin, OH 43017

Report: 50538845

Building: 1

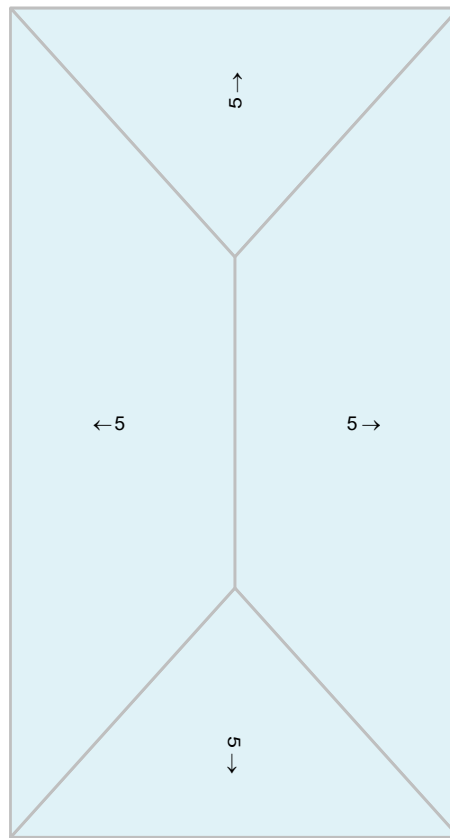
PITCH DIAGRAM

Pitch values are shown in inches per foot, and arrows indicate slope direction. The predominant pitch on this roof is 5/12

Note: This diagram contains labeled pitches for facet areas larger than 20.0 square feet. In some cases, pitch labels have been removed for readability. Blue shading indicates a pitch of 3/12 and greater.

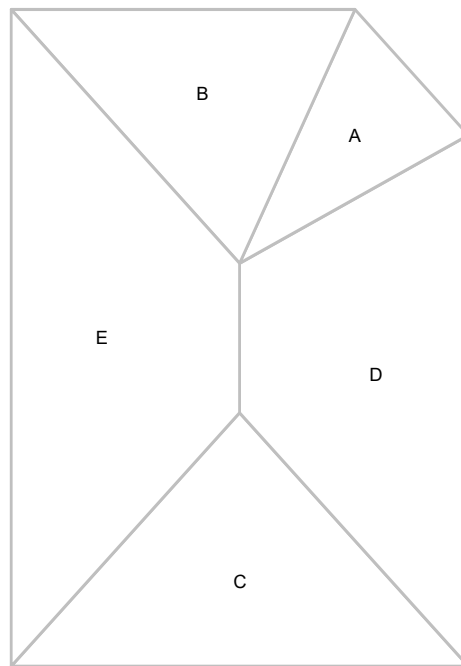
NOTES DIAGRAM

Roof facets are labeled from smallest to largest (A to Z) for easy reference.
