## PLANNING REPORT

# Architectural Review Board

## 119 S. HIGH STREET OUTBUILDING DEMOLITION – BACKGROUND 23-116DEMO

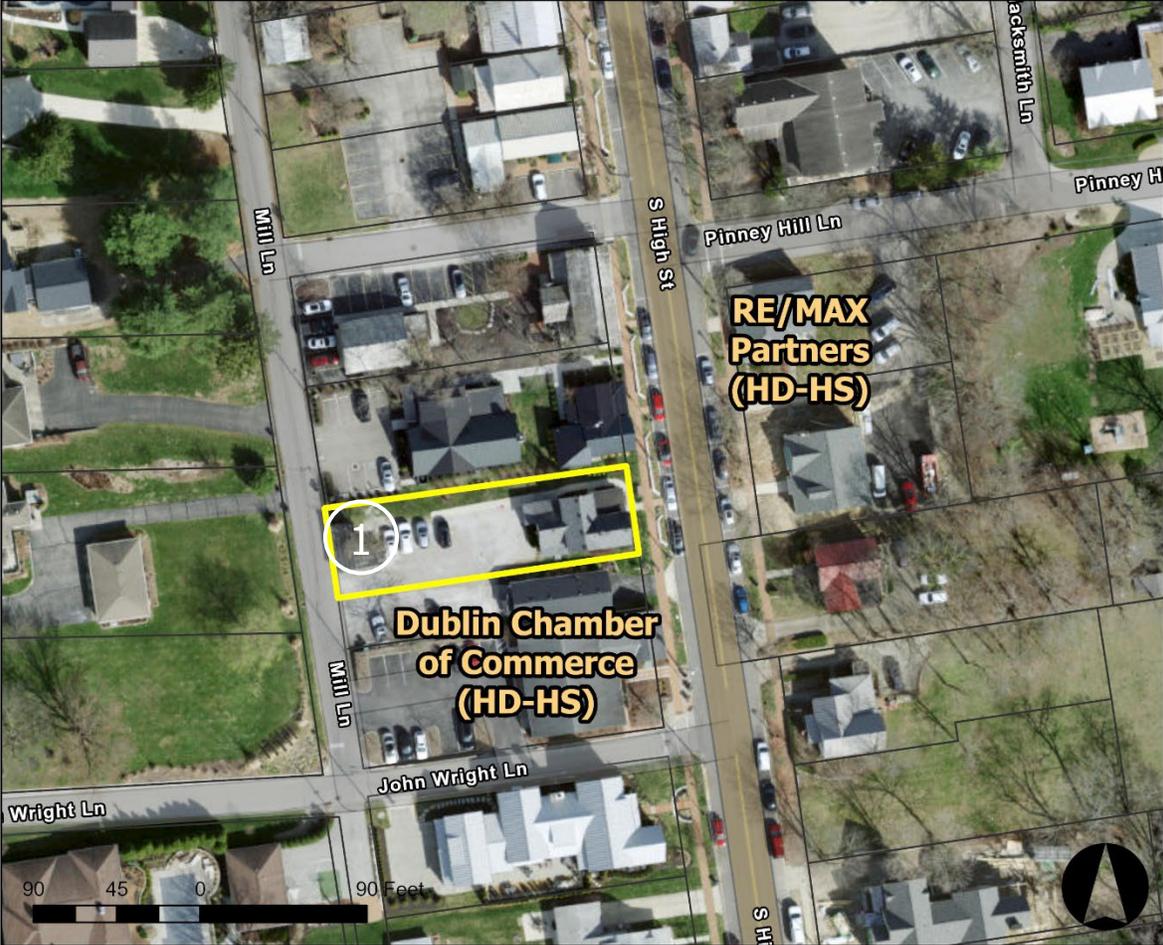
**Site Features**

1 Structure requested for demolition

The subject outbuilding is an ell-shaped structure with shed roofs. The ell is toward the interior of the site. Per the owner, it was constructed in 1927 and used as a chicken coop or garage. The Franklin County Auditor's website indicates construction in 1900. The Dublin Historical Society notes that this structure is likely a chicken coop, with the smaller ell being the described wellhouse, based on the OHI. For clarity, this report will refer to the larger structure as the "chicken coop", and the smaller structure being the "wellhouse" or ell to the east.
