PLANNING REPORT

Architectural Review Board

Wednesday, November 15, 2023

119 S. HIGH STREET OUTBUILDING DEMOLITION – NON-CONTRIBUTING 23-116DEMO

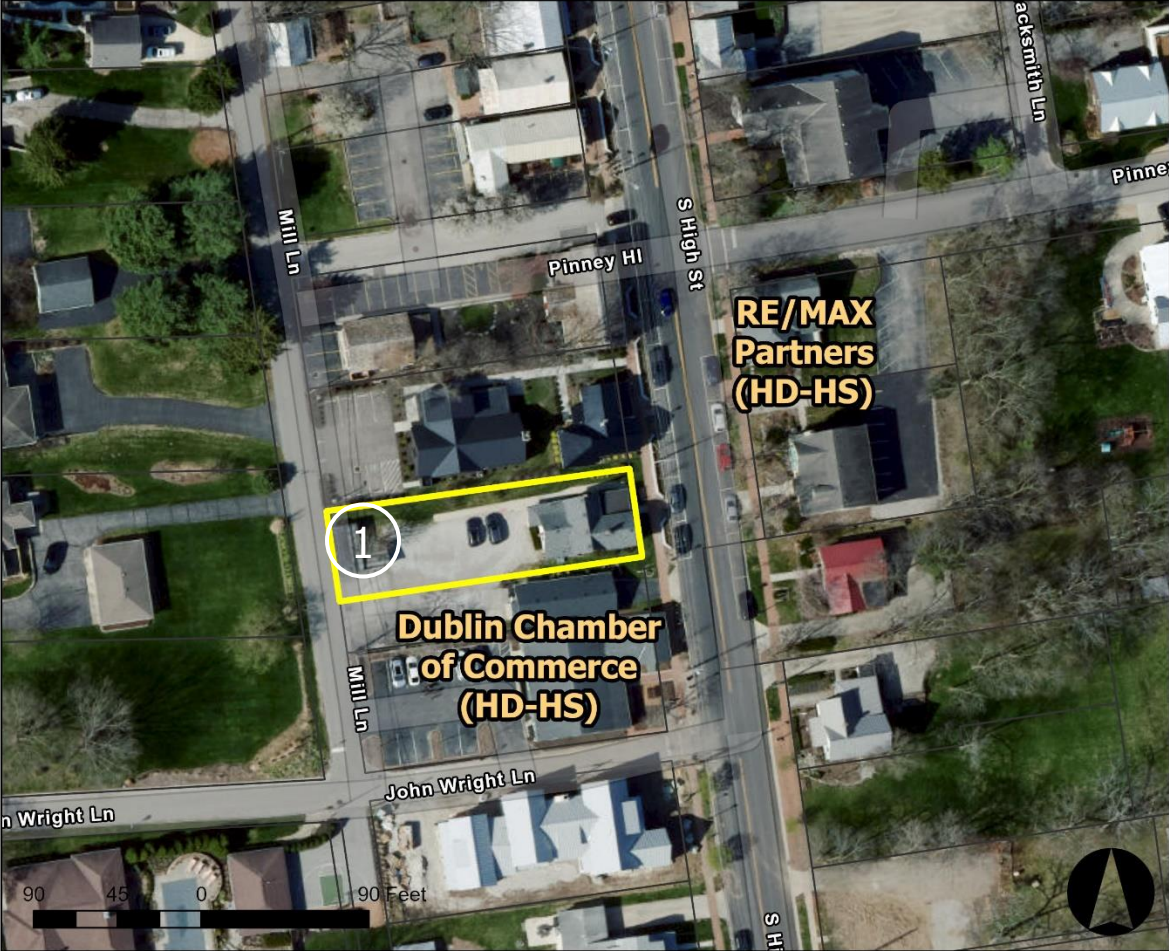
1 Chicken coop & well house

The subject outbuilding is an ell-shaped structure with shed roofs. The ell is toward the interior of the site. Per the owner, it was constructed in the 1927 and used as a chicken coop or garage. The Franklin County Auditor's website indicates construction in 1900. The Dublin Historical Society notes that this structure is likely a chicken coop, with the smaller ell being the described well house, based on the OHI.

Based on Dubscovery information, the structure is approximately 560 square feet in size. The structure appears to be adjacent to the right-of-way for Mill Lane, but not within it. The structure is surrounded by gravel parking on the south and east, grass on the north, and the Mill Lane pavement to the west. It is one of many outbuildings within Historic Dublin that add to the character, charm, and a greater sense of history to the district.
