# Historic and Archaeological Research for the COhatch Riverview Village Development, City of Dublin, Franklin County, Ohio

Project #: 2025-0048

10 September 2025

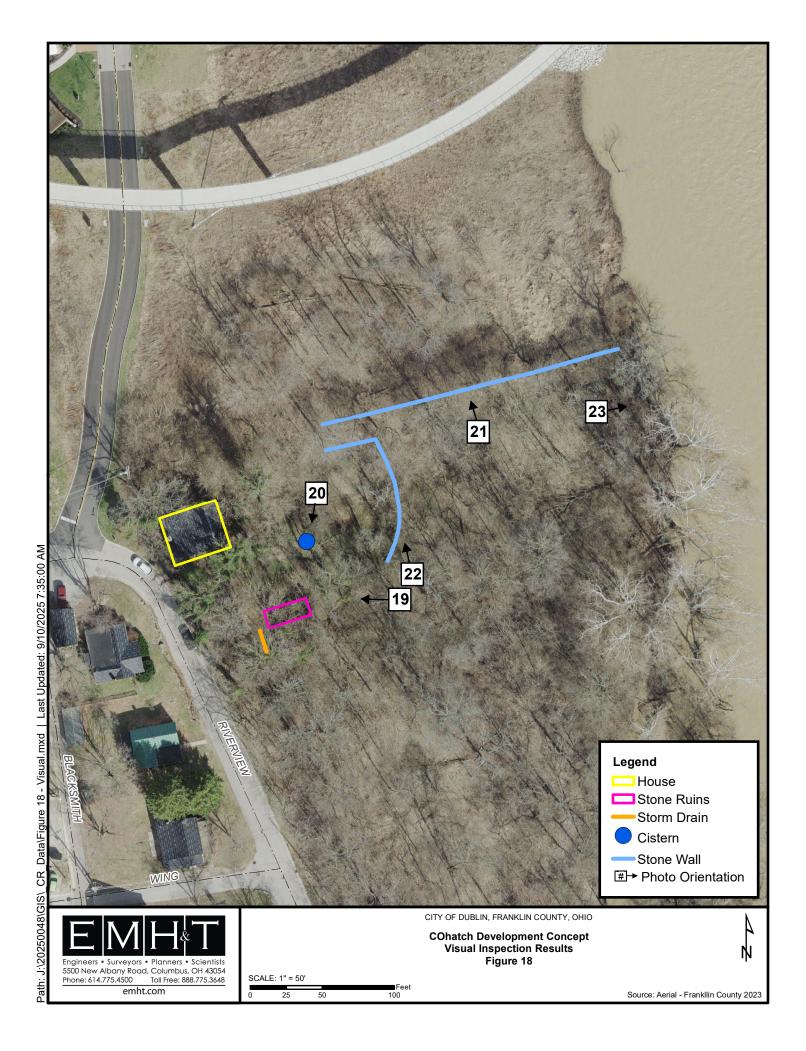
- Figure 18: Visual Inspection Results
- Figure 19: House, stone ruins, and storm drain built into slope
- Figure 20: Cistern and stone ruins
- Figure 21: Stone wall lining northern boundary of 62 North Riverview Street

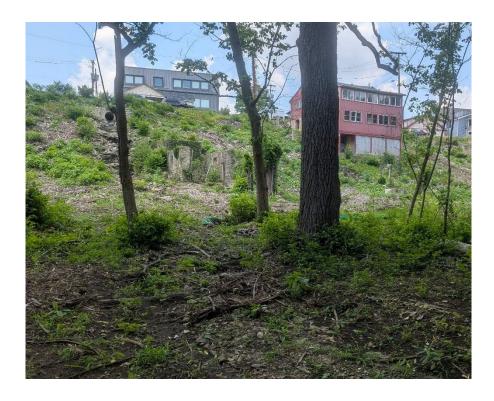
Figure 19. House, stone ruins, and storm drain built into slope.

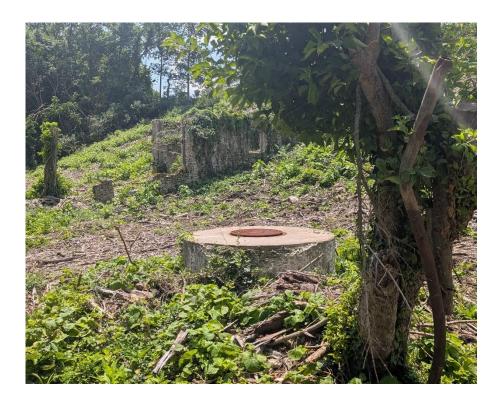
Figure 20. Cistern and stone ruins.

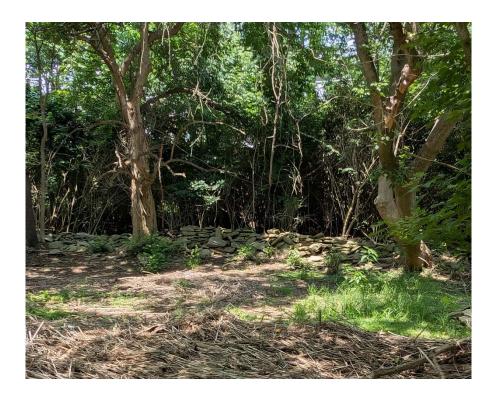
Figure 21. Stone wall lining northern boundary of 62 North Riverview Street.

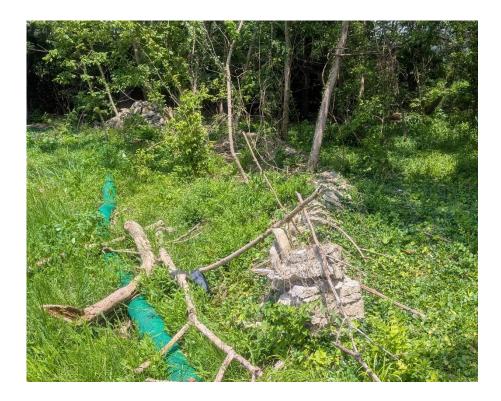
Figure 22. Mortared stone wall located near the center of the 62 North Riverview Street.

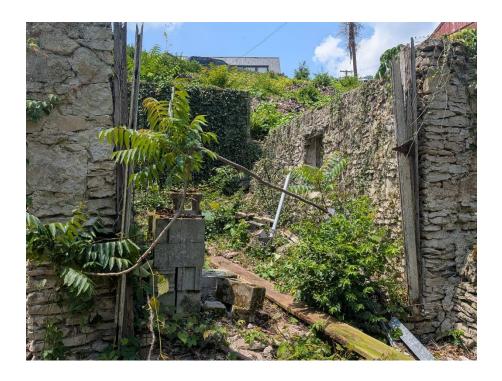
Figure 24. Walls and interior of stone ruins.

The walls of the building were examined to determine if any temporally diagnostic materials had been incorporated into the building walls since expedient materials are often used in vernacular stone construction. No diagnostic material could be found. Nominal sized dimensional lumber was utilized in the construction of the window frames (Figures 26-28). They consisted of nominal sized 2"x4" pine horizontal elements and 1"x4" cedar vertical elements. Nominal size standards for lumber were established in the United States in 1924 (Smith and Wood 1964). Wire nails were used to construct the frames (Figures 27 and 28). Wire nails are well documented as a post 1890 occurrence at most historic sites (Nelson 1968). While these materials could have been added to an early building at a later date, they were mortared into place with mortar that was macroscopically not discernible from the mortar used to fit the stone that comprises the building walls. Based on the date ranges for these materials, the building is assumed to post-date 1890.

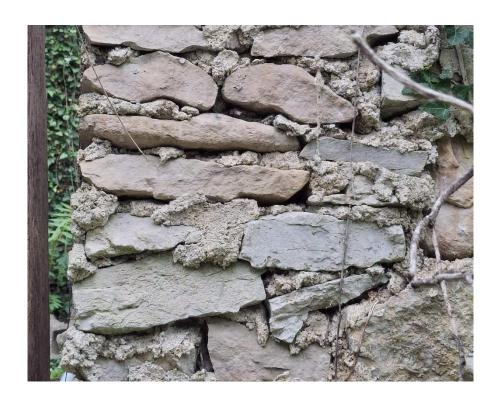
Figure 25. Closeup of ruins showing stone and mortar in wall.

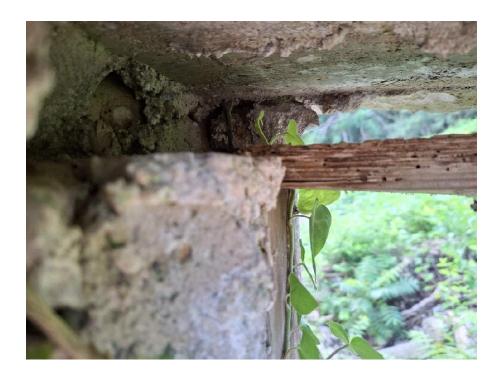
Figure 26. Closeup of ruins showing lumber incorporated into wall.

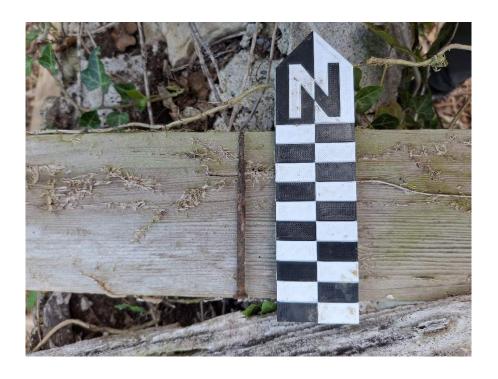
Figure 27. Closeup of dimensional lumber and wire nail utilized in stone ruins.

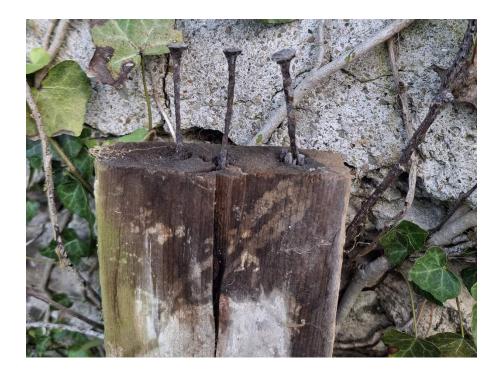
Figure 28. Closeup of wire nails in dimensional lumber utilized in stone ruins.

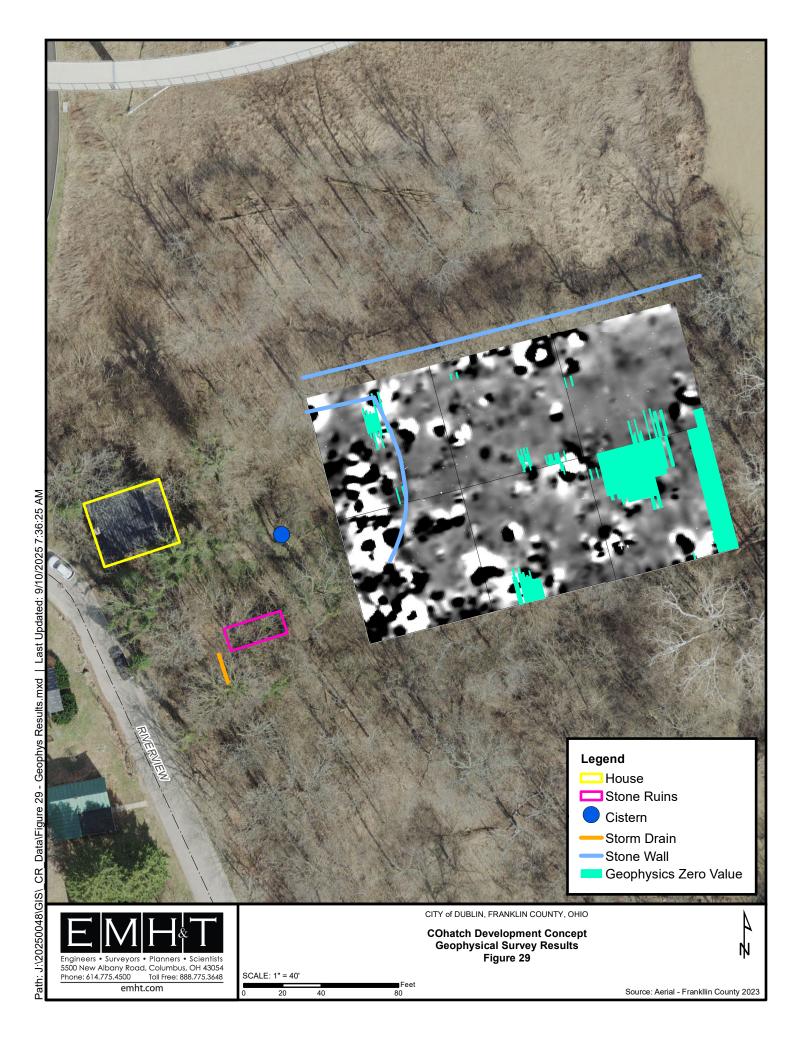
- Figure 28: Closeup of wire nails in dimensional lumber utilized in stone ruins
- Figure 29: Geophysical Survey Results
- Figure 30: Comparison of Geophysical Results (Left) and 1950 Map of the Historic Village of Dublin (Right)

Field conditions presented some limitations to geophysical survey. Gradiometry survey requires the traverse of virtually straight paths on an accurately spaced grid. As previously mentioned, the surveyed parcels are located in young growth forest. There were instances where forest vegetation was too thick to allow for the establishment of accurate or straight paths. In these situations, the location is assigned a "dummy value" or zero reading as a place marker.
