A NEW HOME FOR THE HISTORIC BRIDGE STREET DISTRICT OF DUBLIN, OHIO

73 SOUTH RIVERVIEW STREET

73 S. RIVERVIEW

DUBLIN, OHIO

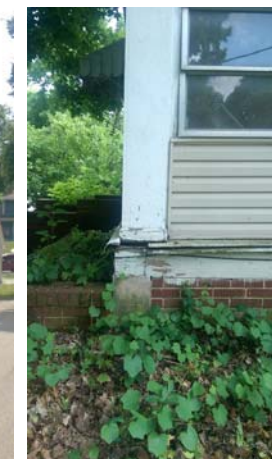
RESIDENCE NON-ORIGINAL CONSTRUCTION

1. THE EXISTING STRUCTURE IS A VINYL CLAD 1 1/2 STORY RESIDENCE WITH MARGINAL ORIGINAL DETAILING REMAINING. IT HAS BEEN ADDED ONTO AT THE REAR AND FRONT.
