# OHIO HISTORIC INVENTORY

1.No. FRA-8853-2		2.County FRANKLIN		4.Present Name(s) DUBLIN ARTS CENTER		<input type="checkbox"/> CODED	
3.Location of Negatives CITY OF DUBLIN				5.Historic or Other Name(s) GELPI RESIDENCE			
Roll No. 4		Picture No.(s) 0

**Parcel** 273-009098      **Address** 7125 Riverside Dr      **OHI** FRA-8853-2

**Property Name:** Gelpi Residence/Dublin Art Center

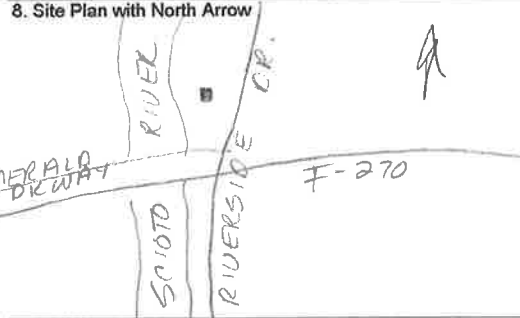
7.City or Village If Rural, Township & Vicinity DUBLIN				18. Style or Design FRENCH NORMAN		30. Foundation Material STONE	
8. Site Plan with North Arrow

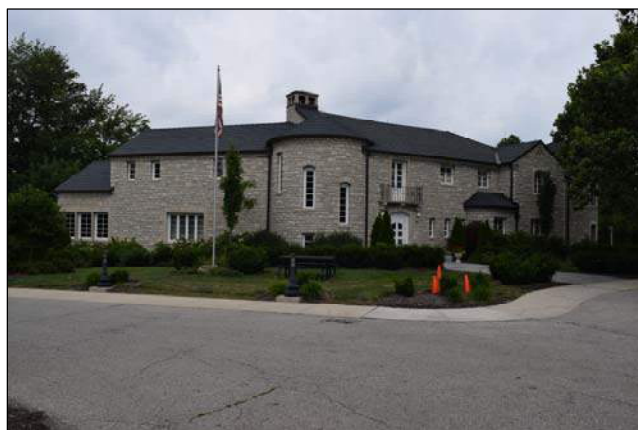
7125 Riverside Dr, looking northwest

**Description:** The two-story French Norman-style building was built as a private residence but currently functions as the Dublin Art Center. The building has an irregular footprint, with two-story hipped-roof component extending north-south, and another gable-roofed wing extending southwest, with a circular conical-roofed tower at their juncture. A cross gable is on the north end of the façade, a one-story side-gable section is on the structure's southwest corner, and a modern stair tower has been added to the north elevation. The exterior of the building is clad in stone, with asphalt shingles sheathing the roof. The front door is arched, with a multi-light door opening to a balcony above. Windows are multi-light casements.

**Condition:** Good
