MEMO

Re: Minor Project Review for 106 S. HIGH STREET

106 S. High Street

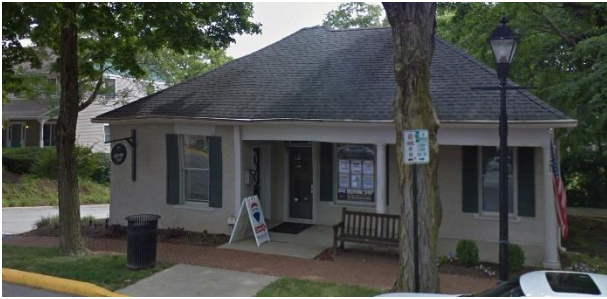
1. 106 S. High Street, west (front) side. (Source: Google Earth)

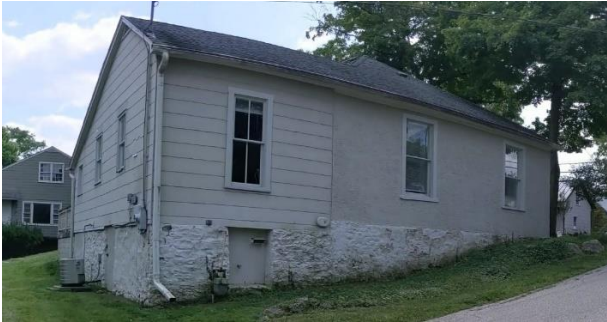
2. 106 S. High Street, north side. (Source: Jacobs Grant Design LTD, July 2019)

Proposed improvements to 106 S. High Street include stone foundation restoration, window restoration and preservation, window replacement, exterior paint, and landscape enhancements. The north and east side of the building foundation have been covered with stucco and paint and are deteriorating. The applicant proposes to clean the stone and tuck-point it to restore it to its original appearance. The one-over-one sash windows on the north, west, and south sides of the building will be retained; the historic glass will be preserved and the sash repaired, re-caulked, and painted. Shutters will be added to the north and south faces, and the existing shutters on the west face will be replaced. In addition, windows on the back (east face) of the building will be replaced due to extensive frame and sill deterioration. The new windows will be aluminum-clad wood windows similar to the one-over-one sash windows on the front of the building. Since these replacement windows are located in the additions to the rear of the historic building, they will have little impact on the integrity of the main structure. The applicant also proposes to re-paint the entire building with gray walls, white trim, and dark green shutters. And the landscape enhancements will include a brick-paved sitting area with a bench shaded by a redbud tree and surrounded by a grass lawn bordered by boxwoods and deciduous hedges. Hydrangeas will be planted to the northwest of the building to hide the utilities and meters.

- Window manufacturer information and details. The applicant has selected aluminum-clad wood windows, and I suggest they submit additional information regarding the windows to ensure that the style is traditional in nature and compatible with the historic one-over-one sash windows.
- Elevations with paint colors/locations noted. In particular, will the stone foundation be painted? Generally, it is not recommended to paint masonry since it is difficult, if not impossible, to remove it without damaging the masonry. However, since portions of the foundation already have stucco and paint, it may be difficult to return the stone foundation to its natural state.

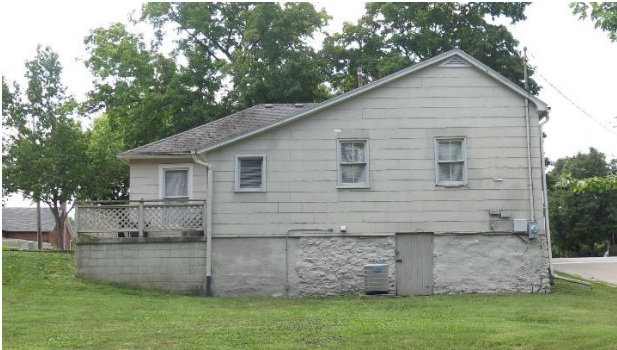
3. 106 S. High Street, east (rear) side. (Source: Jacobs Grant Design LTD, July 2019)

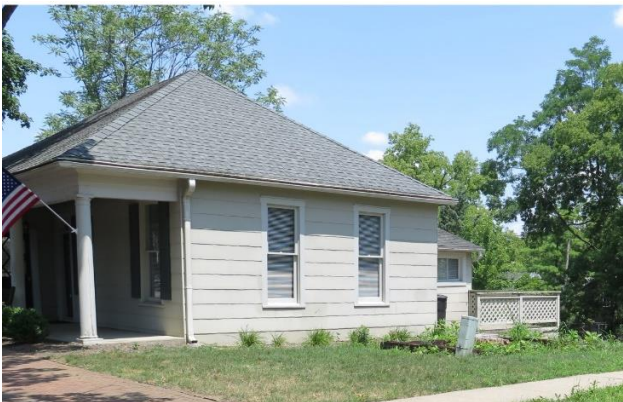
4. 106 S. High Street, south side. (Source: Jacobs Grant Design LTD, July 2019)

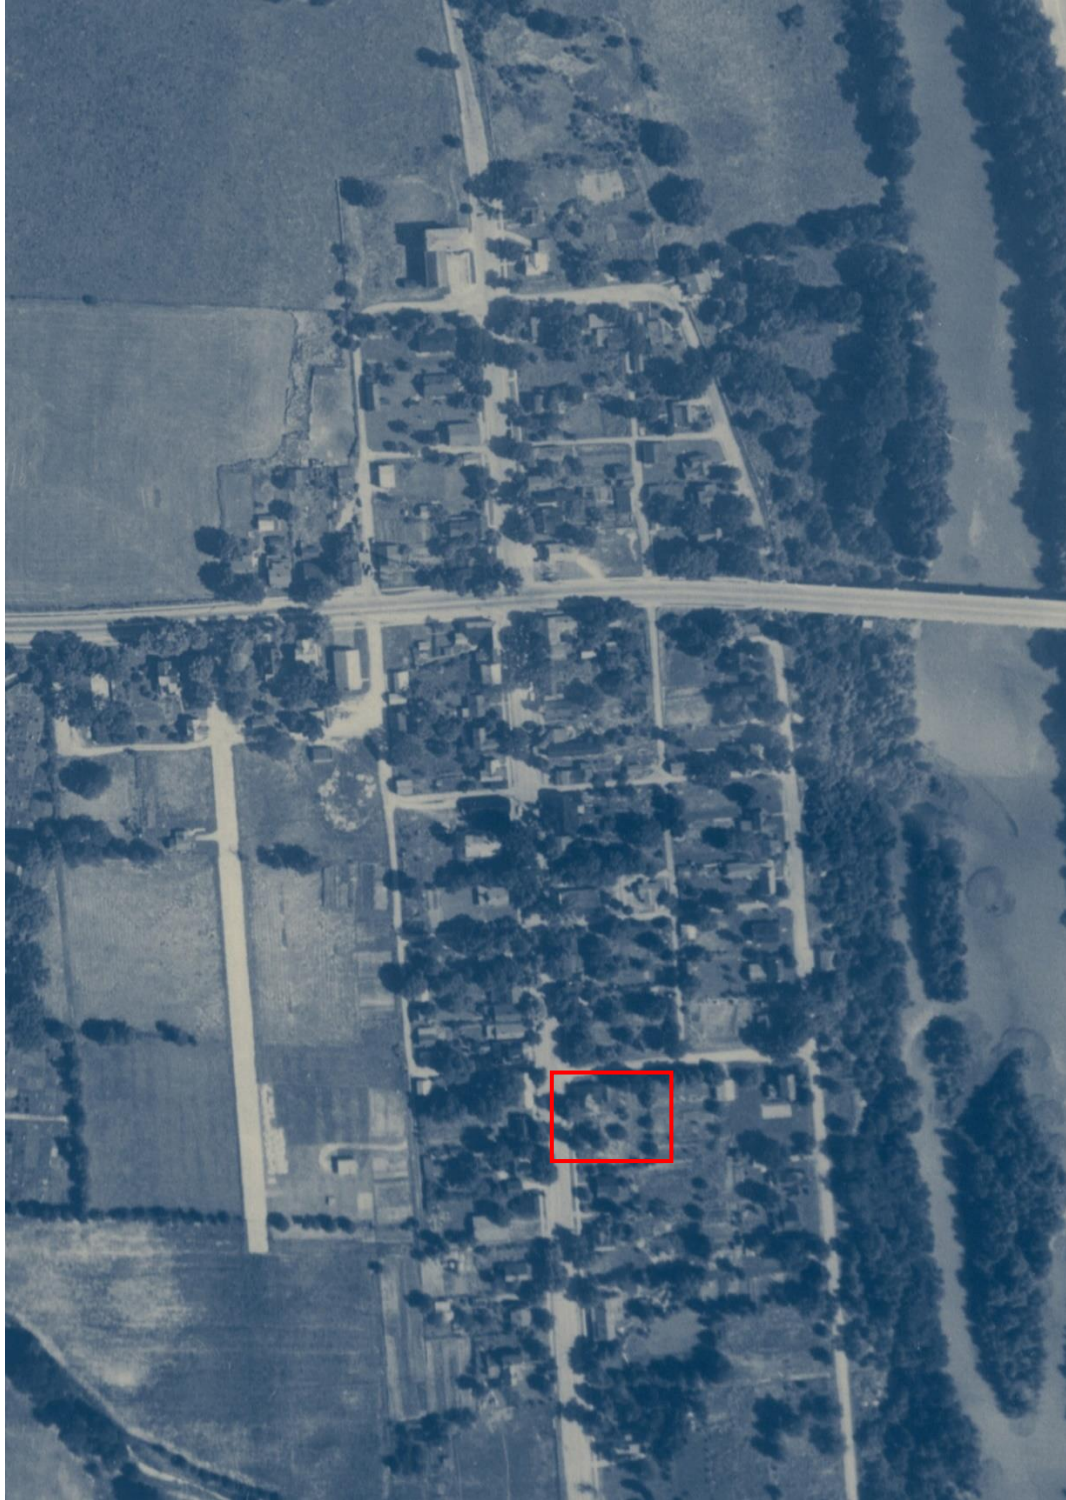
5. 1947 Aerial View of Dublin, Ohio. The property at 106 S. High Street is visible, with an L-shaped building and a neighboring garden area. (Columbus and Ohio Map Collection at the Columbus Metropolitan Library)
