OHIO HISTORIC INVENTORY

1.No. FRA-8801-1		2.County FRANKLIN		4.Present Name(s)		<input type="checkbox"/> CODED <input type="checkbox"/> CODED		FRA- 8801-1 FRANKLIN
3.Location of Negatives CITY OF DUBLIN				5.Historic or Other Name(s)				
Roll No. 1		Picture No.(s) 20

106 S. HIGH

Parcel 273-001978 **Address** 106 S High St **OHI** FRA-8801-1

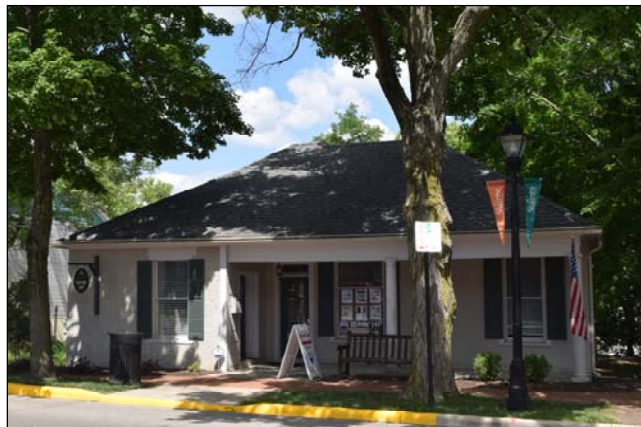
Description: The one-story building has an L-plan footprint with a rectilinear hipped roof core and a side-gable wing on the northeast corner. The structure rests on a stone foundation. The exterior walls are clad in stucco with asbestos shingles on the rear wing. The roof is sheathed in asphalt shingles. The façade is divided into four fenestration bays. A recessed porch is on the south three bays; it is supported by Doric columns. The front door is within the porch, it is topped by a transom. The widows are one-over-one wood sashes. Each features a broad lintel and is flanked by shutters.

106 S High St, looking east-northeast

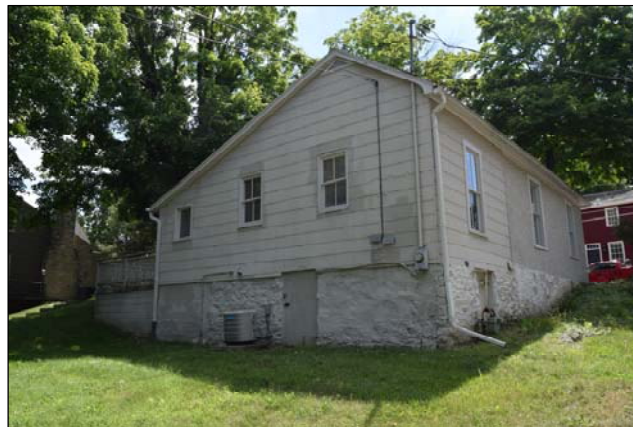
106 S High St, privy, looking southwest
