ASBESTOS MATERIAL SURVEY
AT
5800 Post Road
DUBLIN OHIO 43016

Ohio Technical Services Job # OTS-16- 2084

OTS-16- 2081 Date: May 2, 2016

Asbestos Survey for Demolition of 5800 Post Road, Dublin Ohio 43016

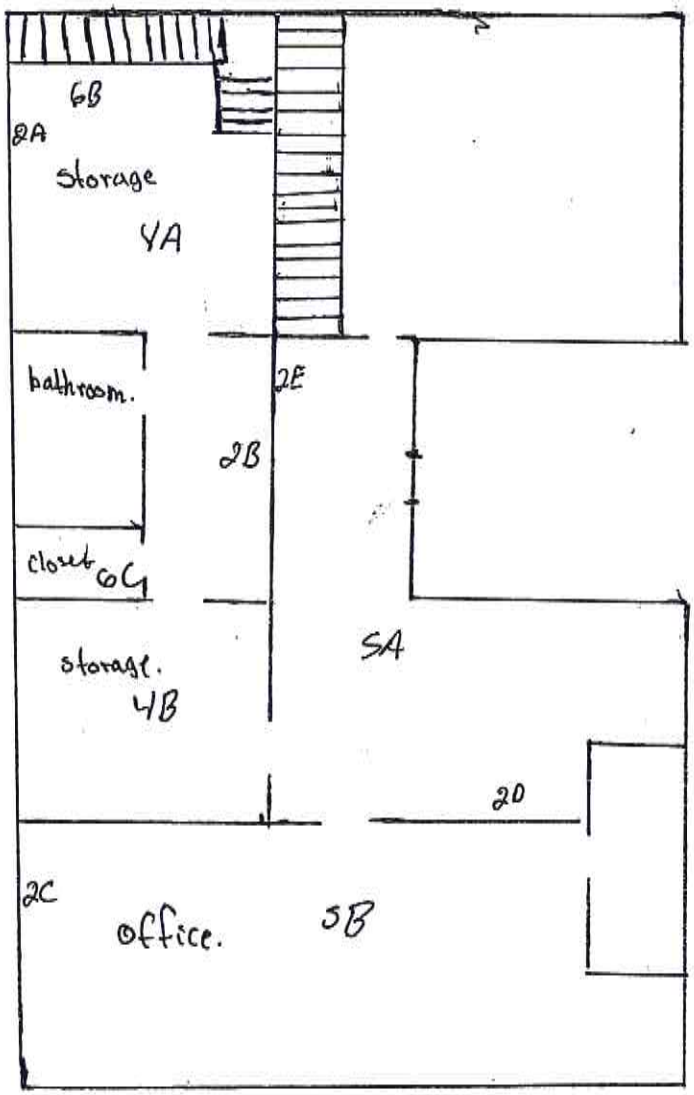
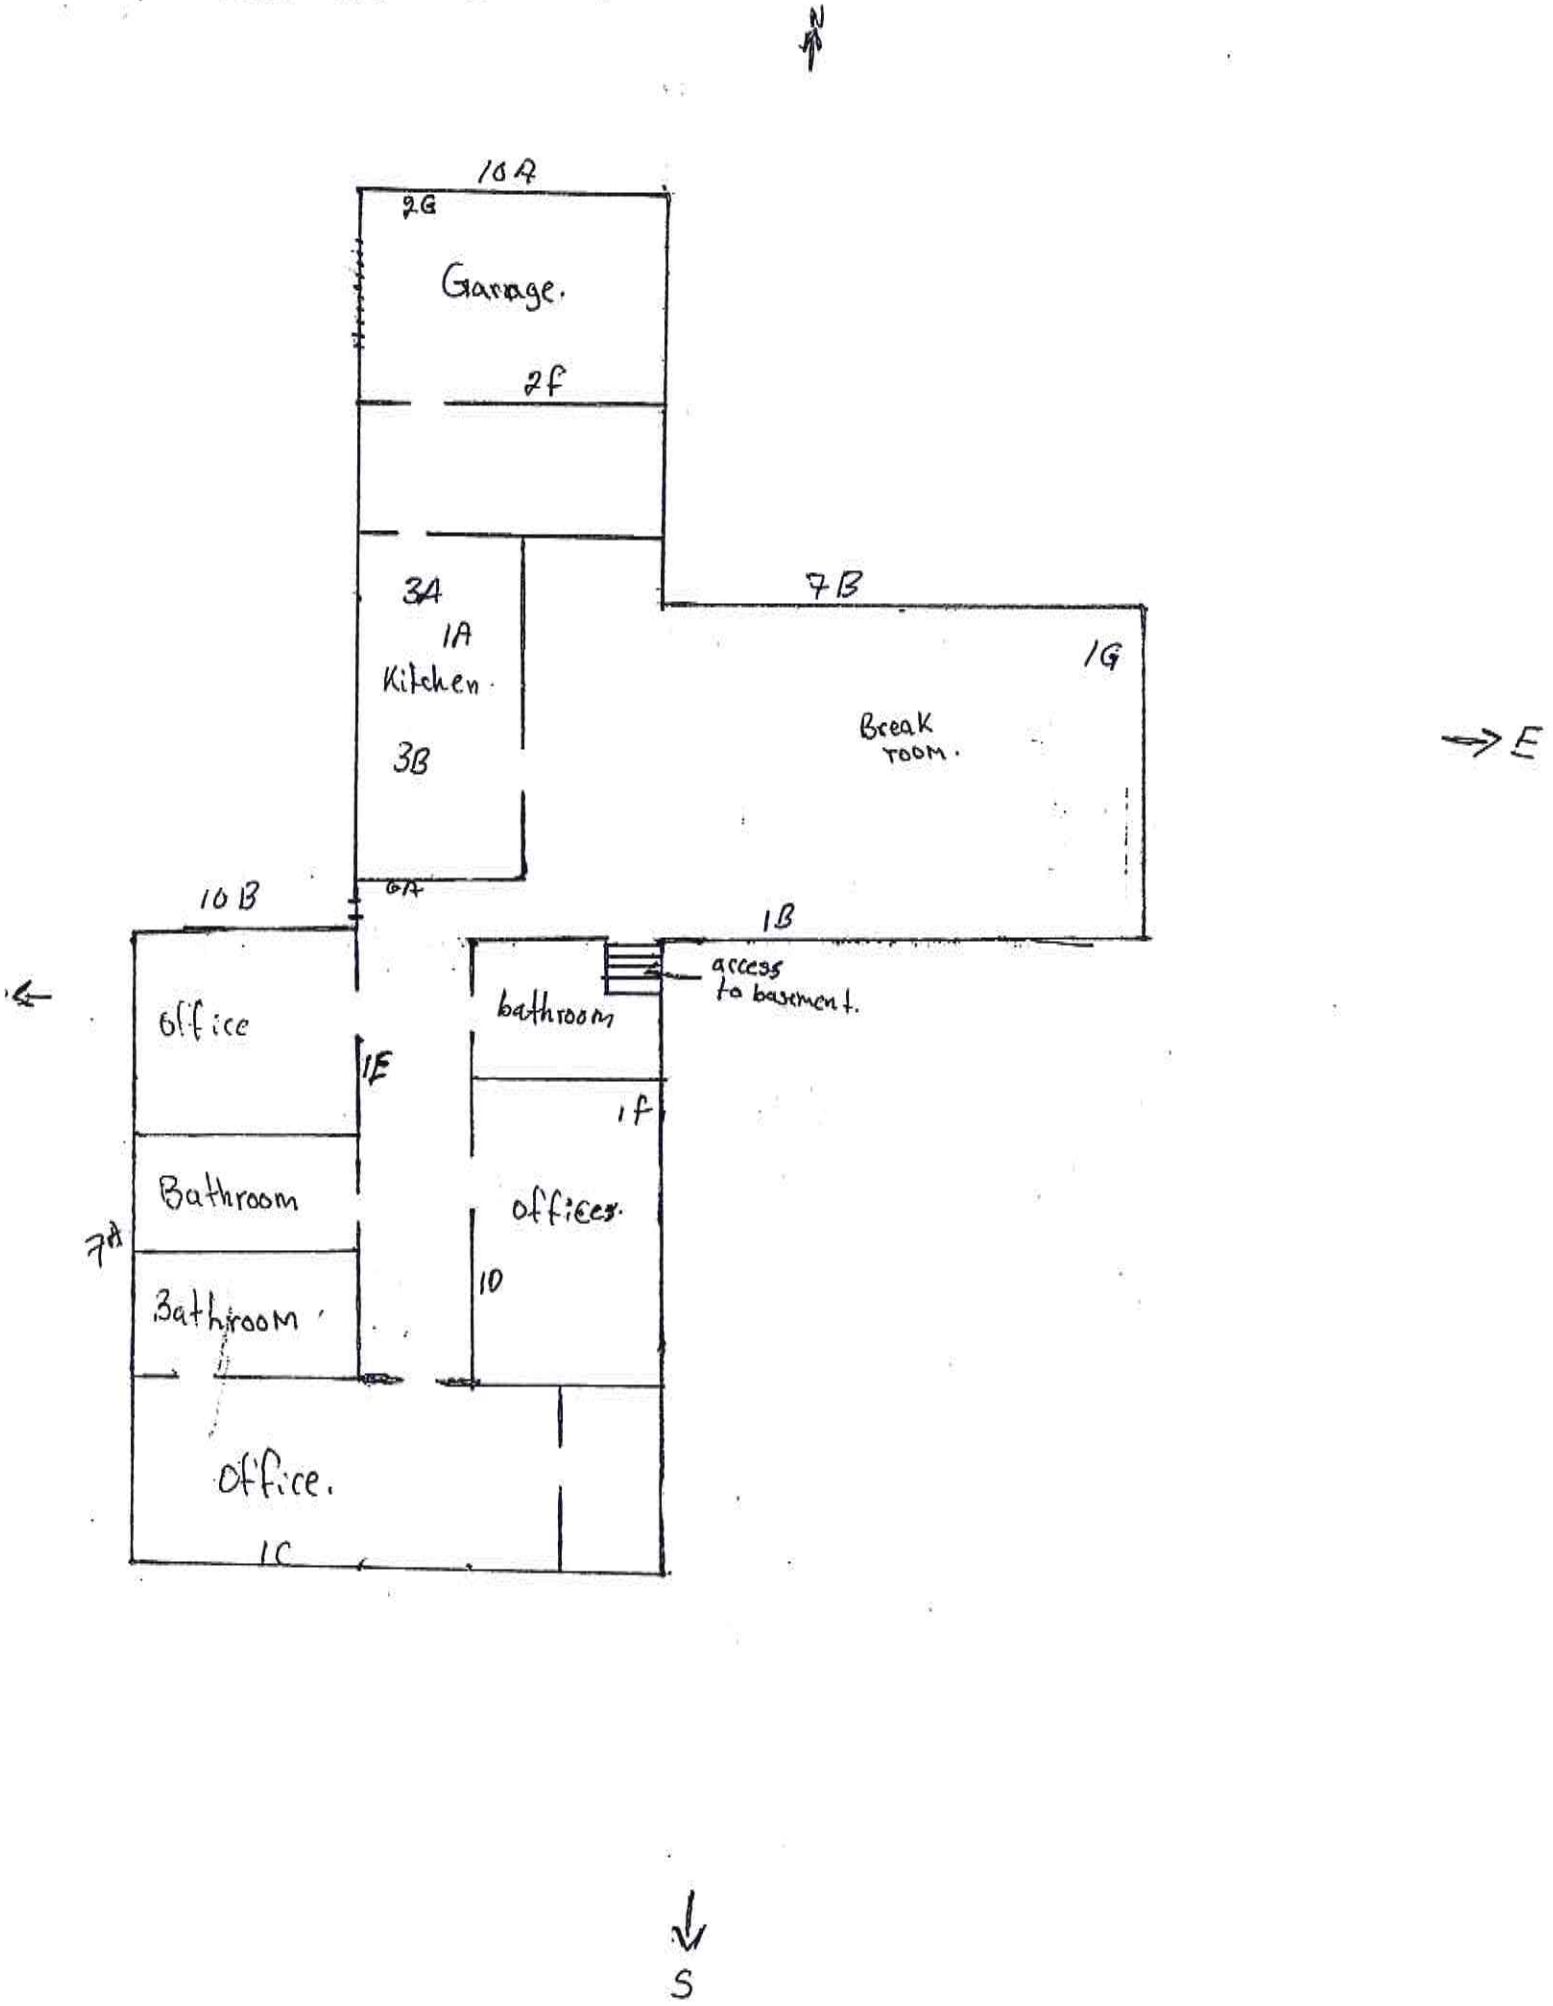
BULK SAMPLE LOCATION DIAGRAMS

N
10A
2G
Garage.
2F
3A
1A
Kitchen.
3B
7B
1G
Break room.
E
10B
6A
1B
access to basement.
office
bathroom
1E
1F
Bathroom
officer.
7A
10
Bathroom
office.
1C
S
