# MEMO

Date: November 7, 2022

Re: Stone Retaining Wall located on 40 N High and partially on 38 N High;  
Informal Review of Submittals, Preservation POV

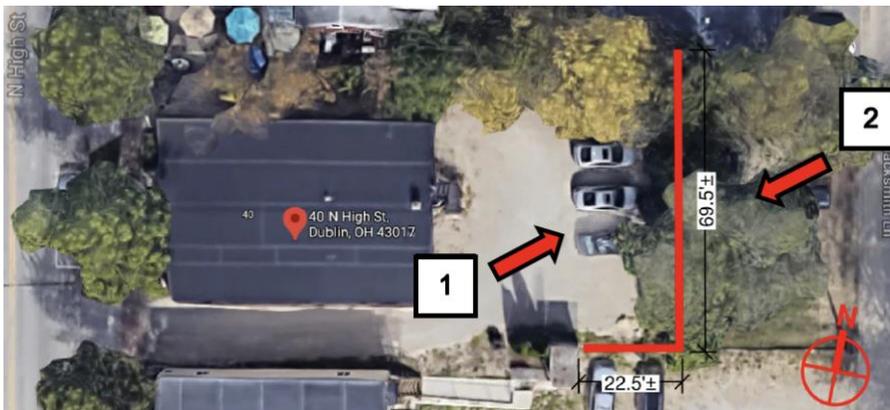
Fig. 1: View of 40 N High and north side of 38 N High, with the retaining wall marked in red (Kooi, Bernie. *Overall plan view of property*. 2021. 40 North High Street, Korda/Nemeth Engineering, Inc. 2021, p.1).

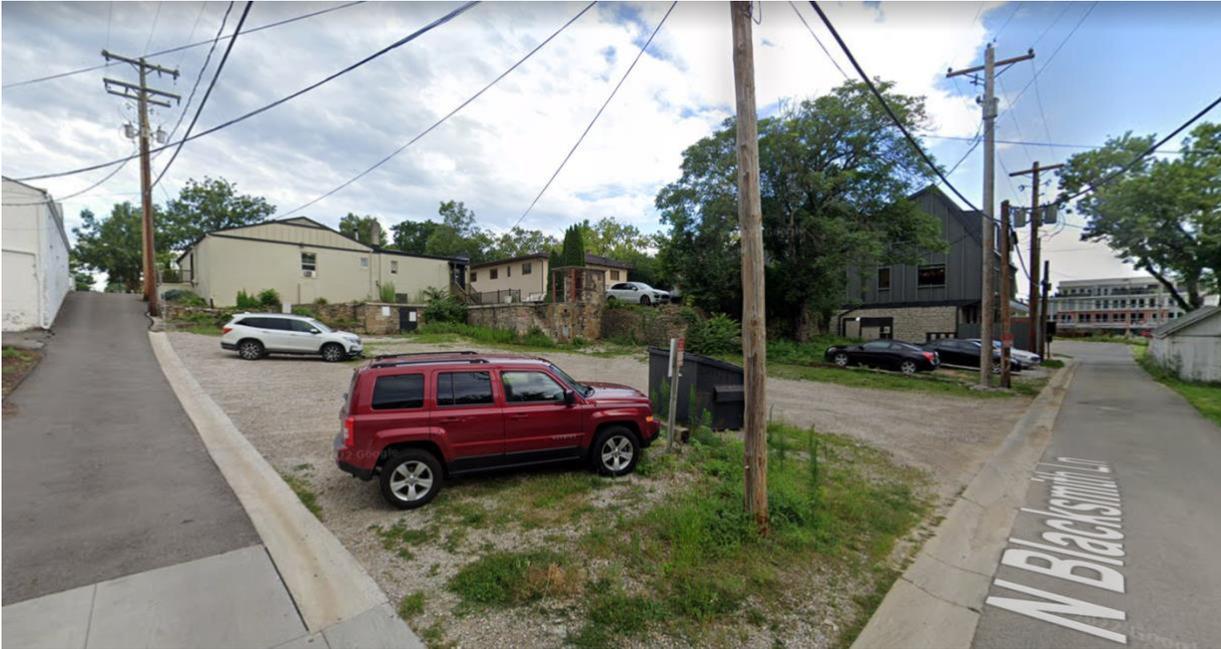
PHOTO 1: Panoramic Photo taken from the southeast corner of the 36 N High lot, from looking west (left) up Wing Hill Lane and north (right) up N Blacksmith Lane (Photo downloaded from the Google Maps website, 'Street View', accessed November 4, 2022, at <https://www.google.com/maps/@40.1002827,-83.1131823,3a,84y,268.38h,92.84t/data=!3m6!1e1!3m4!1sek7jLdJ6VVRXo-oYpW1Smw!2e0!7i16384!8i8192>).
