## HISTORICAL ANALYSIS AND DESIGN REVIEW:

**Property Address:** 119 S High  
Dublin, Ohio 43016

**Owner/Applicant:** Richard J Toberen

### HISTORICAL ANALYSIS:

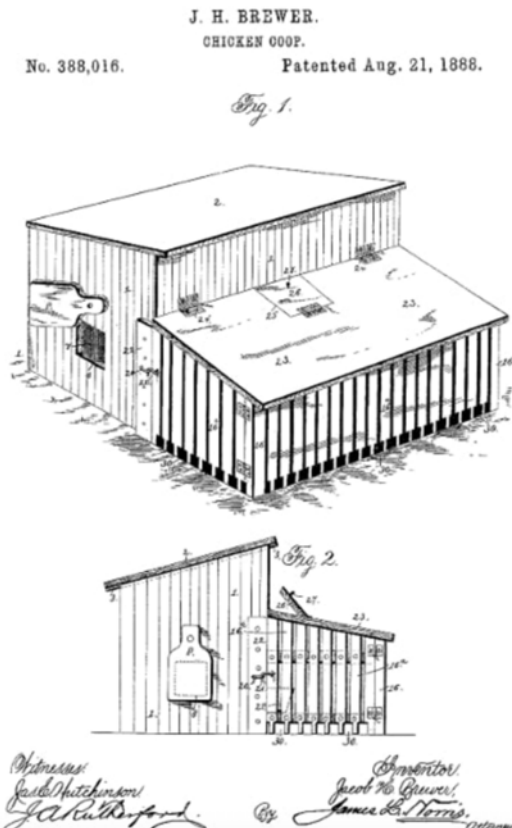
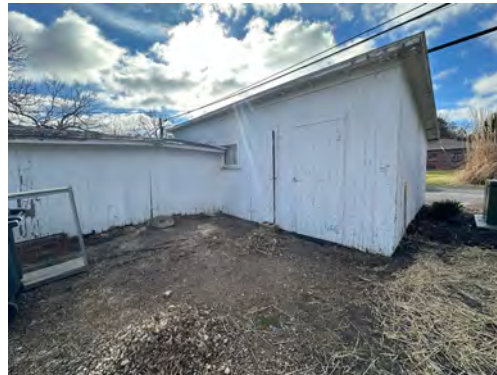
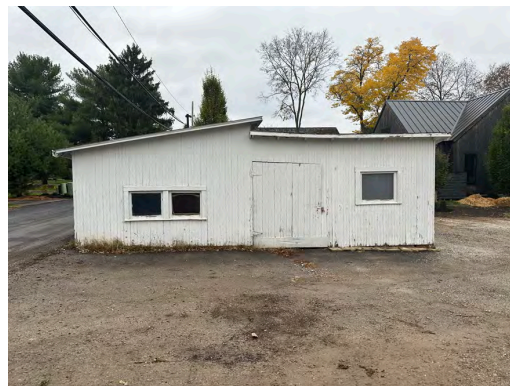
The materials of this outbuilding are wood and a combination of roofing materials with some masonry that looks to have been retrofitted through its lifetime. As stated earlier, the building is in poor condition and disrepair and much, if not all, would need to be replaced rather than restored if it is deemed worthy of keeping.

The rotten wood is an occurrence with natural wood siding. Wood is difficult siding to maintain and susceptible to a lot of damage. This structure shows signs of many kinds of damage including water, sun, wind and ground movement. I would defer to a structural engineer for specific structural dangers but it is apparent from a visual examination that there is instability in the roof structure, damaged and rotten wood members both inside and out, misalignment of windows and doors, uneven floors and cracked masonry from settling and/or tree root uplift.

Restoring or replacing vintage wood siding is a done frequently because wood siding requires a lot of attention to keep it in pristine shape and is often not cared for over the years. This particular wood restoration project would require intensive repair and replacement of much of the deteriorated materials. For much of the structure it will be more practical and even essential to replace old wood siding, roofing and foundation, with new. All of the materials, or extremely similar materials, are available and the structure could be rebuilt to represent the original structure.

Additionally, if there is a decision to retain the structure much of it will need to be replaced. There is significant water damage, rotted rafters and framing, , deteriorated roof sheathing, uneven and uplifted slab, painting, gutters and regrading will need to be done.
