## HISTORICAL ANALYSIS AND DESIGN REVIEW:

**Property Address:** 119 S High  
Dublin, Ohio 43016  
**Owner/Applicant:** Richard J Toberen

### HISTORICAL ANALYSIS:

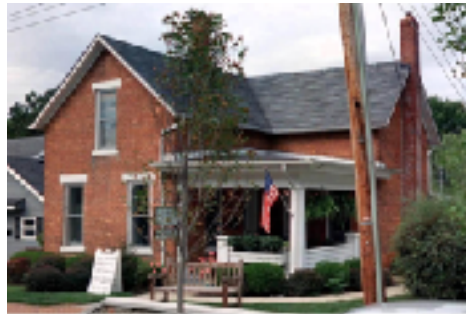
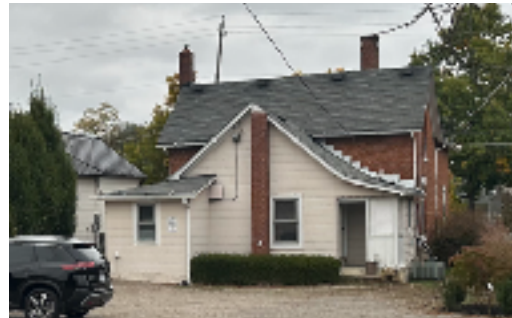
Primary structure:

The primary structure associated with this outbuilding is located at 119 S High Street in Historic Dublin and is an example of early American Vernacular. Built in 1900, the existing structure is a front facing gable with a front porch. Originally built as a residential structure, the home was converted to retail/commercial use and currently houses The Magnolia Salon Boutique. No significant exterior additions have been done in its lifetime although there was significant fire restoration in 2011 and a substantial investment to change to commercial use in 2020.
