February 27, 2024

HISTORICAL ANALYSIS AND DESIGN REVIEW:

Project: COhatch Riverview Village
Property Addresses: 37 N Riverview Street,
45 N Riverview Street,
53 N Riverview Street,
62 N Riverview Street
Stone structure south of 62 N Riverview
Dublin, Ohio 43016
Owner: COhatch
Applicant: Tim Lai ArchitecT

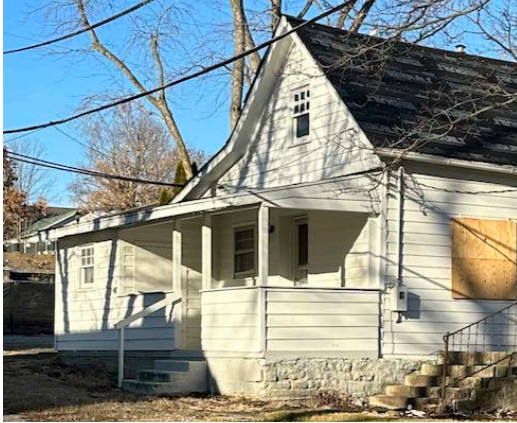
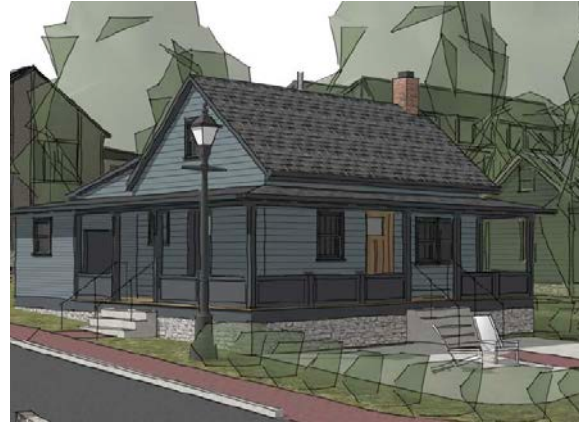
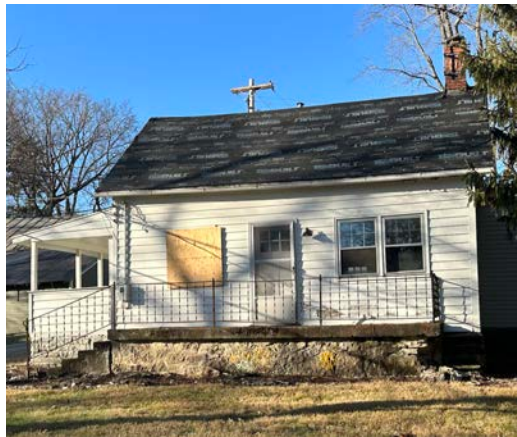
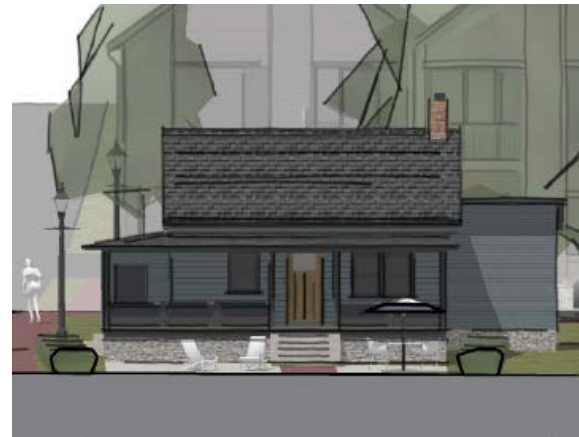
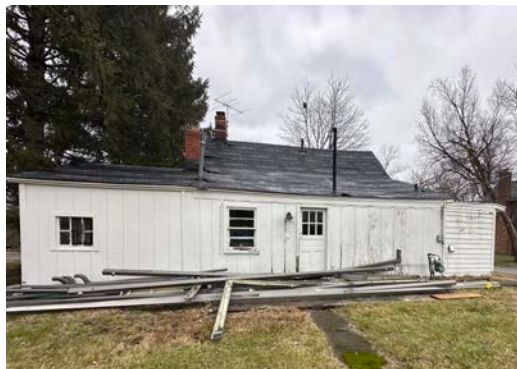
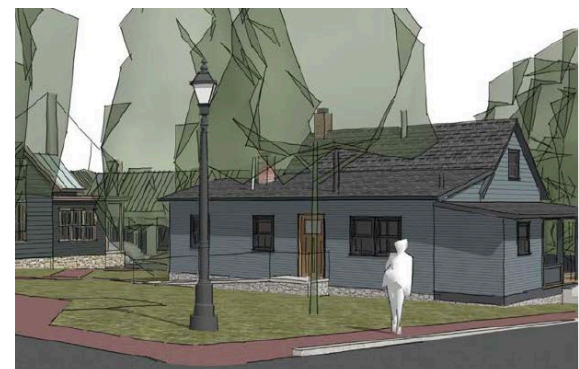
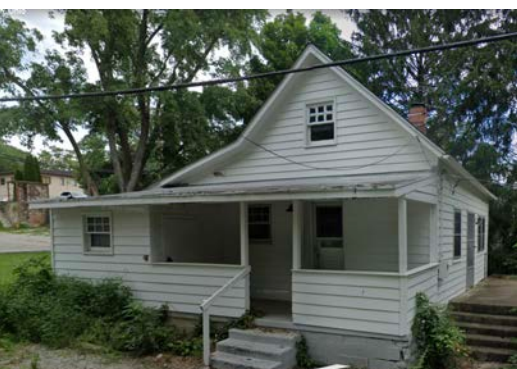
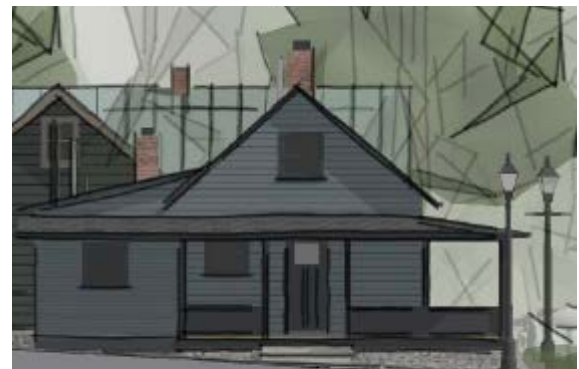
37 N Riverview Street::

The applicant is proposing to keep the porch on the south side and continue the porch to the east facade, creating a wrap-around porch. Some of the existing additions would be retained, although the ceiling/roof might be raised. The color of the exterior is proposed to be a dark gray. Below are conceptual comparison to the existing structure.

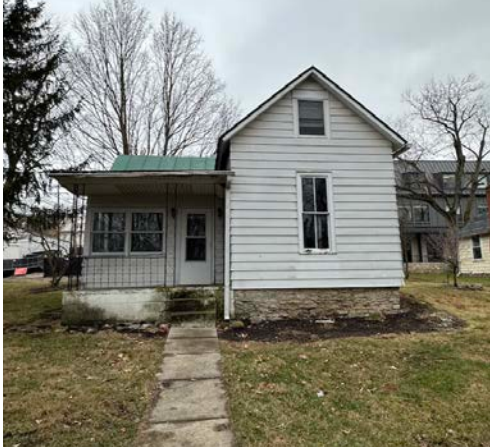
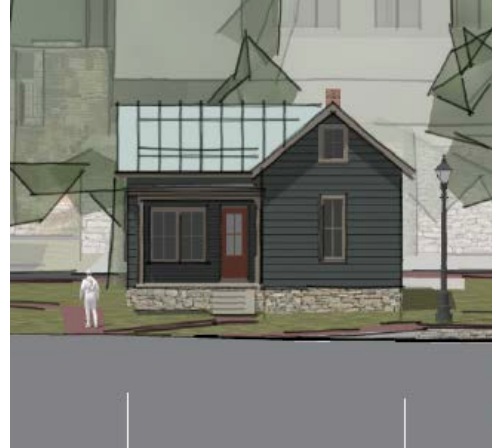
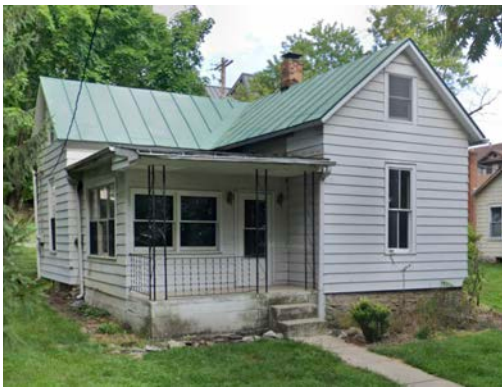
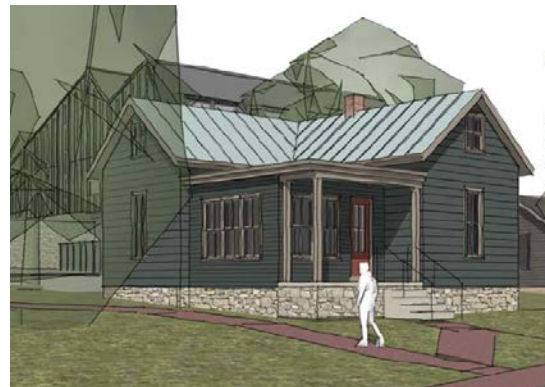
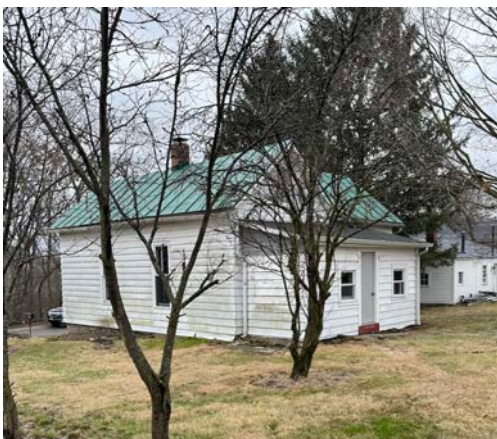
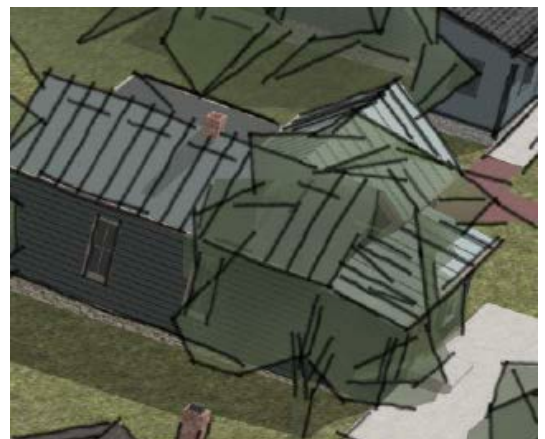
45 N Riverview Street:

In the conceptual drawings there are minimal changes. The enclosed porch would remain, the metal columns would be replaced with wood ones, and the stone water table will be extended to skirt the porch. The original wood siding would be restored, repaired or replaced as needed and darker paint colors are proposed.

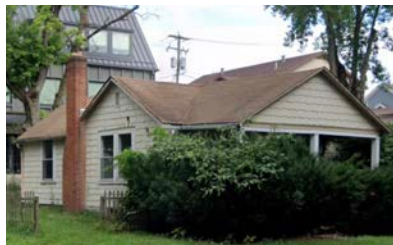
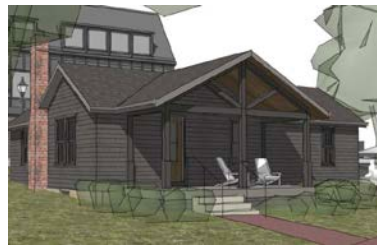
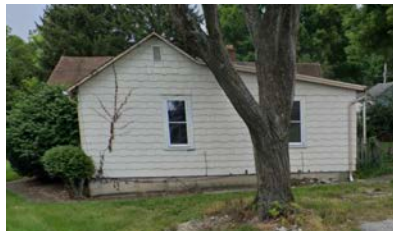
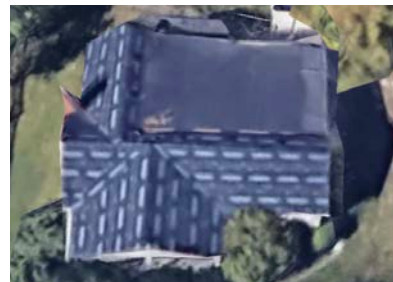
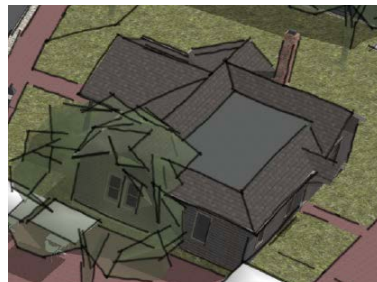
53 N Riverview Street:

Below are side by side comparisons of the existing structure and the proposed changes. Of all of the existing structures this one will undergo the most change to the original structure. All of the changes are an improvement as this structure is the one in most disrepair. The low porch ceiling will be opened and the porch gable will be detailed as a Craftsman-style gable roof with exposed timbers. A new window on the north elevation will provide more balance below the gable. Additionally, the flat roof will be changed to a mansard roof allowing greater height on the interior. These conceptual changes seem both reasonable and good as this structure does not have the charm or historical significance of the others but DOES have great interior space.

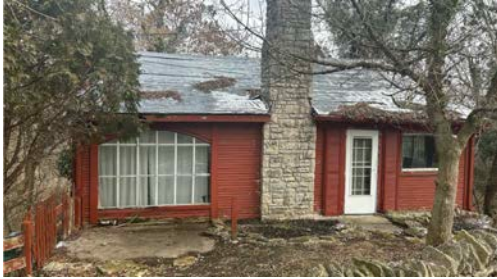
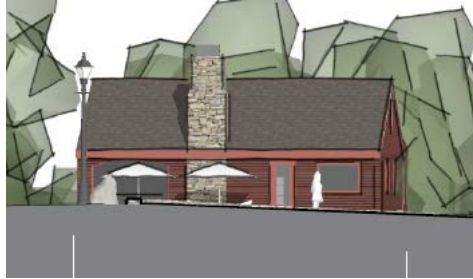
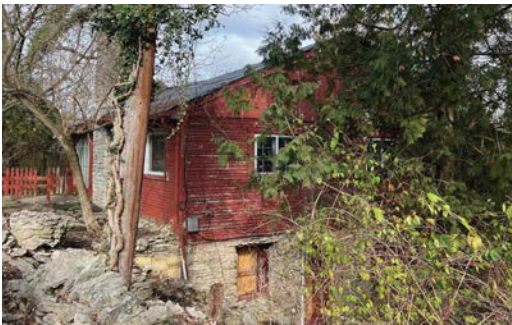
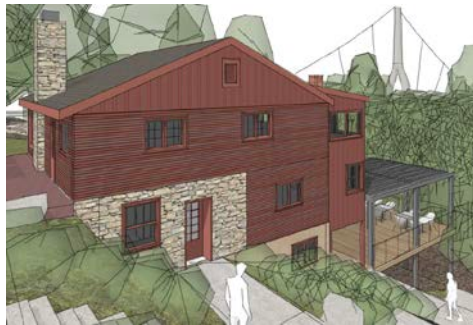
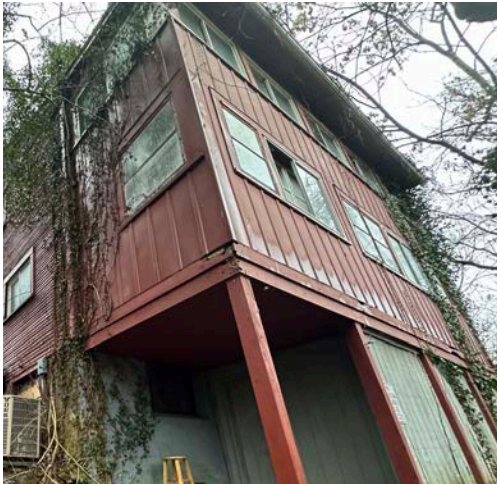
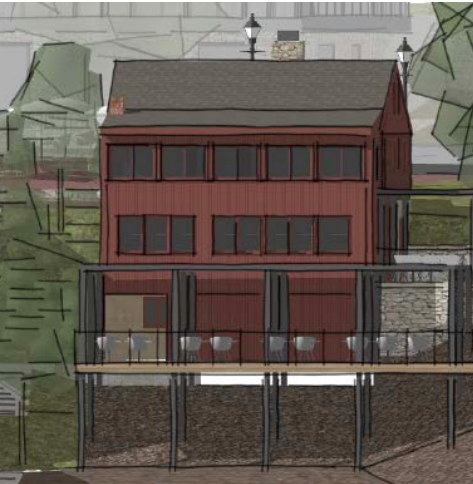
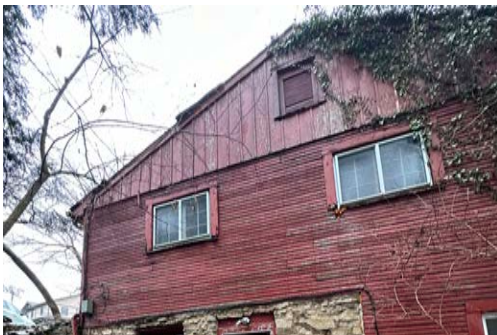
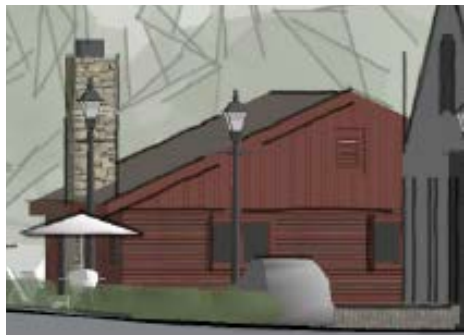
62 N Riverview Street:

Below are comparisons of the existing structure to the conceptual design:
